DELAWARE COUNTY, INDIANA
CULVERT INSPECTION & REPORT

DECEMBER 31, 2008

SMALL BRIDGE INSPECTION REPORT

DELAWARE COUNTY, INDIANA
December 31, 2008

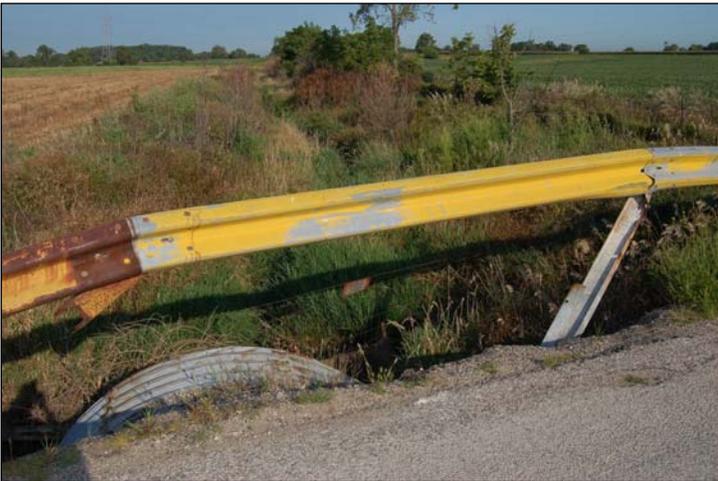
Damaged Railing

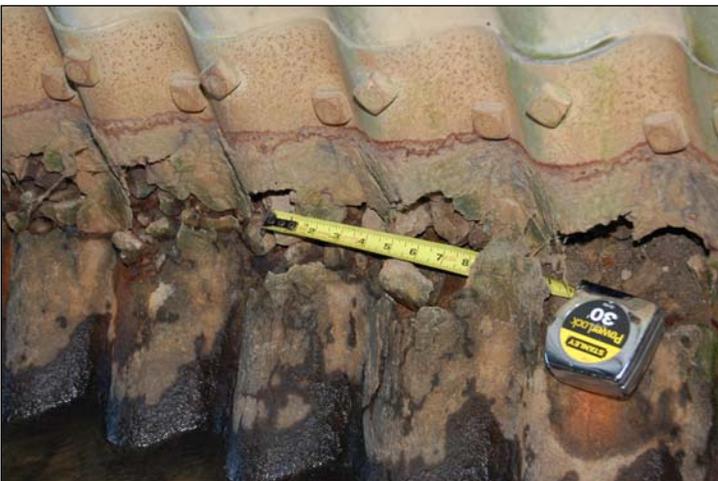
Corrosion - up close

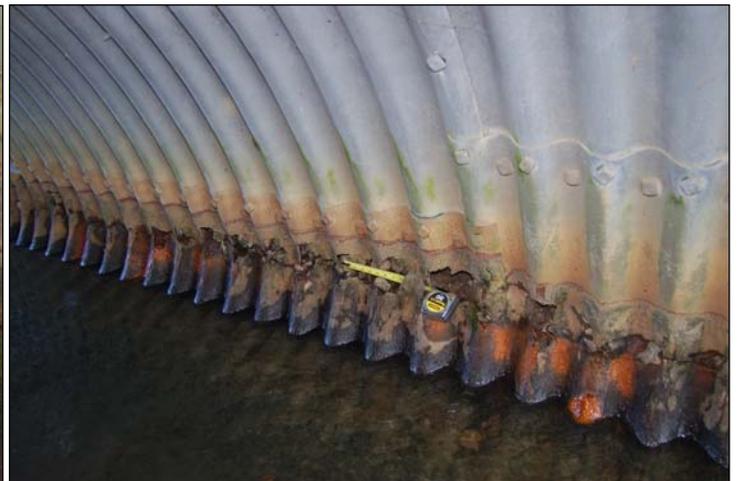
Corrosion – North Side

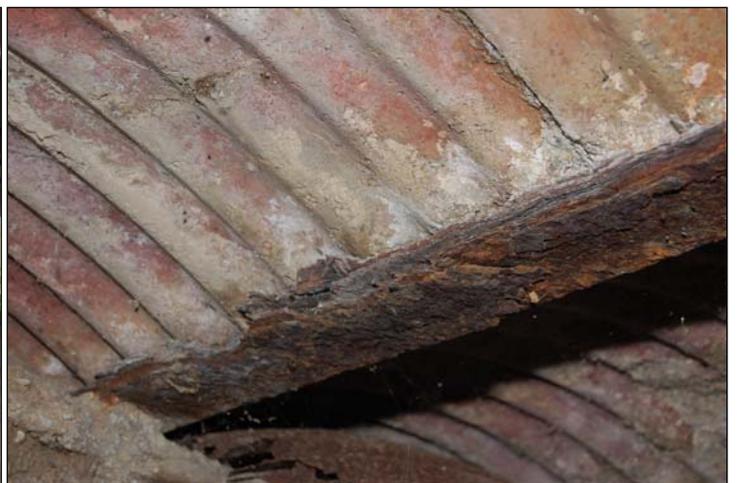
Beam Corrosion
