CITY OF MUNCIE, INDIANA  
**American with Disabilities Act  
Transition and Implementation Plan**

December 2, 2011

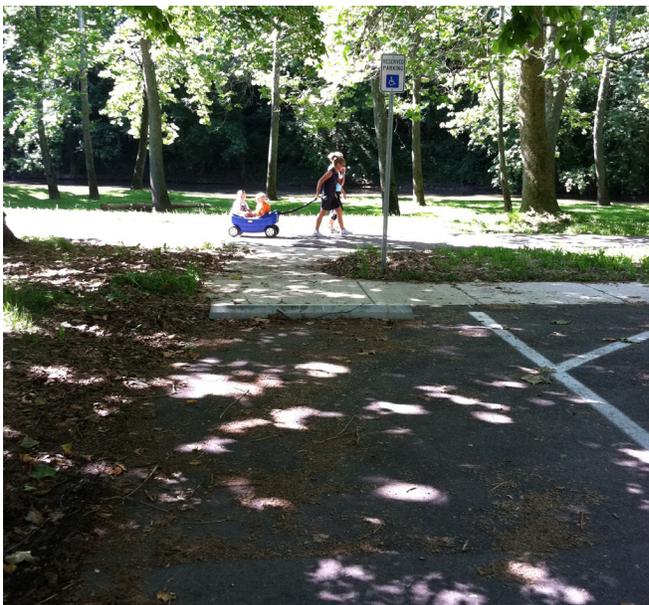
Accessible parking at trailhead

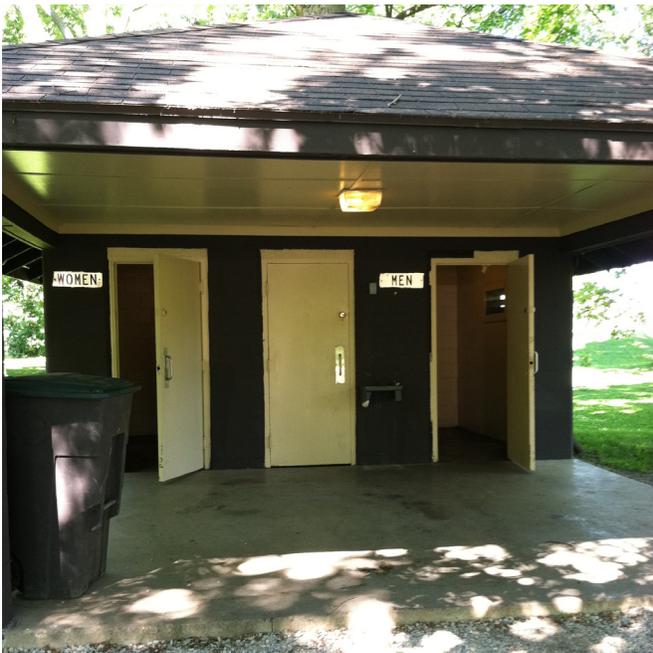
Restroom building with attached drinking fountain

COMPLIANCE ITEM AND CORRECTIVE ACTION	PRIORITY	ESTIMATED COST
Provide accessible route from Playground ADA parking stall to the restroom. Replace gravel path from park road to restroom building with paved walk.	High	\$5.00 LF (5' wide, asphalt)

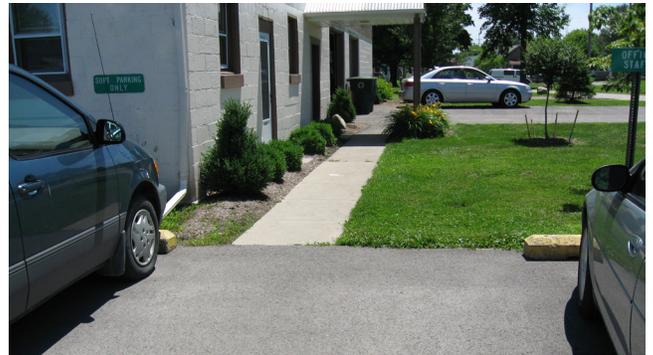
*Right*  
Proposed location of accessible parking at park office.

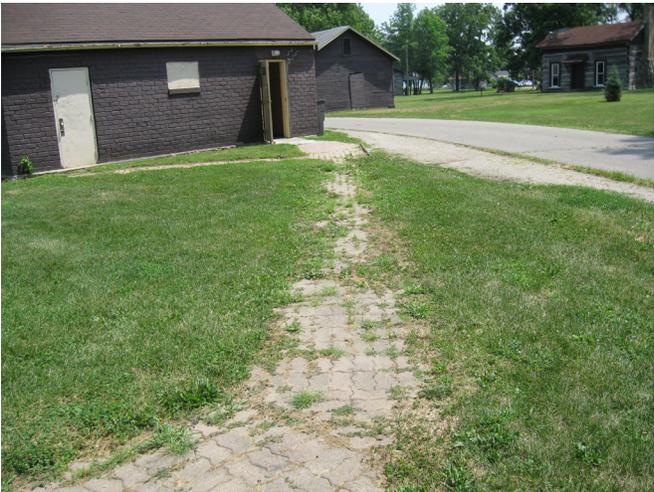
Approach to Men’s Restroom Door

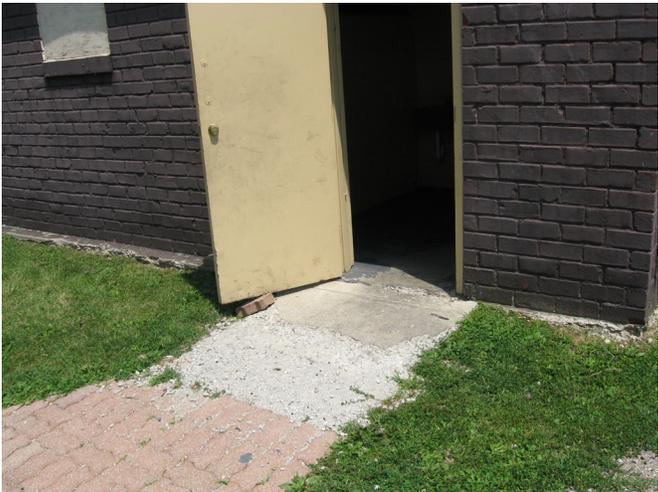
Concrete Pad at Men’s Restroom Door

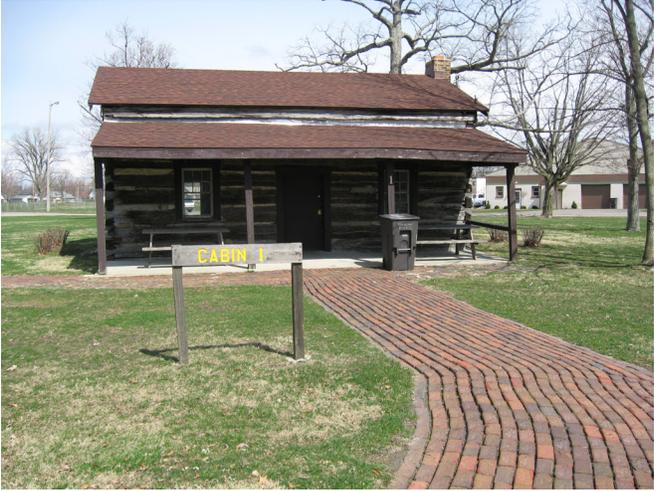
Cabin 1 Approach

COMPLIANCE ITEM AND CORRECTIVE ACTION	PRIORITY	ESTIMATED COST
Repair or replace walk to Cabin 1	High	\$2.50 SF (asphalt) \$4.00 SF (concrete)
Repair or replace walk to Cabin 2	Low	\$2.50 SF (asphalt) \$4.00 SF (concrete)
Repair or replace walk to Cabin 4	High	\$2.50 SF (asphalt) \$4.00 SF (concrete)
Repair or replace walk to Cabin 5	High	\$2.50 SF (asphalt) \$4.00 SF (concrete)

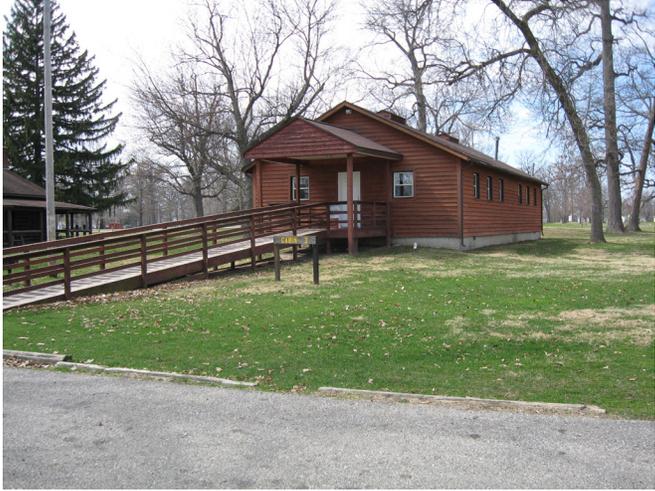
Cabin 3 Approach

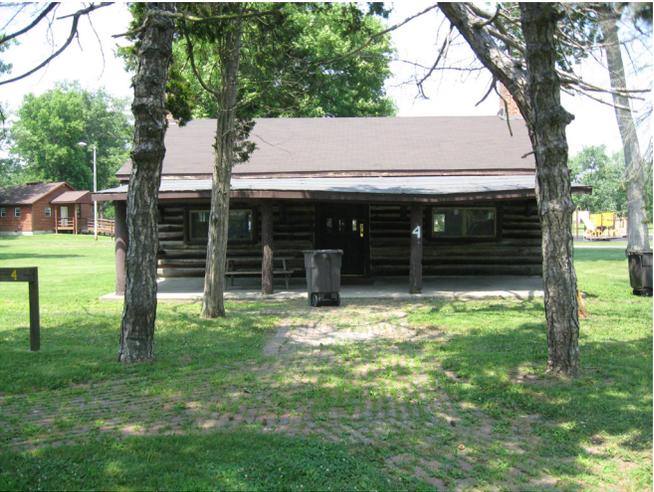
Cabin 4 Approach

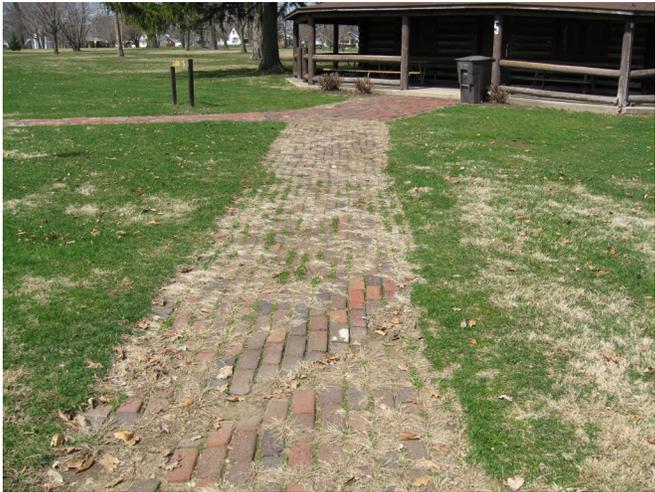
Cabin 5 Approach
