DELAWARE COUNTY, INDIANA
CULVERT INSPECTION & REPORT

DECEMBER 31, 2008

SMALL BRIDGE INSPECTION REPORT

DELAWARE COUNTY, INDIANA
December 31, 2008

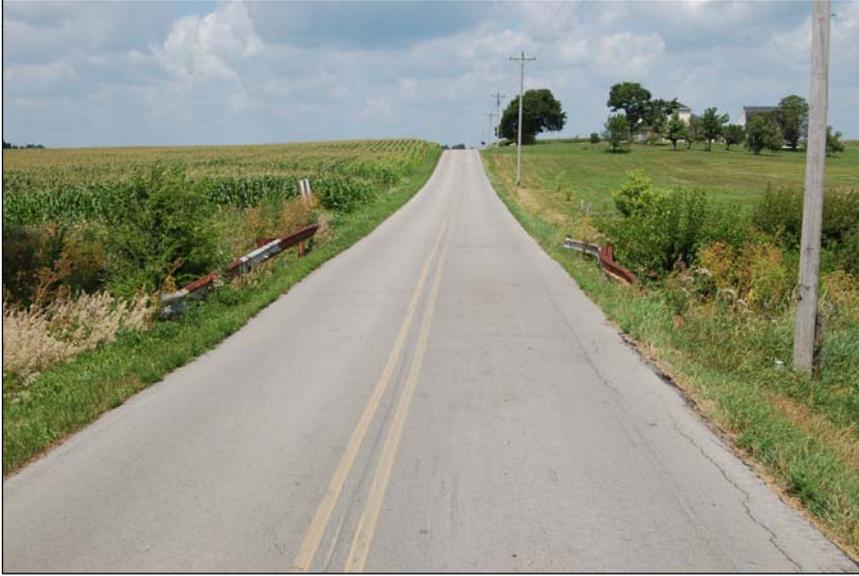
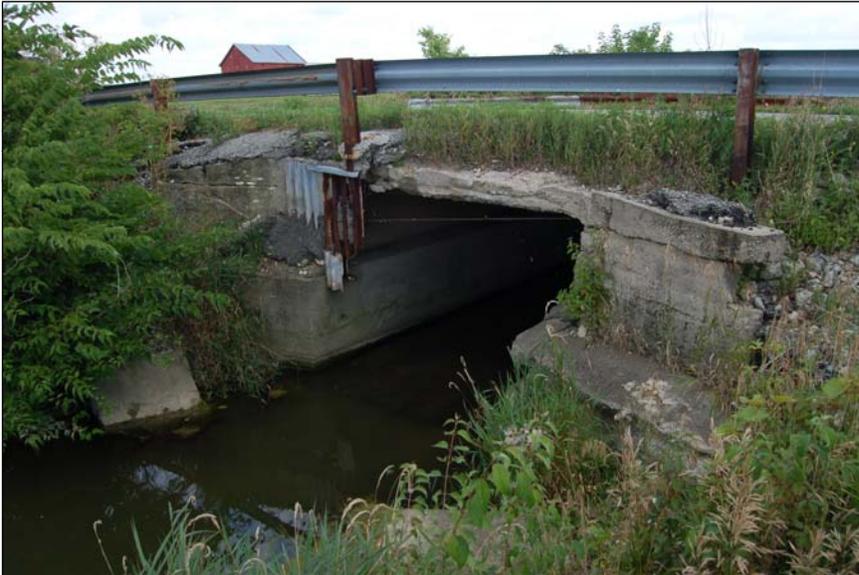
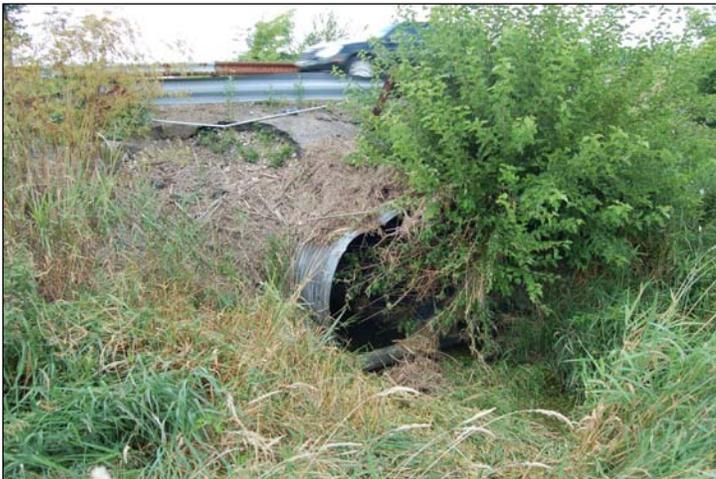
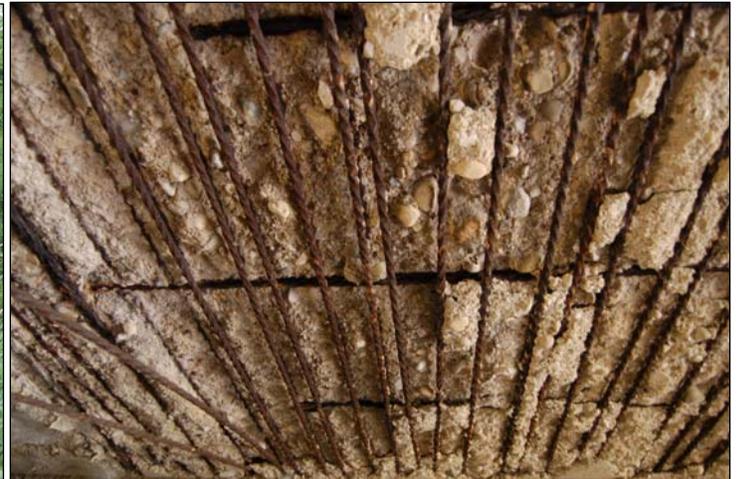
Small Bridge No. 0095

Poor, heavy spalling

Poor, heavy spalling & rust

Poor, failed

Remarks: Recommend 12-month reinspection.

<u>Description</u>	<u>Priority</u>	<u>Cost</u>
Bank/Stream:		
Safety-Signs: Post "5 Ton Weight Limit"	1	\$60
Safety-GR:		
Replace: Replace structure	2	\$48,600
Road/Shld:		
Other:

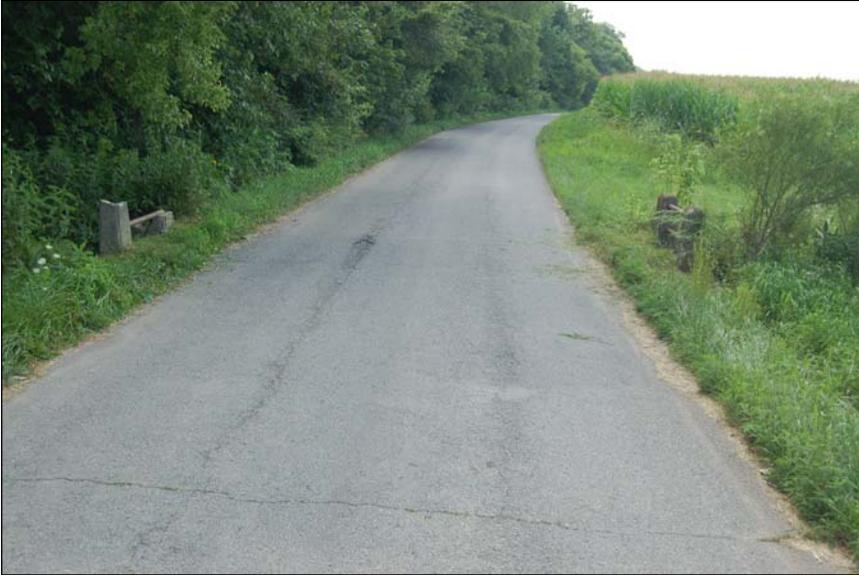
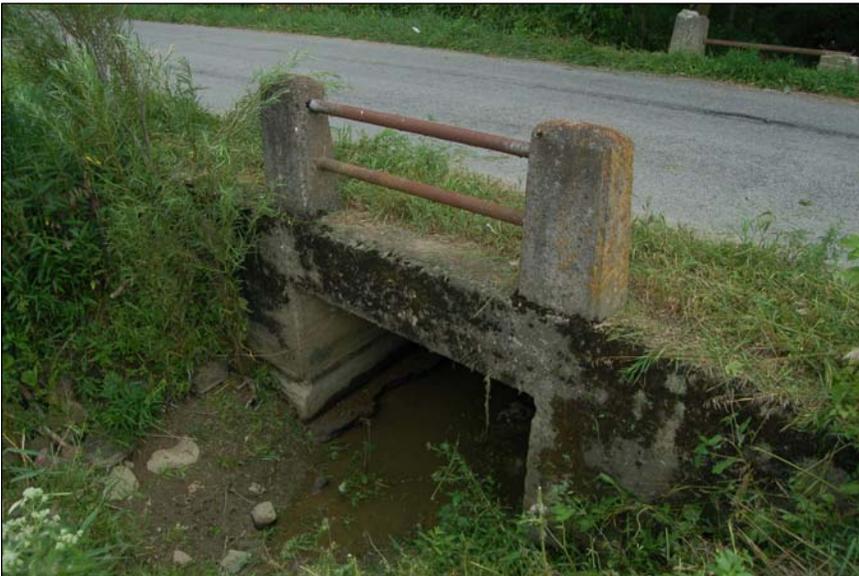
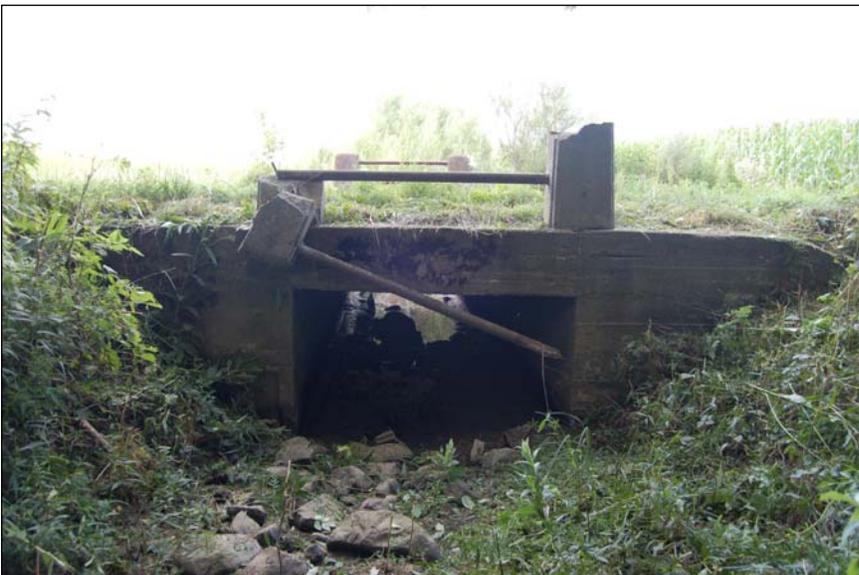
Small Bridge No. 0128

Failed south

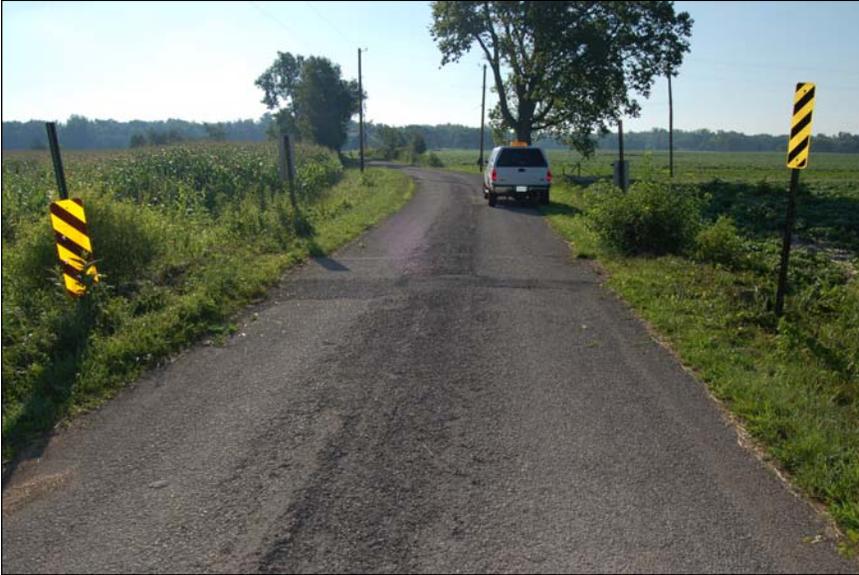
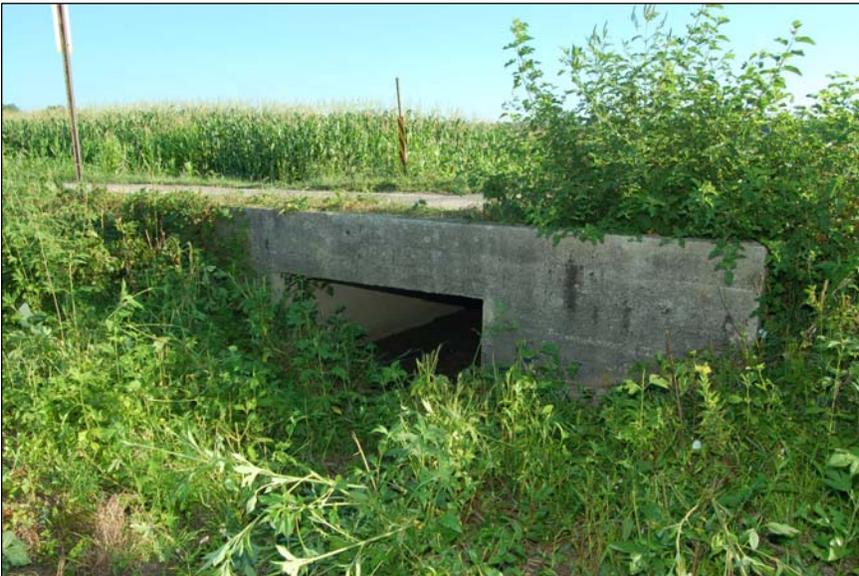
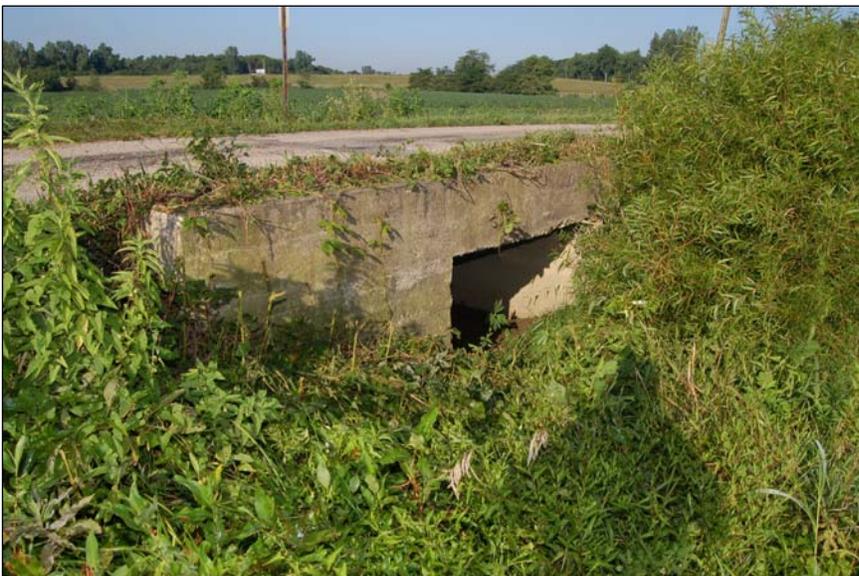
Small Bridge No. 0164

Fair, moderate rust

Safety-Signs: Remount loose OM3s

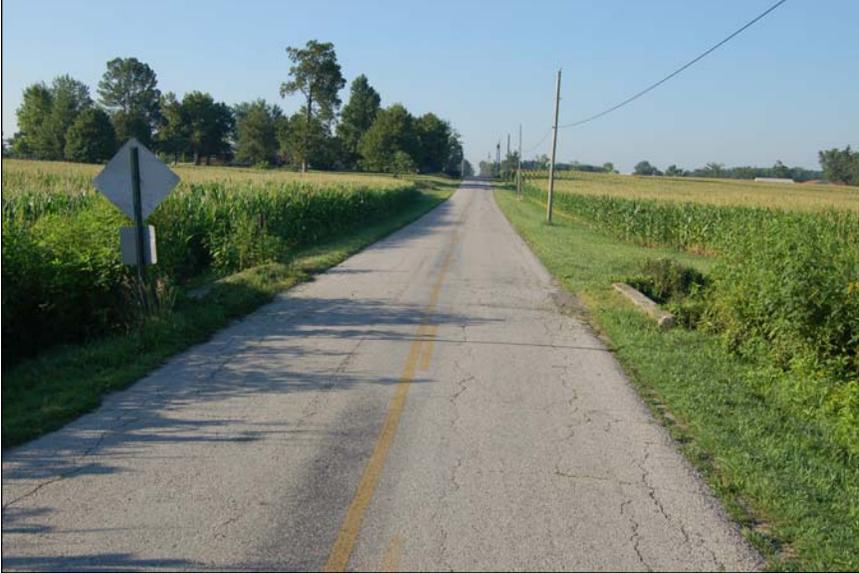
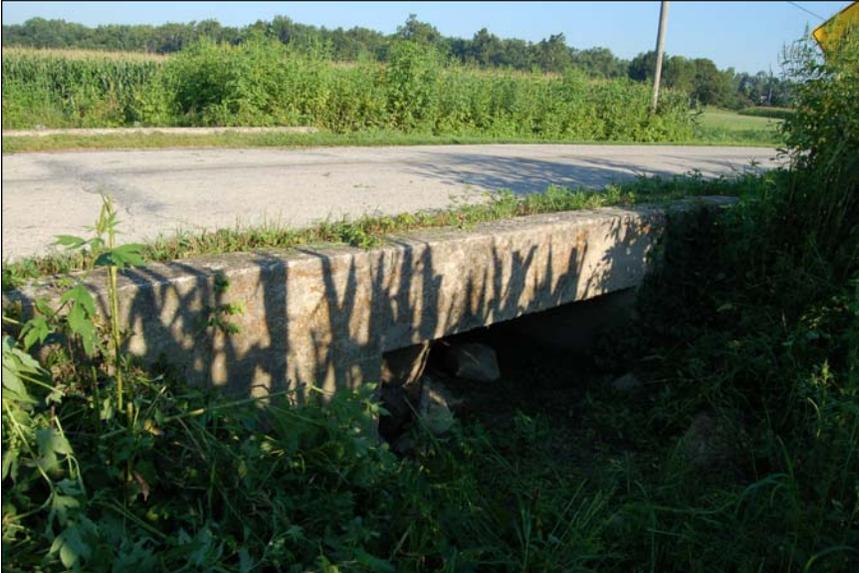
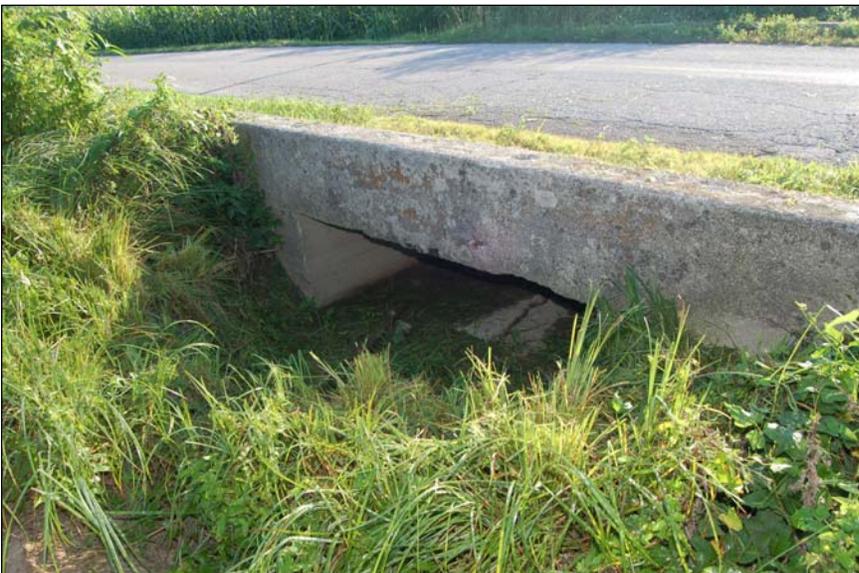
Small Bridge No. 0170

Deck: Concrete	Good
Superstructure: Steel Beam Encased	Good
Substructure: Concrete	Good
Channel: None	n.a.
Headwall: Concrete	Good
Culvert: n.a.	n.a.
Road: Chip & Seal	Fair, cracked
Rail: None	n.a.
Load Rating: H20

<u>Description</u>	<u>Priority</u>	<u>Cost</u>
Bank/Stream:		
Safety-Signs: Place OM2s	3.4	\$38
Safety-GR:		
Replace:		
Road/Shld:		
Other:

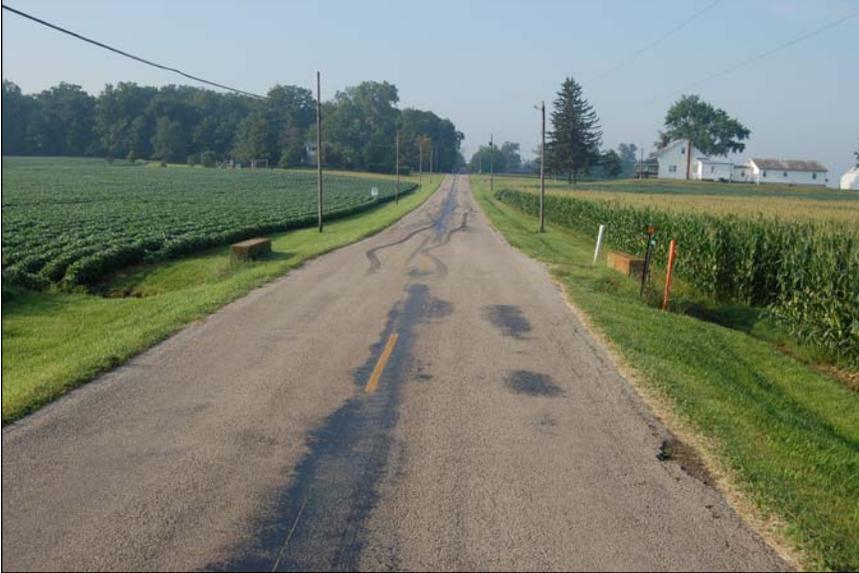
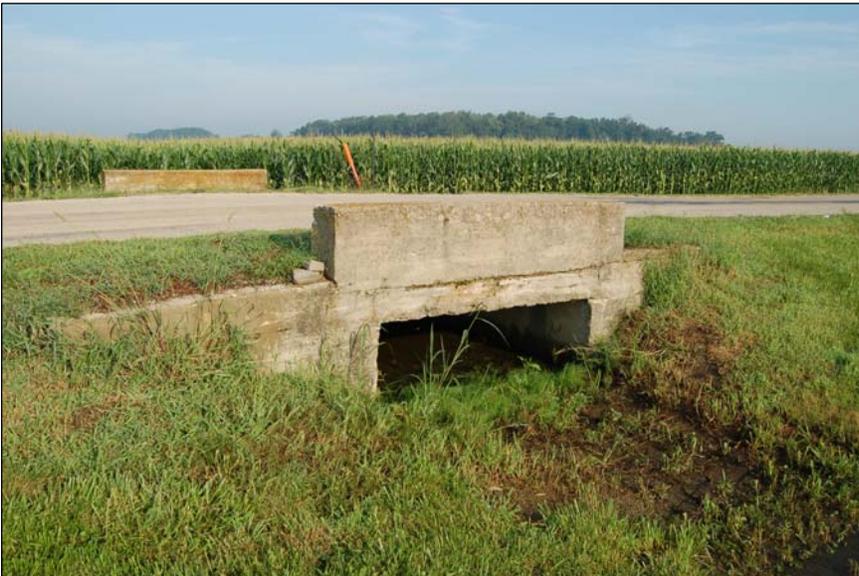
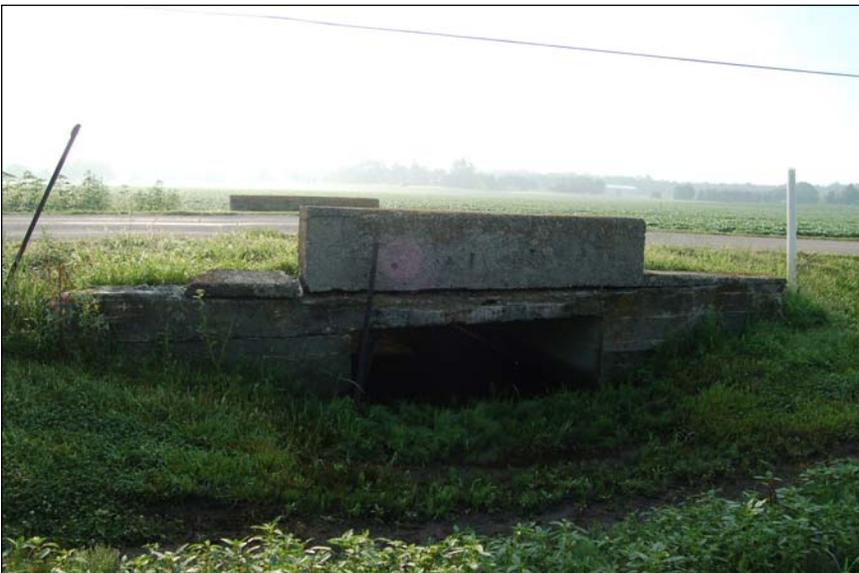
Small Bridge No. 0178

Deck: Concrete Good
Superstructure: Reinforced Concrete Slab Good, light spalling & rust
Substructure: Concrete Good, light to moderate spalling
Channel: None n.a.
Headwall: Concrete Good
Culvert: n.a. n.a.
Road: Chip & Seal Good
Rail: None n.a.
Load Rating: H20

<u>Description</u>	<u>Priority</u>	<u>Cost</u>
Bank/Stream:		
Safety-Signs: Place OM2s	3.7	\$38
Safety-GR:		
Replace:		
Road/Shld:		
Other:

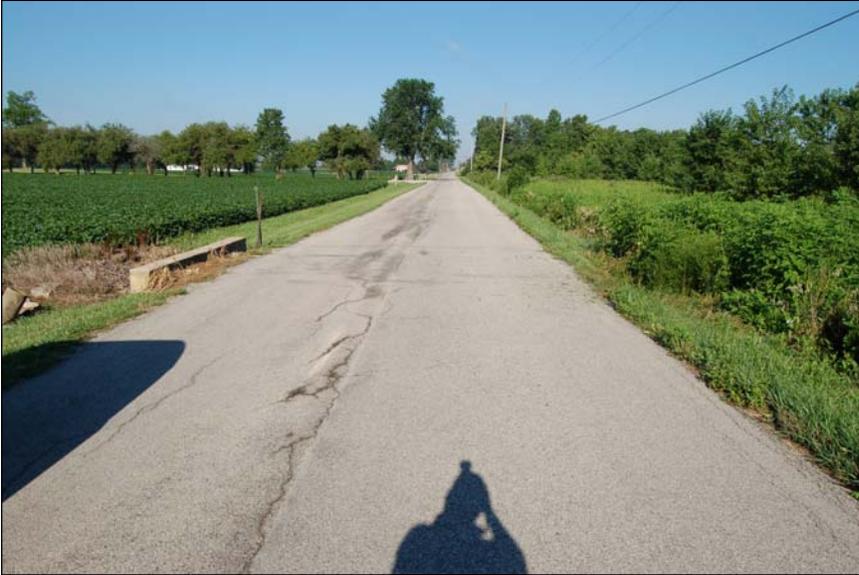
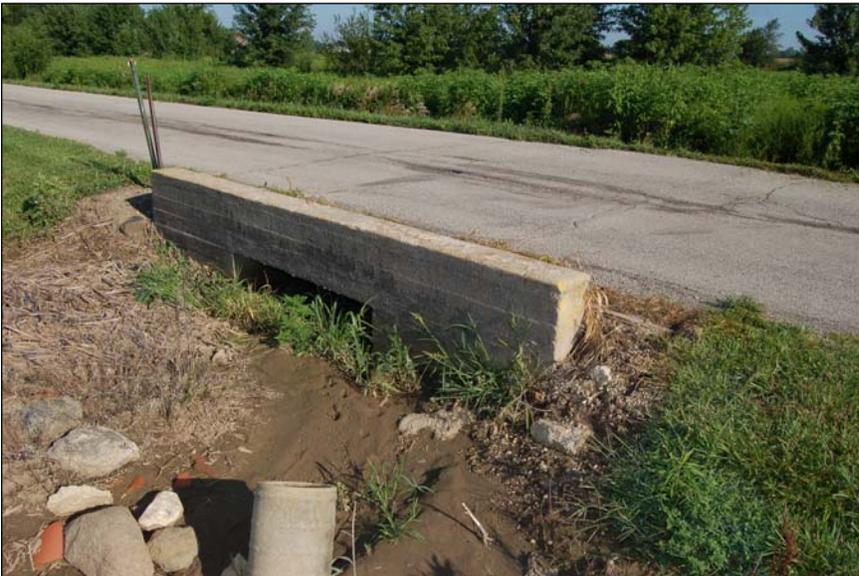
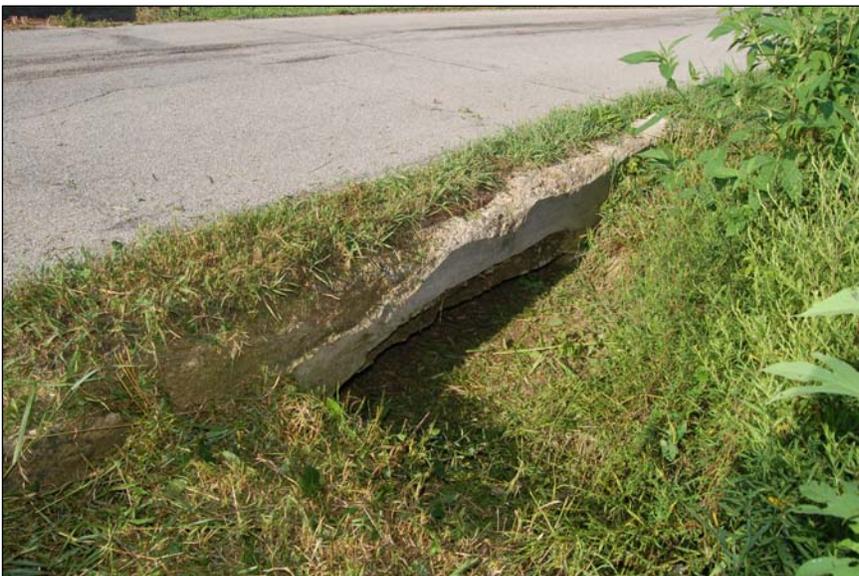
Small Bridge No. 0230

<u>MATERIAL</u>	<u>CONDITION</u>
Deck: Concrete	Fair, minor efflorescence
Superstructure: Steel Beam Encased	Good, light rust
Substructure: Concrete	Good
Channel: None	n.a.
Headwall: Concrete	Good
Culvert: n.a.	n.a.
Road: Chip & Seal	Fair, cracked
Rail: None	n.a.
Load Rating: H20

<u>Description</u>	<u>Priority</u>	<u>Cost</u>
Bank/Stream:		
Safety-Signs: Place OM2s	3.2	\$38
Safety-GR:		
Replace:		
Road/Shld:		
Other:

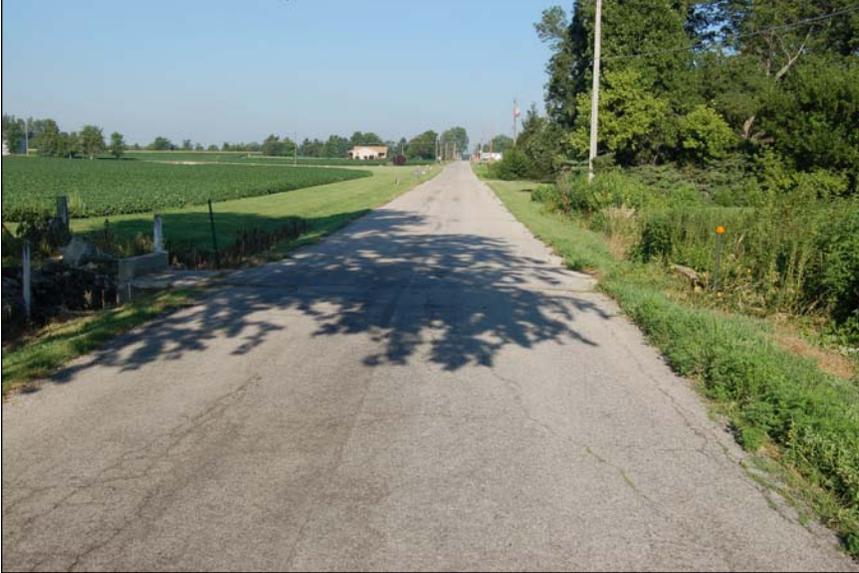
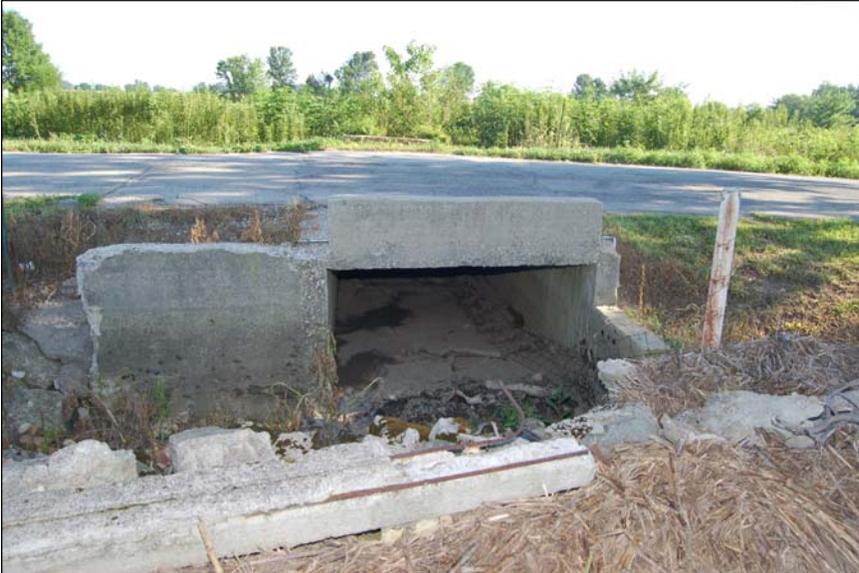
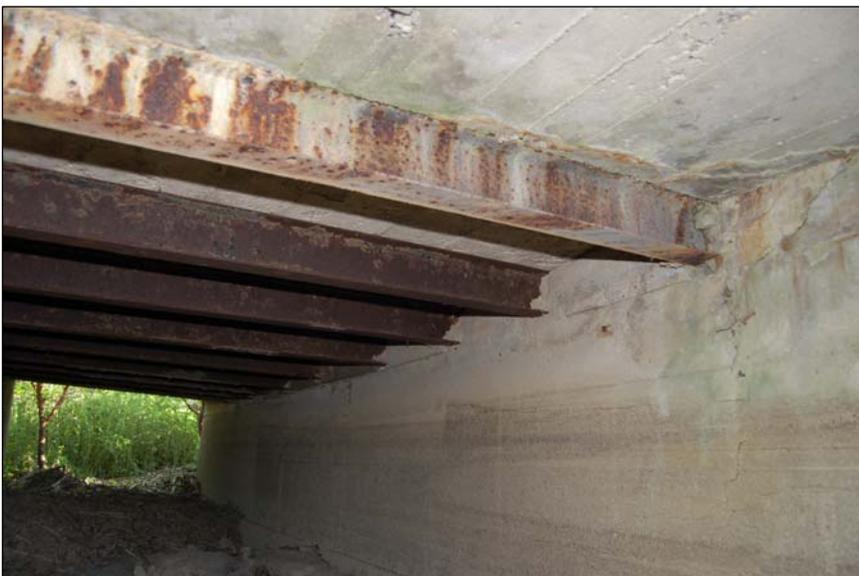
Small Bridge No. 0231

<u>MATERIAL</u>	<u>CONDITION</u>
Deck: Concrete	Fair, minor spalling
Superstructure: Steel Beam	Fair, moderate rust
Substructure: Concrete	Good
Channel: Grass	Good
Headwall: Concrete	Heavy spalling southwest
Culvert: n.a.	n.a.
Road: Chip & Seal	Fair, moderate cracks
Rail: None	n.a.
Load Rating: H17

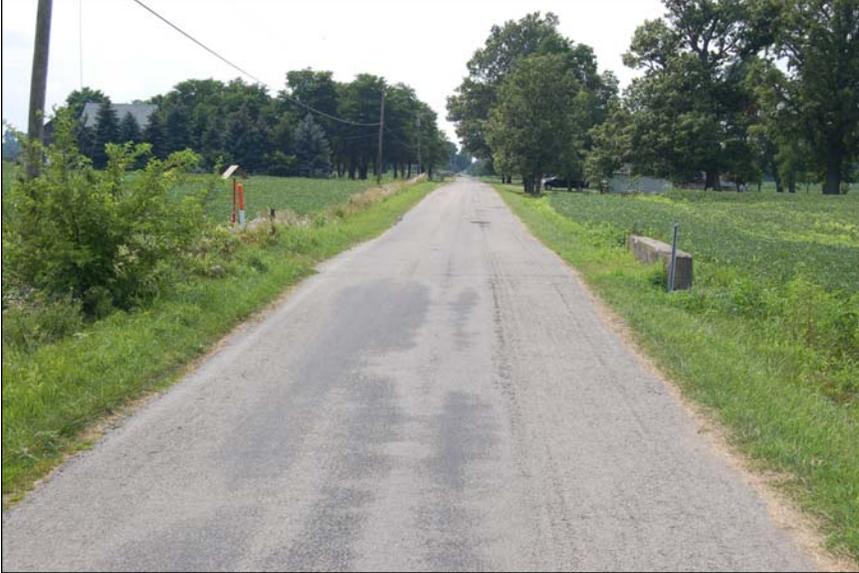
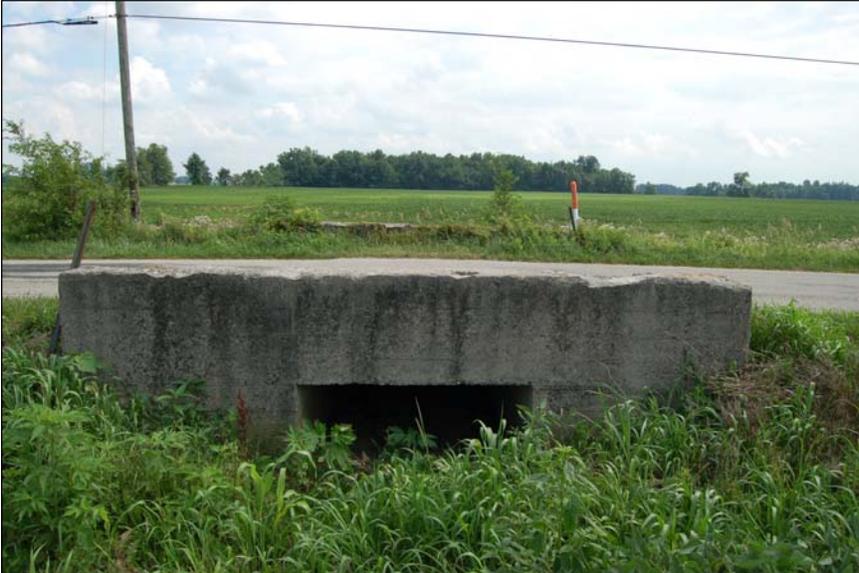
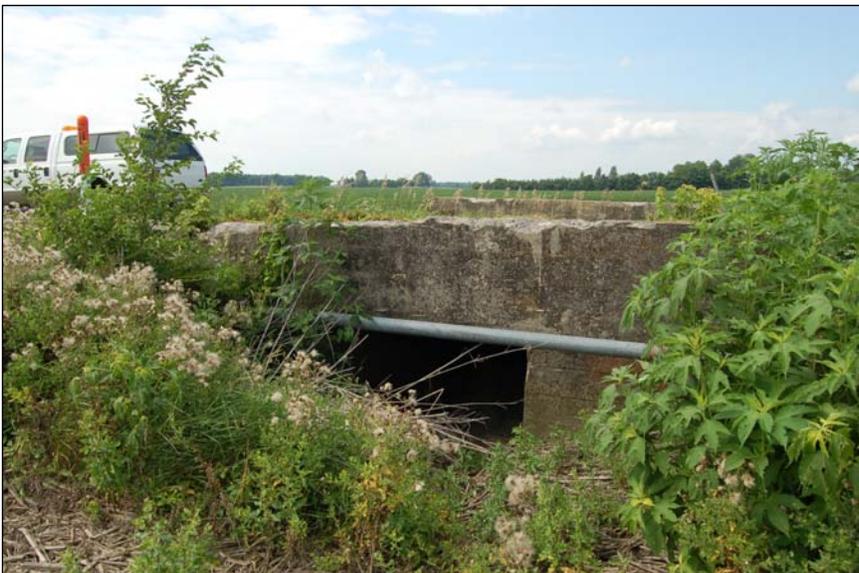
Small Bridge No. 0321

<u>MATERIAL</u>	<u>CONDITION</u>
Deck: Concrete	Good
Superstructure: Reinforced Concrete Slab	Good
Substructure: Concrete	Minor cracks
Channel: None	n.a.
Headwall: Concrete	Good
Culvert: n.a.	n.a.
Road: Chip & Seal	Fair, rough
Rail: Concrete	Not current standards
Load Rating: H20

<u>Description</u>	<u>Priority</u>	<u>Cost</u>
Bank/Stream:		
Safety-Signs: Place OM2s	3.8	\$38
Safety-GR:		
Replace:		
Road/Shld:		
Other:

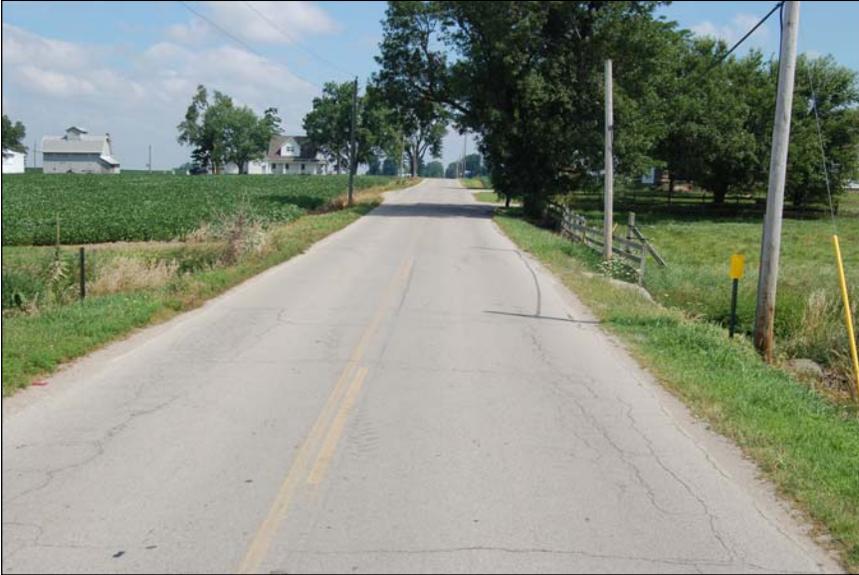
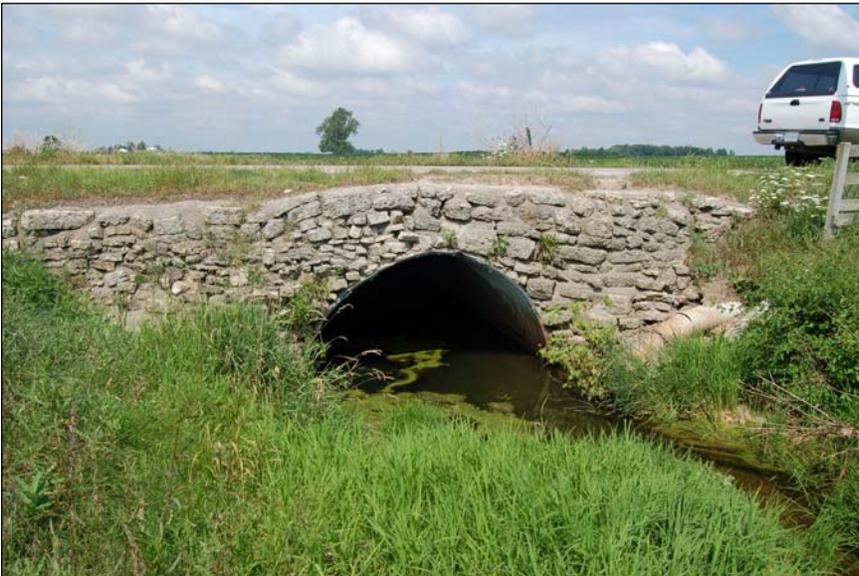
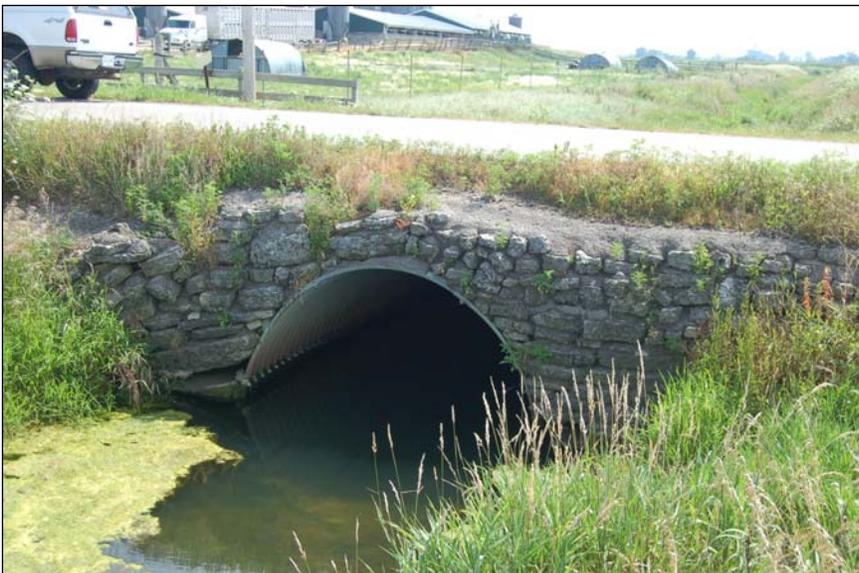
Small Bridge No. 0340

Deck: n.a. n.a.
Superstructure: n.a. n.a.
Substructure: n.a. n.a.
Channel: Grass Good
Headwall: Stone Good
Culvert: Multi Plate Pipe Arch Good
Road: Chip & Seal Good, minor cracks
Rail: None n.a.
Load Rating: H20

<u>Description</u>	<u>Priority</u>	<u>Cost</u>
Bank/Stream:		
Safety-Signs: Place OM2s	3.5	\$38
Safety-GR:		
Replace:		
Road/Shld:		
Other:

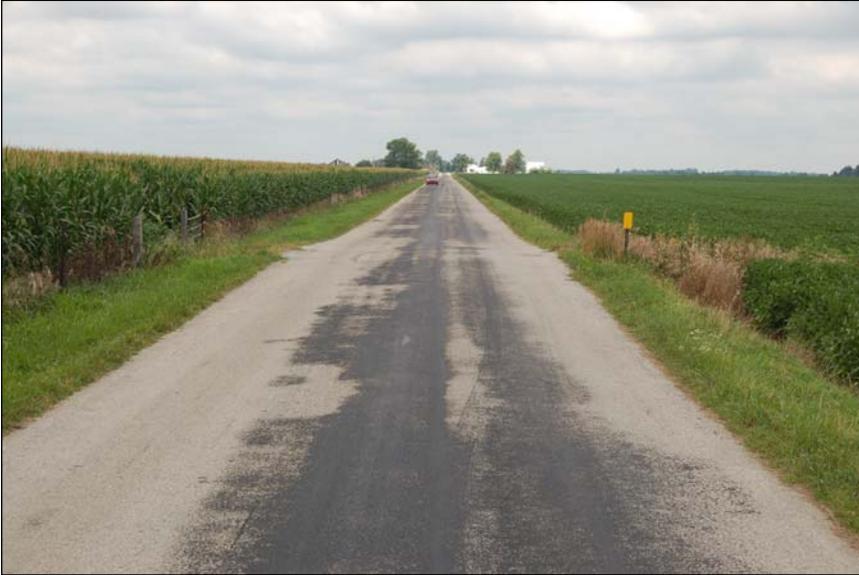
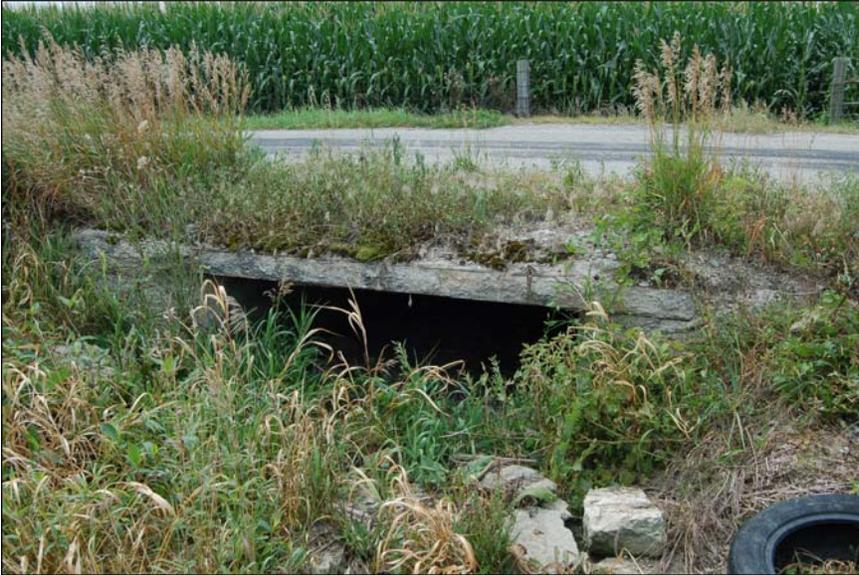
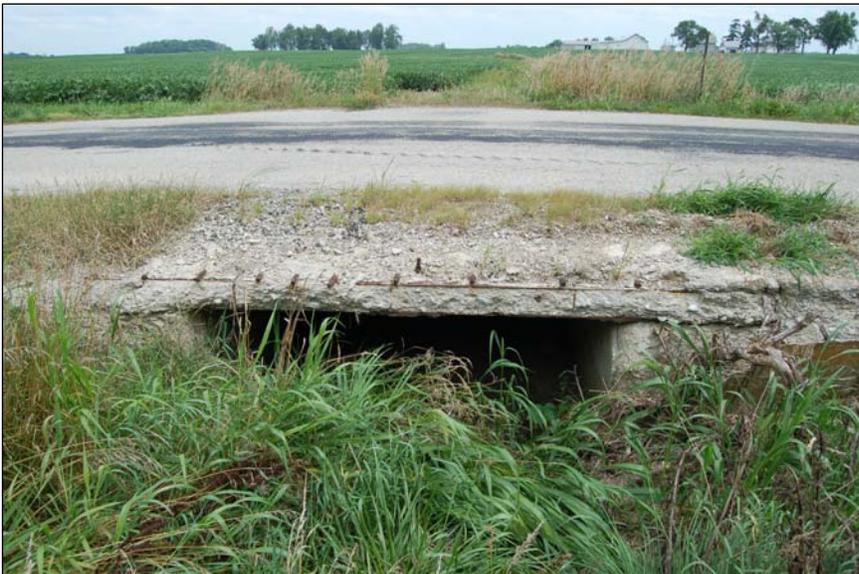
Small Bridge No. 0355

Deck: Concrete Good, spalling at edges
Superstructure: Steel Beam Encased Good, light rust
Substructure: Concrete Good
Channel: Grass Good
Headwall: Concrete Fair, spalled
Culvert: n.a. n.a.
Road: Chip & Seal Good
Rail: None n.a.
Load Rating: H18

<u>Description</u>	<u>Priority</u>	<u>Cost</u>
Bank/Stream:		
Safety-Signs: Place OM2s	3.6	\$38
Safety-GR:		
Replace:		
Road/Shld:		
Other:

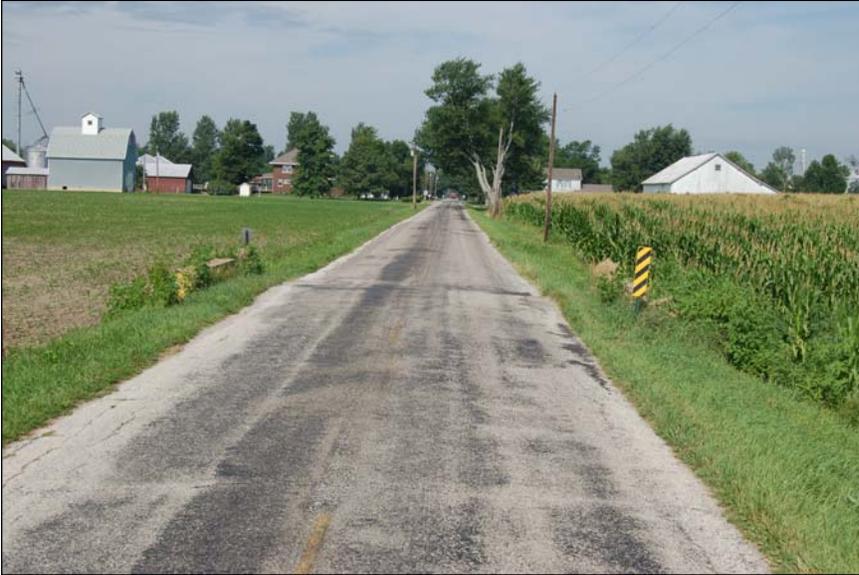
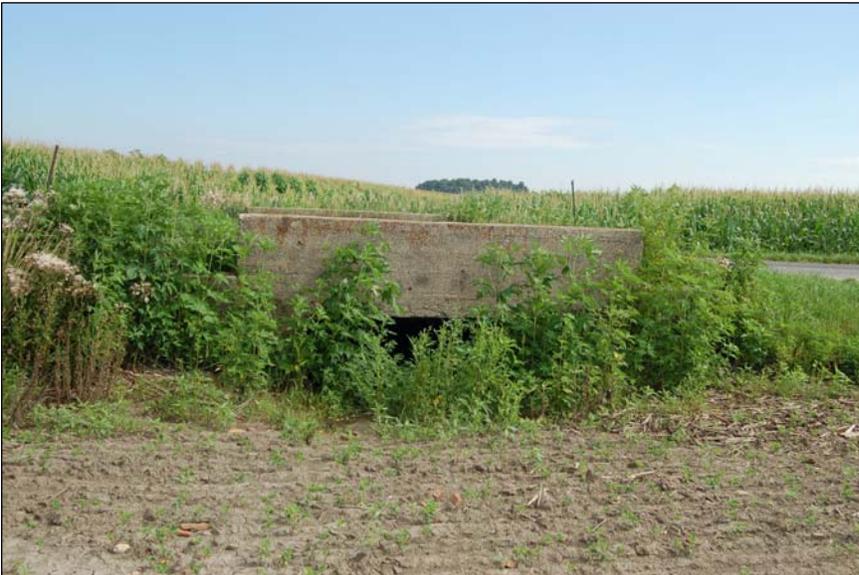
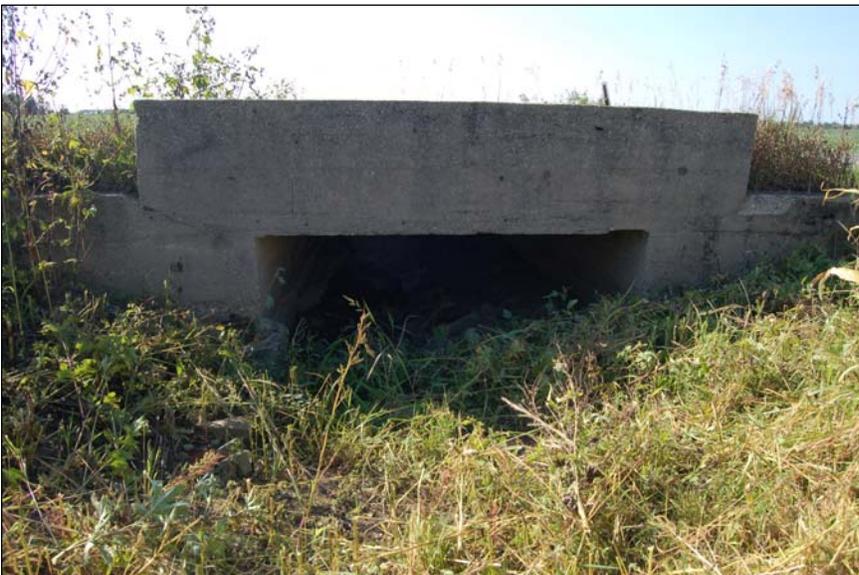
Small Bridge No. 0359

Deck: Concrete	Good
Superstructure: Reinforced Concrete Slab	Good, heavy spalling in one spot
Substructure: Concrete	Good
Channel: None	n.a.
Headwall: Concrete	Good
Culvert: n.a.	n.a.
Road: Chip & Seal	Fair, rough
Rail: Concrete	Not current
Load Rating: H20

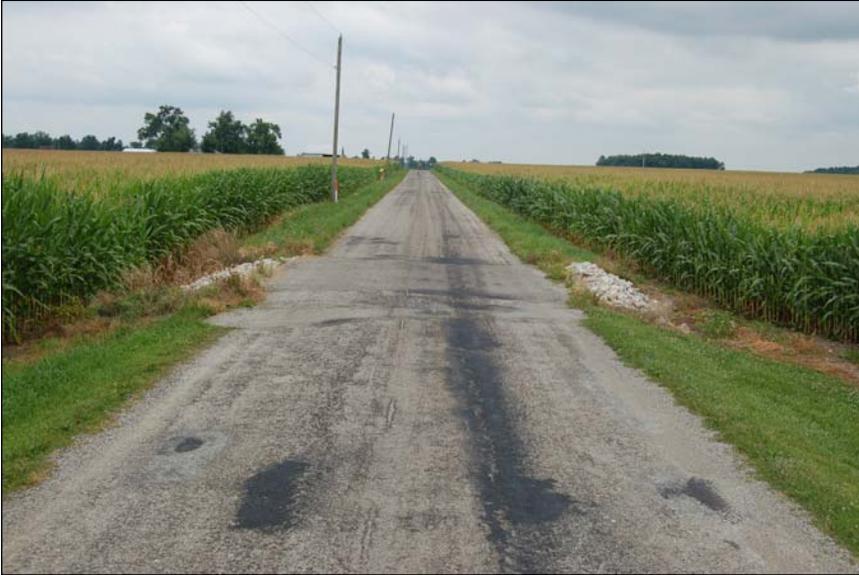
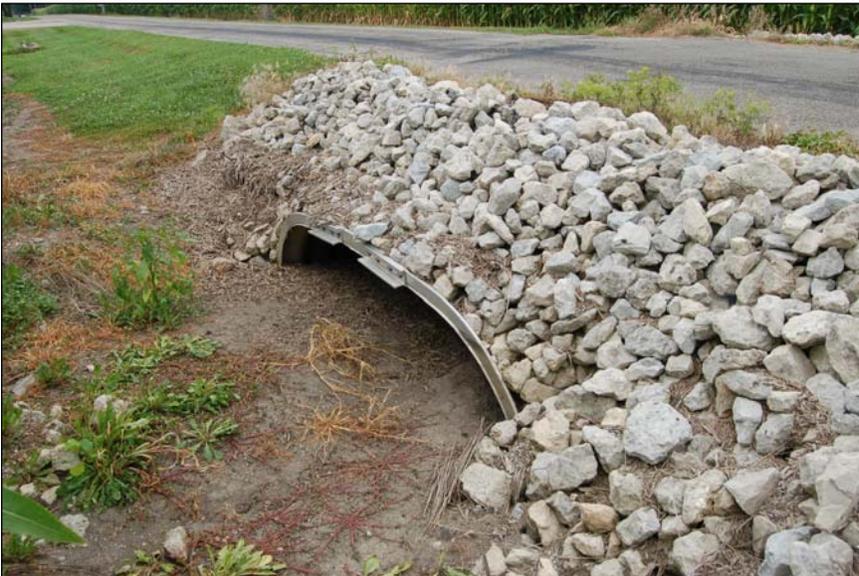
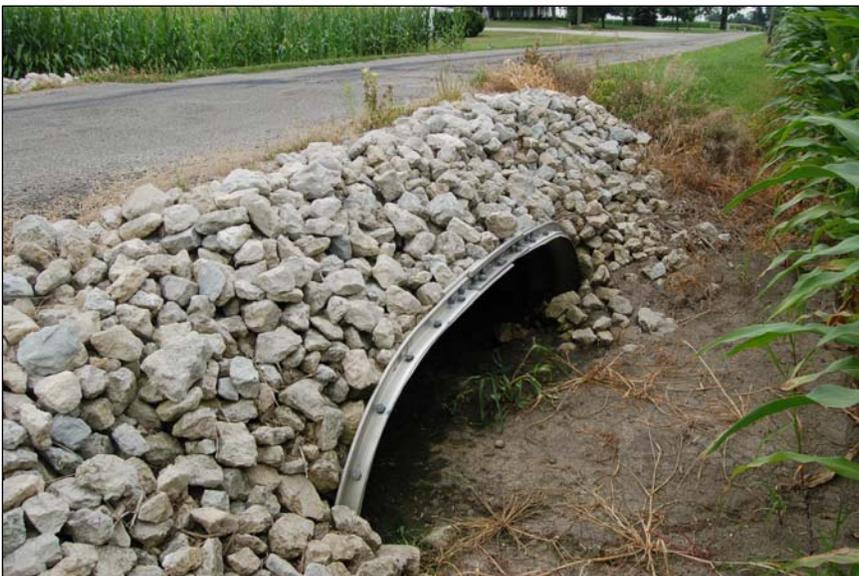
Small Bridge No. 0363

<u>MATERIAL</u>	<u>CONDITION</u>
Deck: n.a.	n.a.
Superstructure: n.a.	n.a.
Substructure: Aluminum Plate	Good
Channel: None	n.a.
Headwall: None	n.a.
Culvert: Aluminum Box Culvert	Good
Road: Chip & Seal	Rough
Rail: None	n.a.
Load Rating: H20

<u>Description</u>	<u>Priority</u>	<u>Cost</u>
Bank/Stream:		
Safety-Signs: Place OM2s.	3.7	\$38
Safety-GR:		
Replace:		
Road/Shld:		
Other:

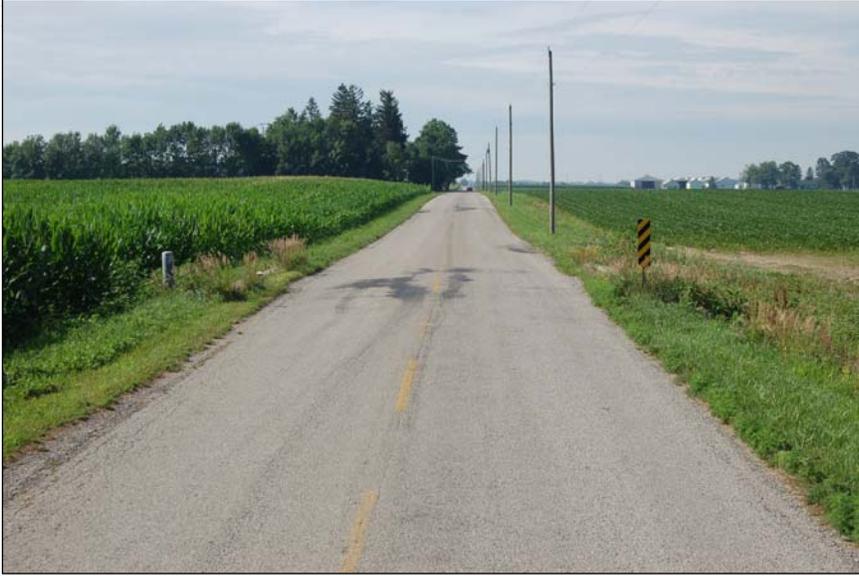
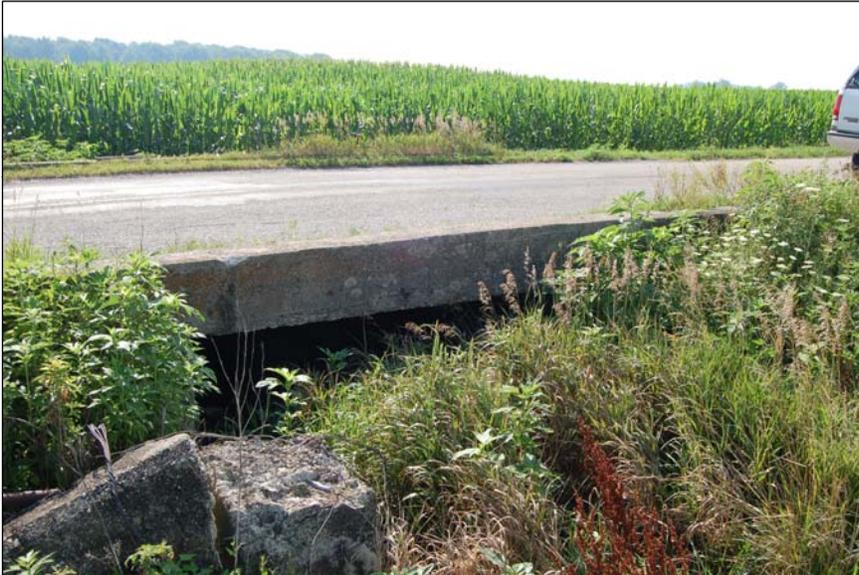
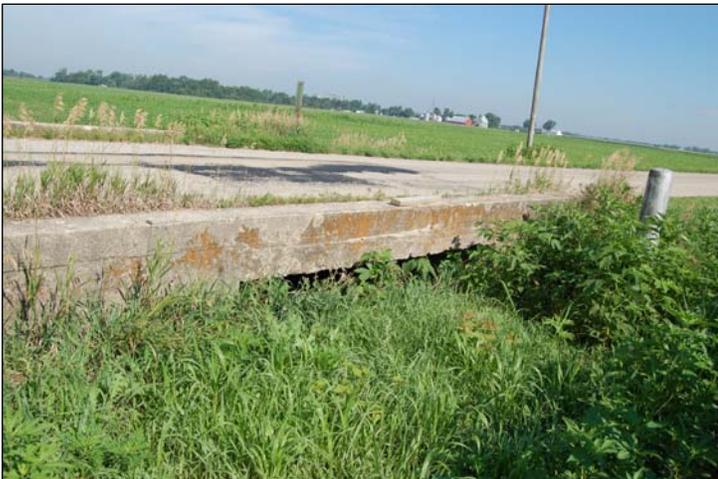
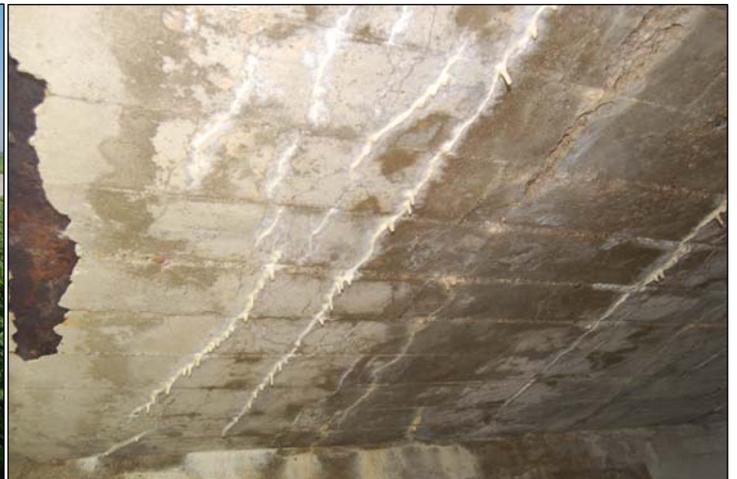
Small Bridge No. 0364

<u>MATERIAL</u>	<u>CONDITION</u>
Deck: Concrete	Poor, spalled
Superstructure: Steel Beam Encased	Poor, moderate to heavy rust, spalling
Substructure: Concrete	Fair, few major cracks
Channel: None	n.a.
Headwall: Concrete	Good
Culvert: n.a.	n.a.
Road: Chip & Seal	Good
Rail: None	n.a.
Load Rating: H17

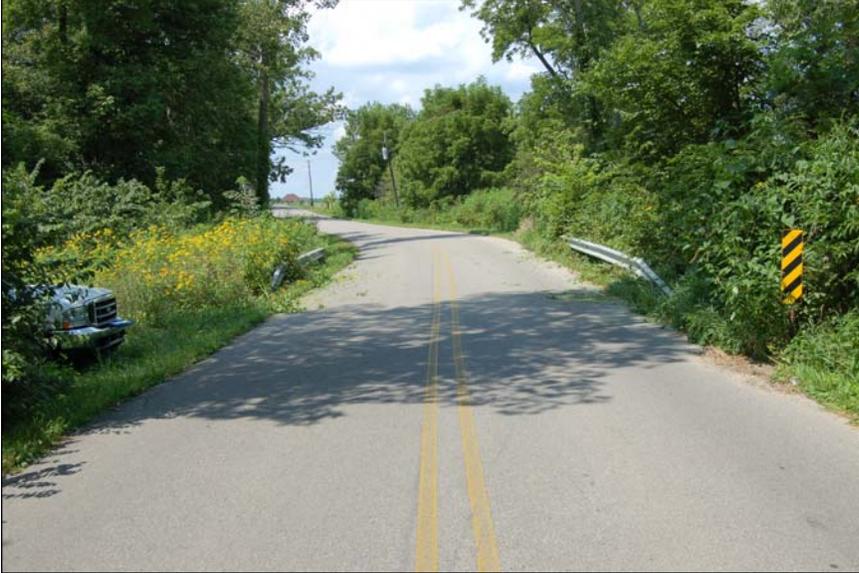
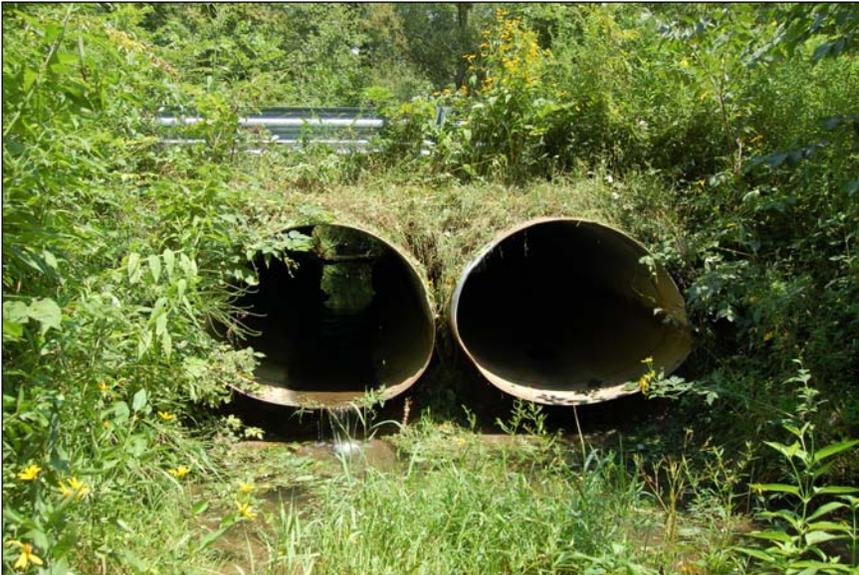
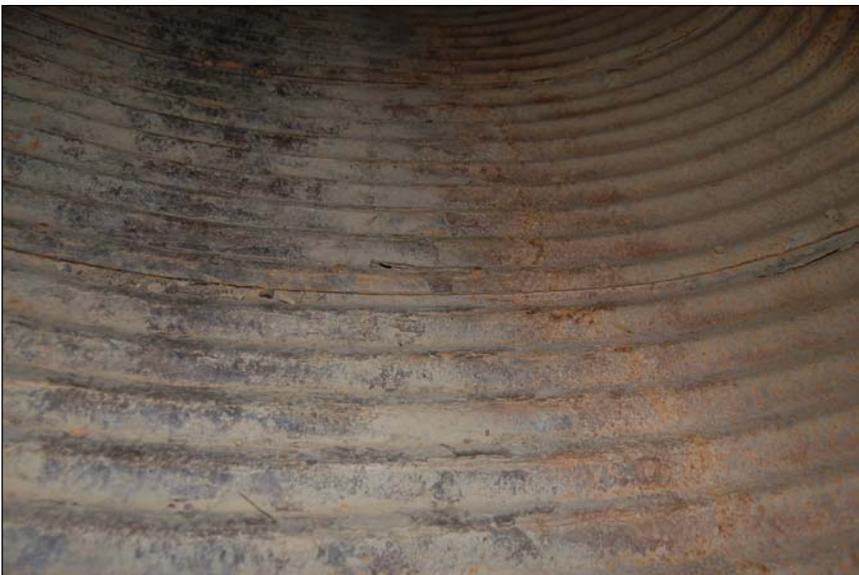
Small Bridge No. 0793

Deck: n.a. n.a.
Superstructure: n.a. n.a.
Substructure: n.a. n.a.
Channel: Natural Overgrown
Headwall: None n.a.
Culvert: Corrugated Metal Pipe Arch Fair, moderate rust
Road: Bituminous Good
Rail: Steel W-shaped Good
Load Rating: H20

<u>Description</u>	<u>Priority</u>	<u>Cost</u>
Bank/Stream:		
Safety-Signs: Add SW OM3	3.3	\$28
Safety-GR:		
Replace:		
Road/Shld:		
Other: Clear vegetation	1	\$0
