DELAWARE COUNTY, INDIANA
CULVERT INSPECTION & REPORT

DECEMBER 31, 2008

SMALL BRIDGE INSPECTION REPORT

DELAWARE COUNTY, INDIANA
December 31, 2008

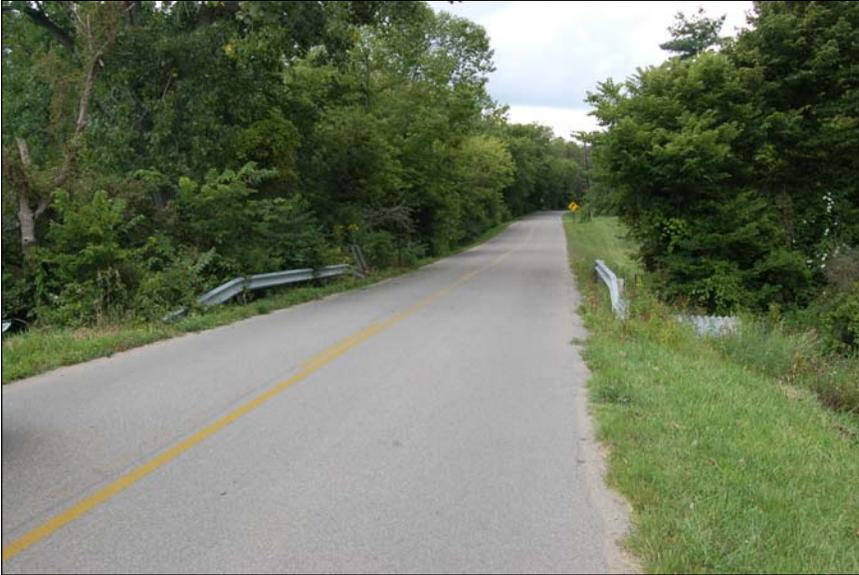
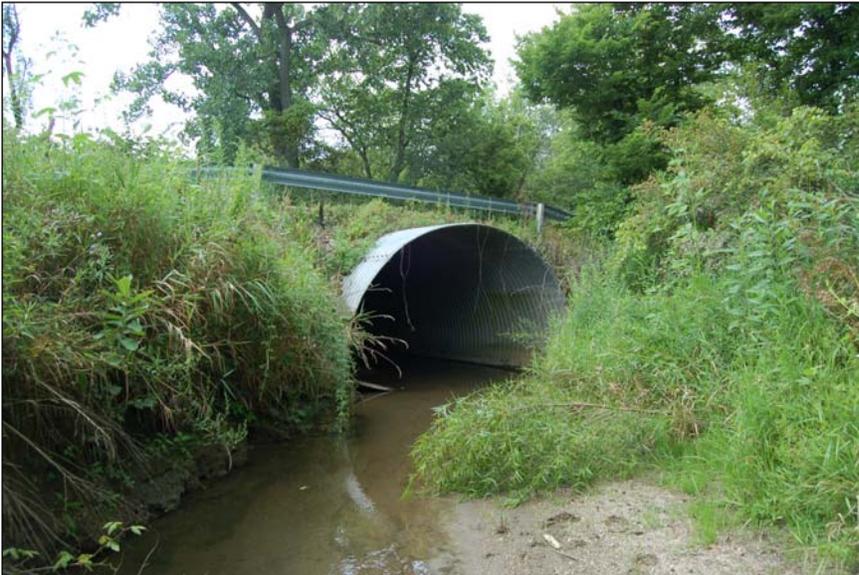
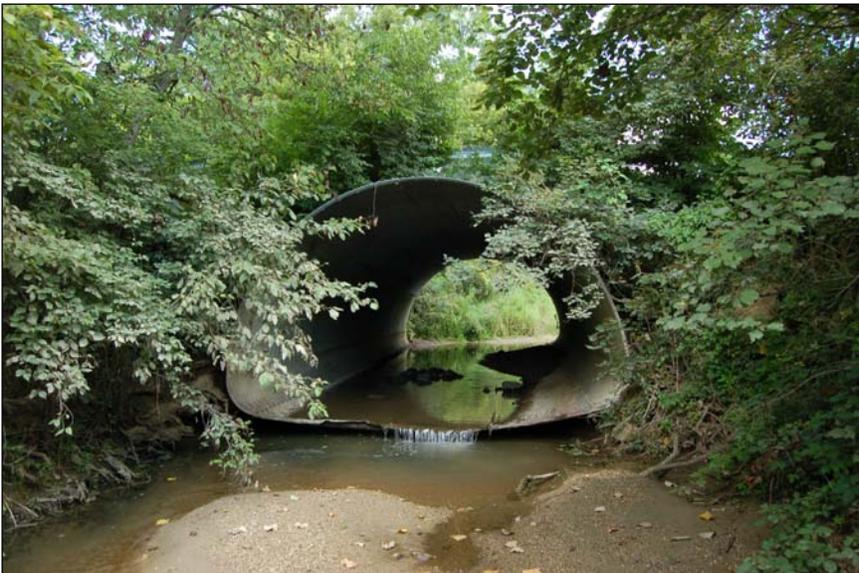
Small Bridge No. 0811

<u>MATERIAL</u>	<u>CONDITION</u>
Deck: n.a.	n.a.
Superstructure: n.a.	n.a.
Substructure: n.a.	n.a.
Channel: Natural	Overgrown, winding
Headwall: None	n.a.
Culvert: Multi Plate Pipe Arch	Good, light rust
Road: Bituminous	Good
Rail: Steel W-shaped	Good
Load Rating: H20

<u>Description</u>	<u>Priority</u>	<u>Cost</u>
Bank/Stream:		
Safety-Signs: Place OM2s	3.2	\$38
Safety-GR:		
Replace:		
Road/Shld:		
Other: Clear vegetation	1	\$0

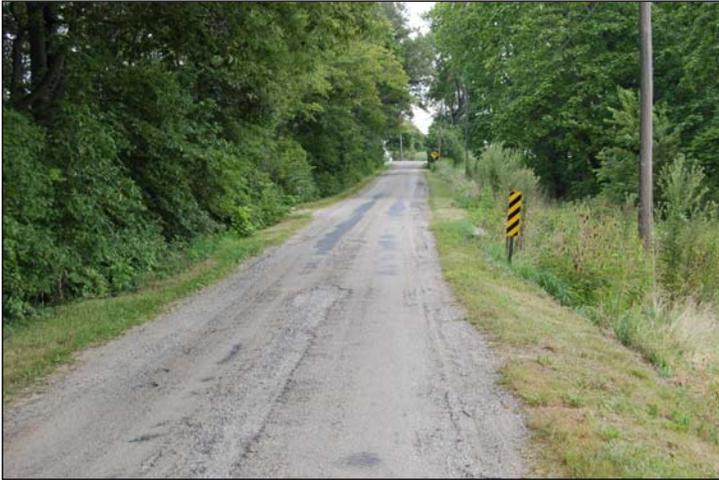
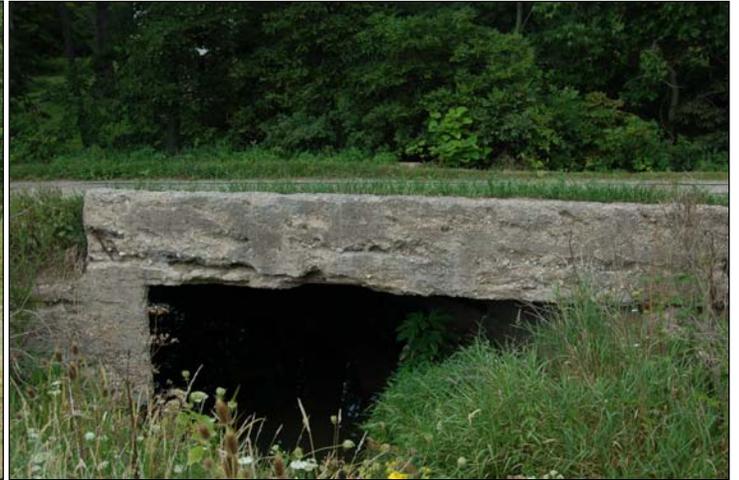
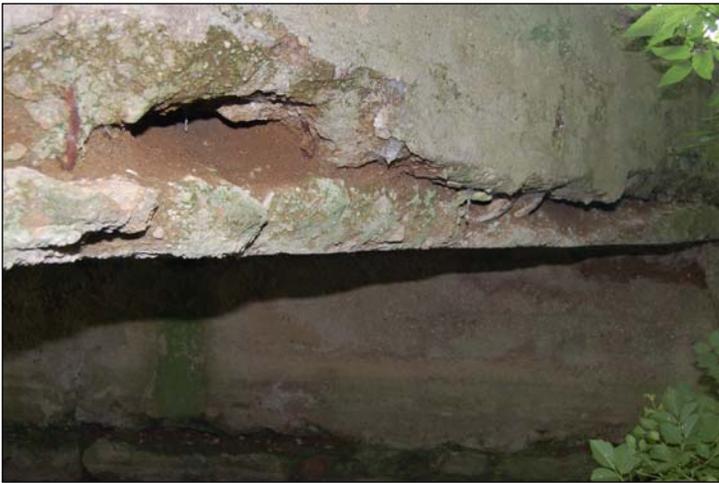
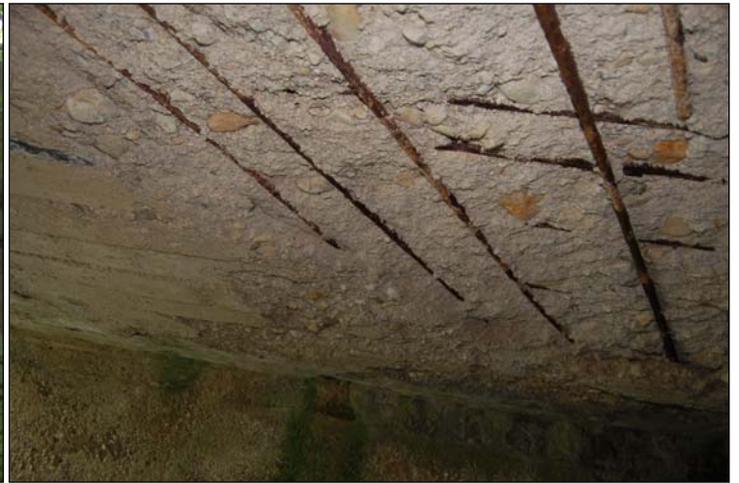
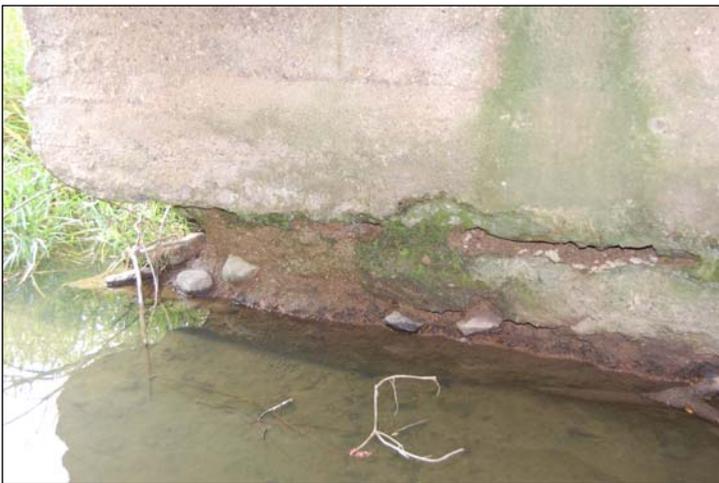
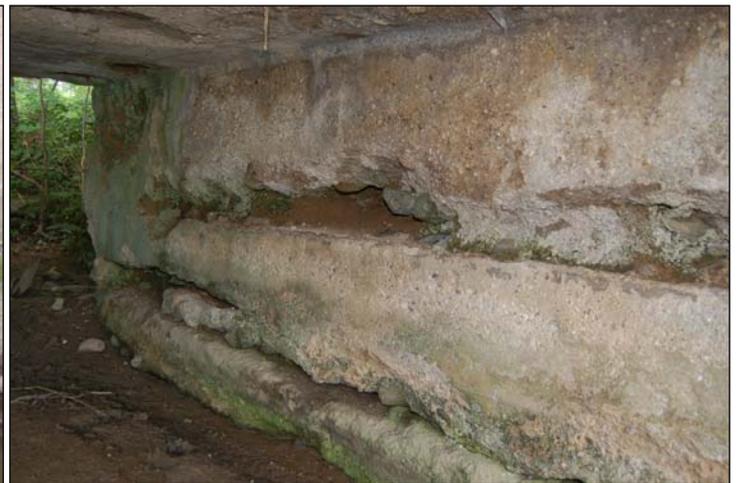
Small Bridge No. 0822

<u>MATERIAL</u>	<u>CONDITION</u>
Deck: Concrete	Poor, heavily spalled
Superstructure: Reinforced Concrete Slab	Poor, heavy spalling & rust
Substructure: Concrete	Poor, heavy spalling
Channel: Natural	Meandering, overgrown
Headwall: Concrete	Poor, heavily spalled
Culvert: n.a.	n.a.
Road: Chip & Seal	Poor, rough
Rail: None	n.a.
Load Rating: H10

<u>Description</u>	<u>Priority</u>	<u>Cost</u>
Bank/Stream:		
Safety-Signs: Post 10 Ton Weight Limit. Add 3 OM3s.	1	\$147
Safety-GR:		
Replace: Replace structure	3	\$74,000
Road/Shld:		
Other:

Remarks: 1 OM3 in place. Recommend 24-month reinspection.

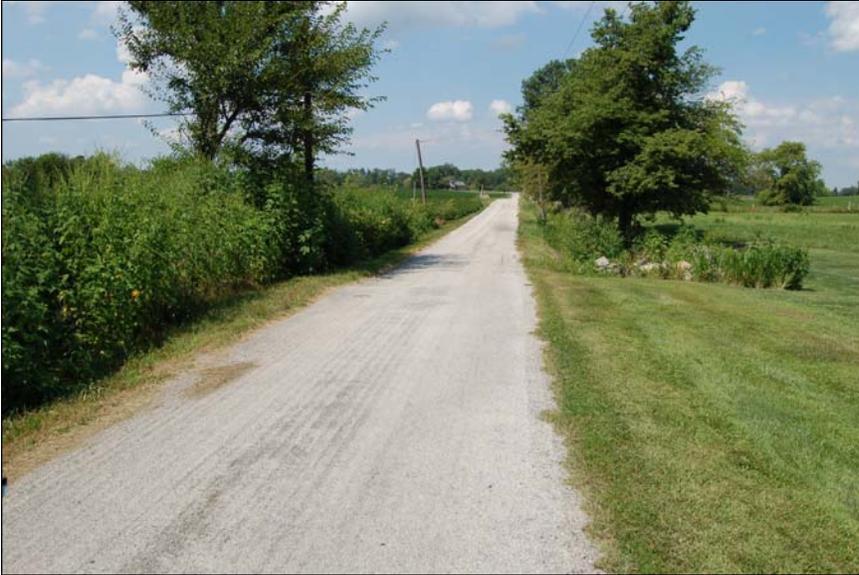
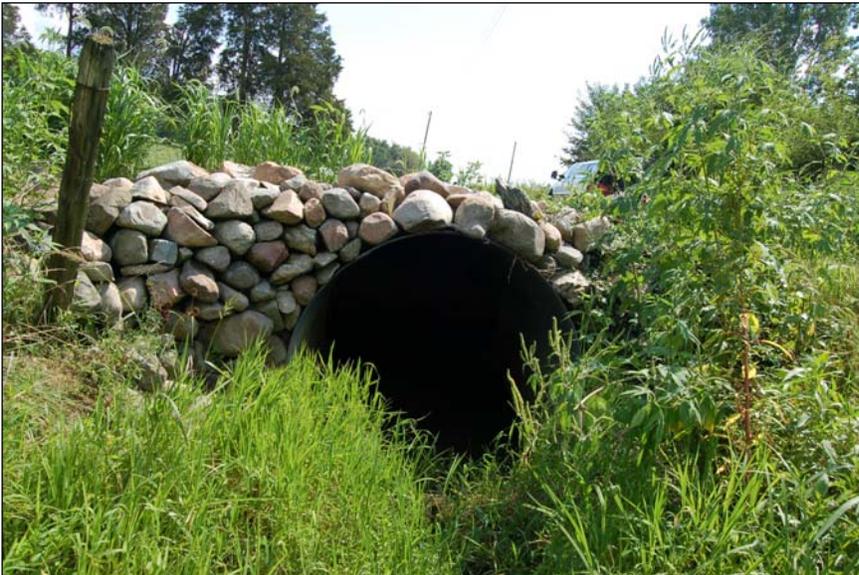
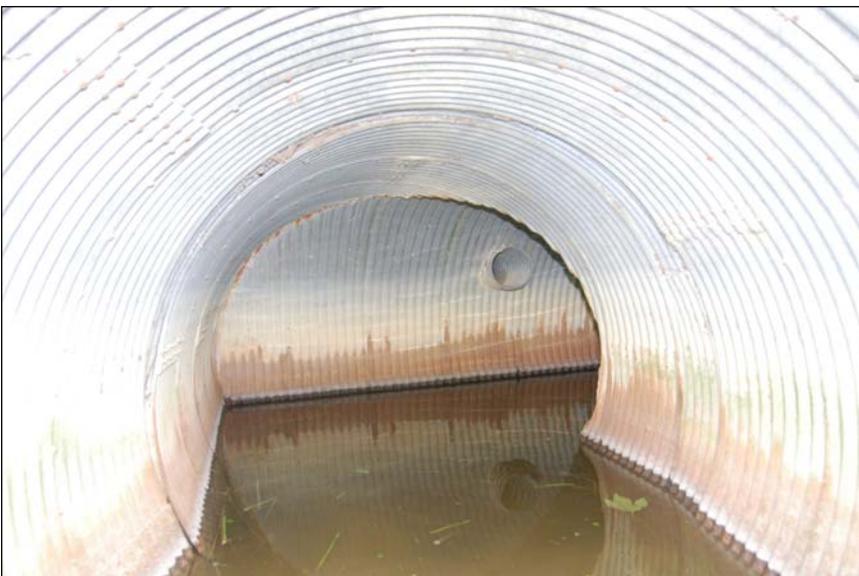
Small Bridge No. 0858

<u>MATERIAL</u>	<u>CONDITION</u>
Deck: n.a.	n.a.
Superstructure: n.a.	n.a.
Substructure: n.a.	n.a.
Channel: Natural	Good
Headwall: None	n.a.
Culvert: Corrugated Metal Pipe	Fair, light rust, 90 degree elbow
Road: Chip & Seal	Fair, rough
Rail: None	n.a.
Load Rating: H20

<u>Description</u>	<u>Priority</u>	<u>Cost</u>
Bank/Stream:		
Safety-Signs: Place OM2s	3.5	\$38
Safety-GR:		
Replace:		
Road/Shld:		
Other:

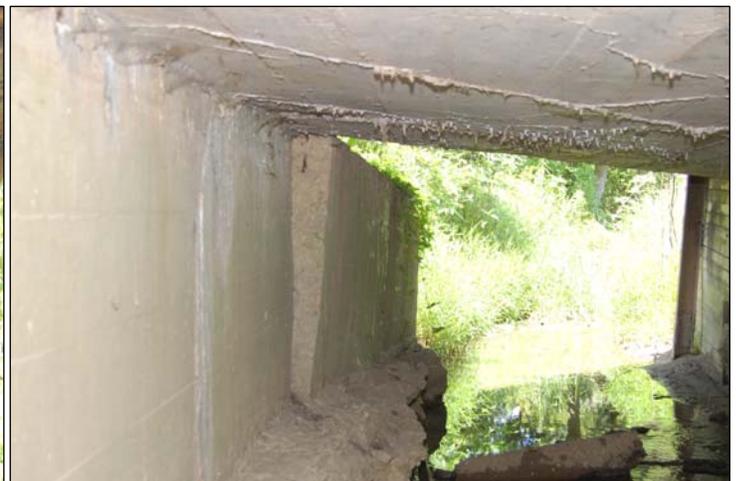
South West Abutment Movement

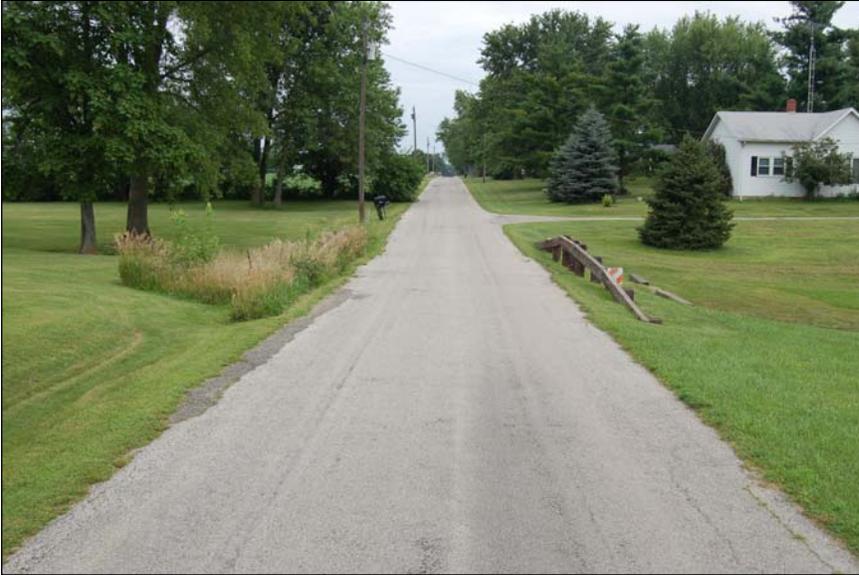
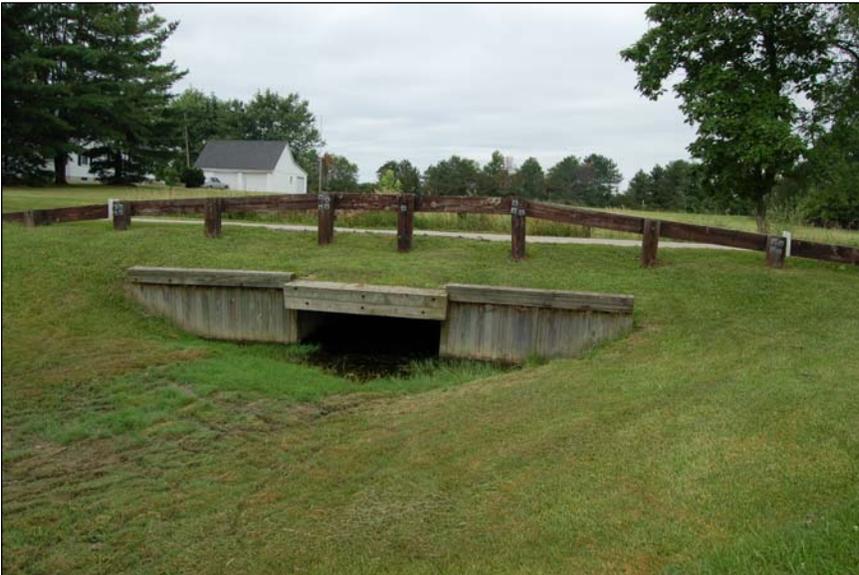
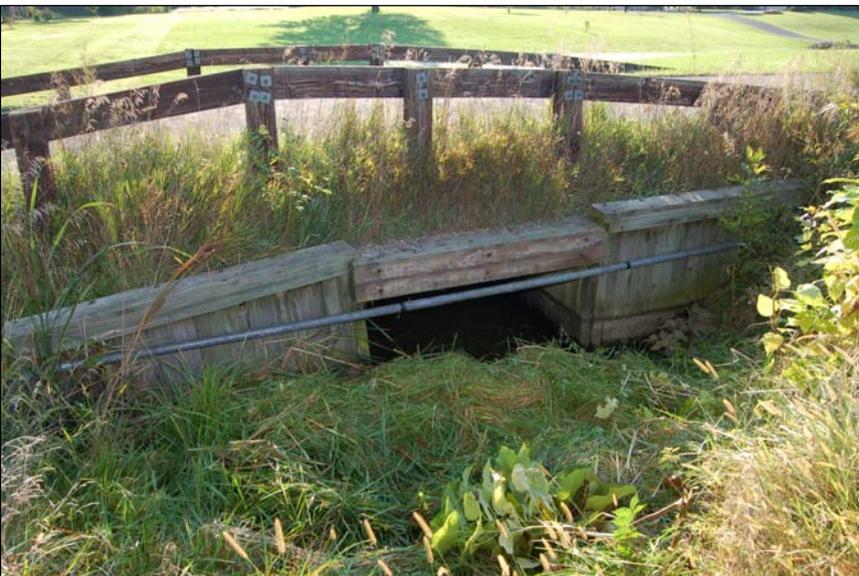
Small Bridge No. 1087

Waterway Open (sqft): 24 **Drain Area (acres):**
Structure Type: Timber Box **Span / Height (ft):** 6.0 / 4.0
Skew (deg): 0 **Approx Cover (ft):** 1.0
Culvert Length (ft): 30 **Roadway Width (ft):** 14.0
No of Spans/Barrels: 1 **Wearing Surface:** Chip & Seal

<u>Description</u>	<u>Priority</u>	<u>Cost</u>
Bank/Stream:		
Safety-Signs: Place OM2s	3.3	\$38
Safety-GR:		
Replace:		
Road/Shld:		
Other:

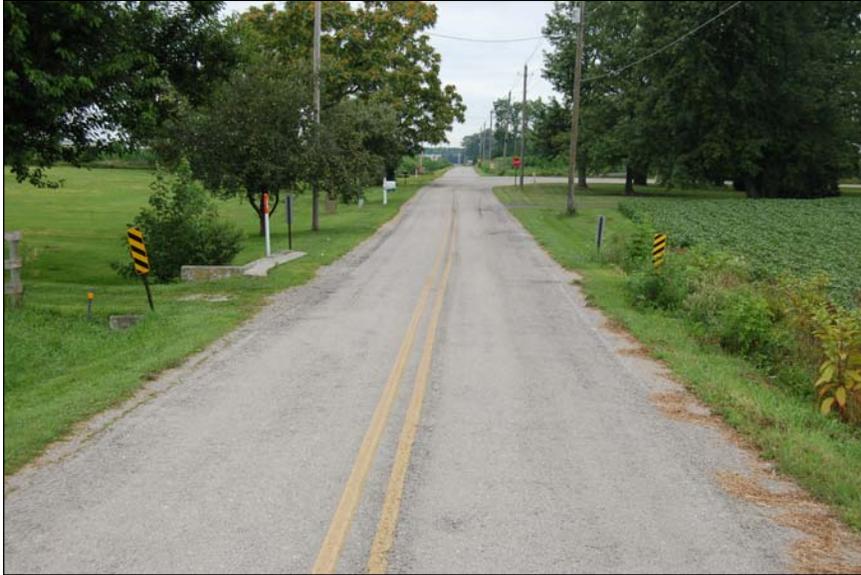
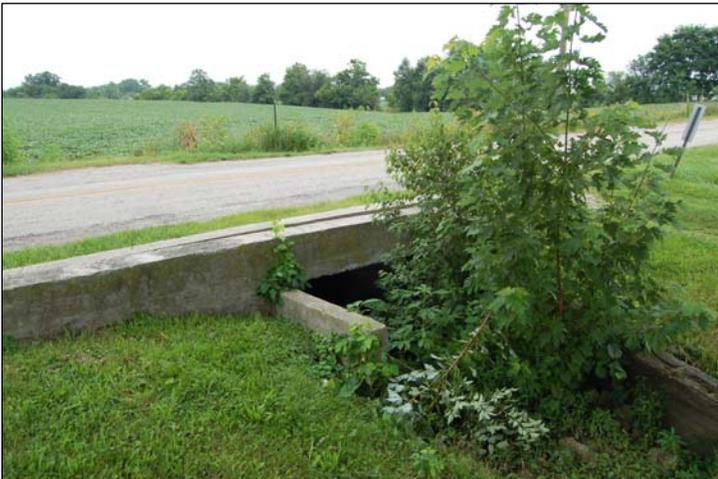
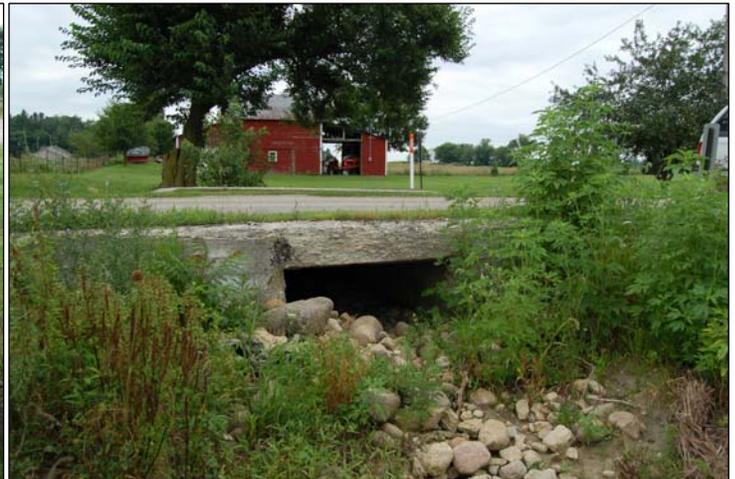
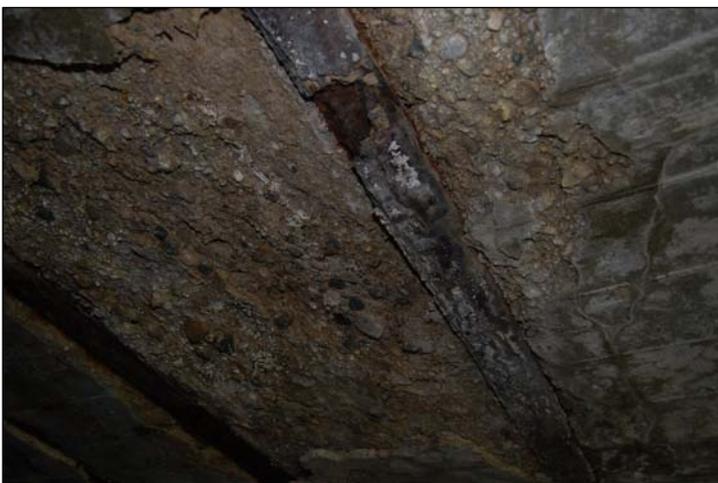
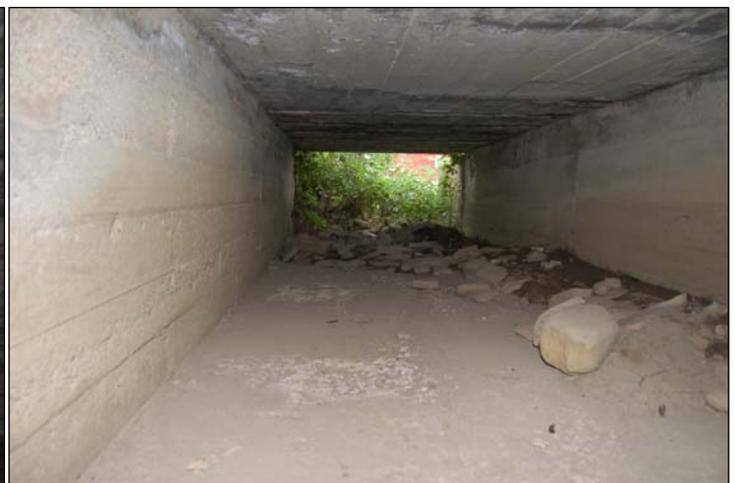
Small Bridge No. 1140

Waterway Open (sqft): 18 **Drain Area (acres):**
Structure Type: Steel Beam Encased **Span / Height (ft):** 6.0 / 3.0
Skew (deg): 0 **Approx Cover (ft):** .3
Culvert Length (ft): 28 **Roadway Width (ft):** 18.0
No of Spans/Barrels: 1 **Wearing Surface:** Chip & Seal

Deck: Concrete	Fair, moderate to heavy spalling
Superstructure: Steel Beam Encased	Poor, heavy to moderate rust
Substructure: Concrete	Fair, light spalling
Channel: None	n.a.
Headwall: Concrete	Fair, spalled
Culvert: -	-
Road: Chip & Seal	Good
Rail: None	n.a.
Load Rating: H18

Inspected by: LJR **Inspection Date:** 7/25/2008
Est Remain Life (yr): 5
Remarks: Recommend 24-month inspection cycle.

<u>Description</u>	<u>Priority</u>	<u>Cost</u>
Bank/Stream:		
Safety-Signs:		
Safety-GR:		
Replace: Replace structure	3	\$23,600
Road/Shld:		
Other:

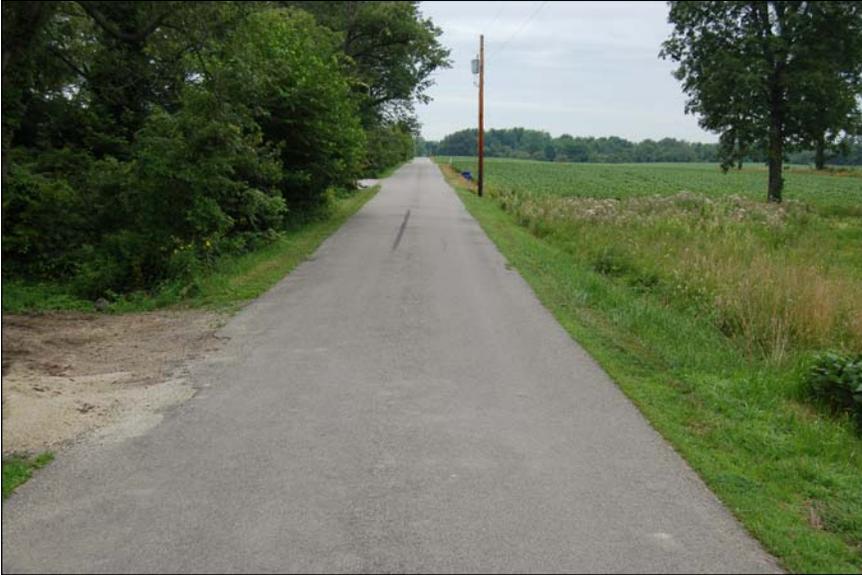
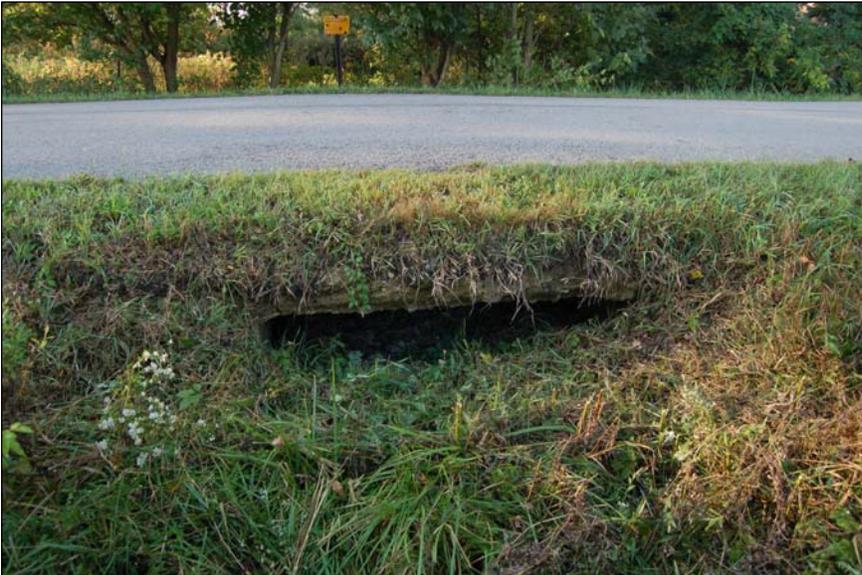
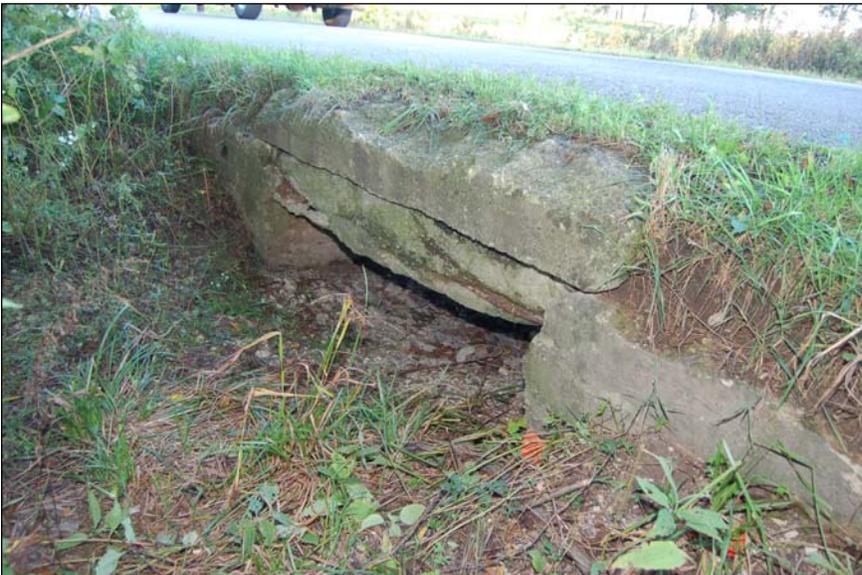
Small Bridge No. 1162

Waterway Open (sqft): 9 **Drain Area (acres):**
Structure Type: Concrete Box **Span / Height (ft):** 6.0 / 1.5
Skew (deg): 0 **Approx Cover (ft):** .5
Culvert Length (ft): 20 **Roadway Width (ft):** 14.5
No of Spans/Barrels: 1 **Wearing Surface:** Cold Mix

Deck: Concrete Good
Superstructure: Reinforced Concrete Slab Good, spalled at edges
Substructure: Concrete Fair, minor spalling
Channel: Grass Good
Headwall: Concrete Fair, spalled
Culvert: - -
Road: Cold Mix Good
Rail: None n.a.
Load Rating: H20

<u>Description</u>	<u>Priority</u>	<u>Cost</u>
Bank/Stream:		
Safety-Signs: Place OM2s	3.2	\$38
Safety-GR:		
Replace:		
Road/Shld:		
Other:

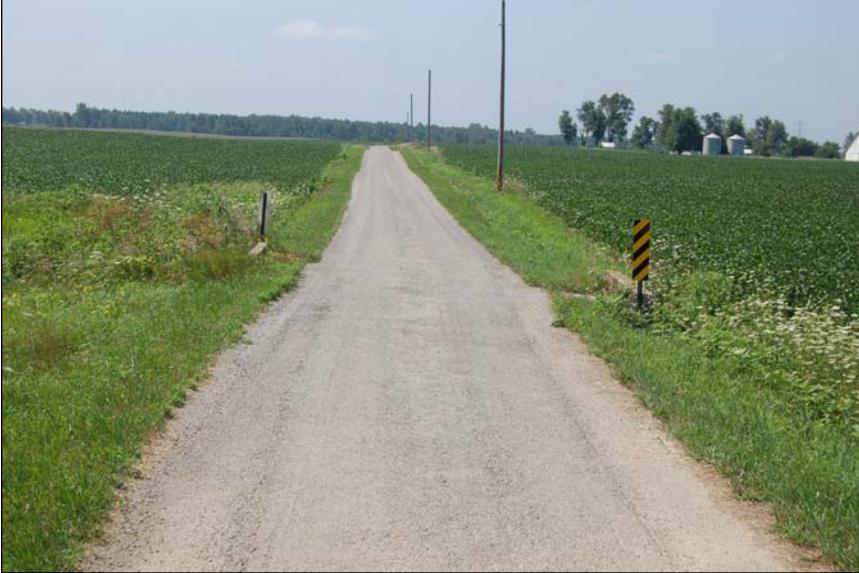
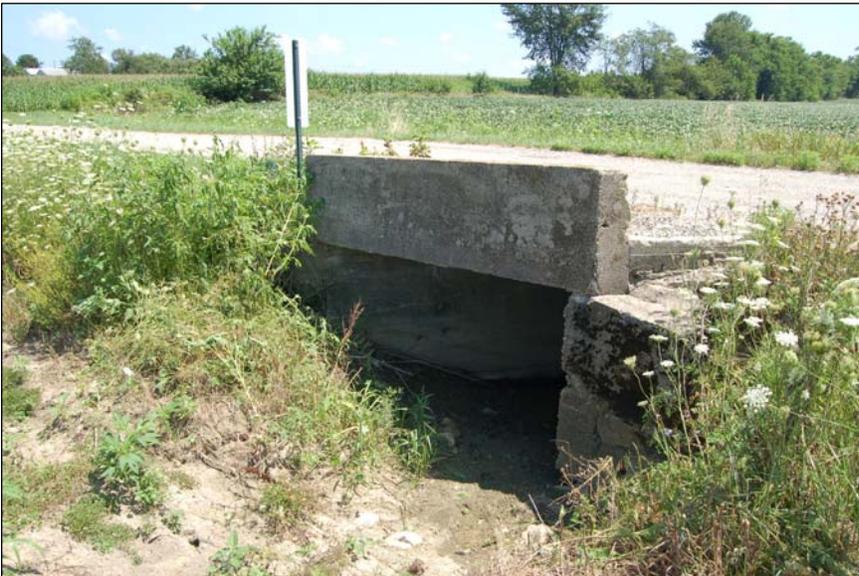
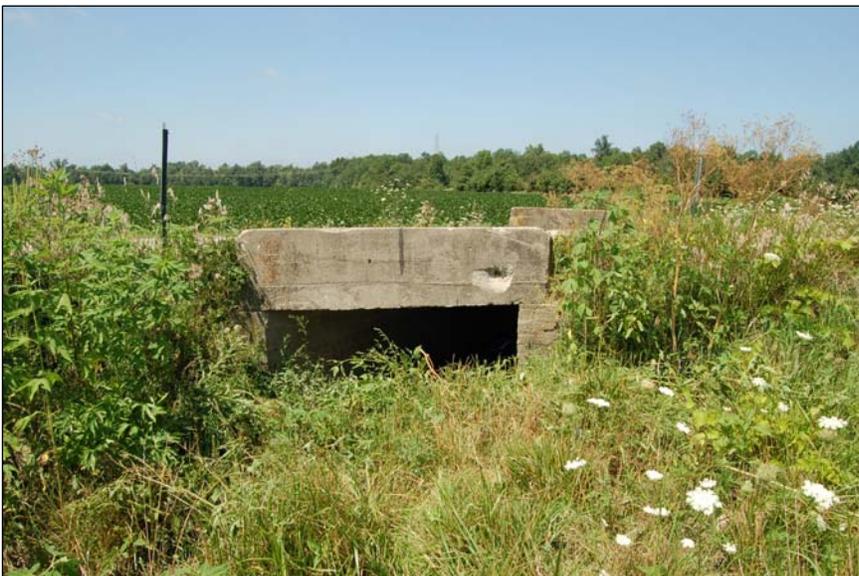
Small Bridge No. 1230

Waterway Open (sqft): 25	Drain Area (acres):
Structure Type: Reinforced Concrete Slab	Span / Height (ft): 6.3 / 4.0
Skew (deg): 25	Approx Cover (ft): 0.5
Culvert Length (ft): 22	Roadway Width (ft): 12.0
No of Spans/Barrels: 1	Wearing Surface: Chip & Seal

<u>MATERIAL</u>	<u>CONDITION</u>
Deck: Concrete	Good
Superstructure: Reinforced Concrete Slab	Good
Substructure: Concrete	Good
Channel: Grass	Good
Headwall: Concrete	Good
Culvert: n.a.	n.a.
Road: Chip & Seal	Good, narrow
Rail: None	n.a.
Load Rating: H20

<u>Description</u>	<u>Priority</u>	<u>Cost</u>
Bank/Stream:		
Safety-Signs:		
Safety-GR:		
Replace:		
Road/Shld: Add fill at SW corner	2	\$120
Other:

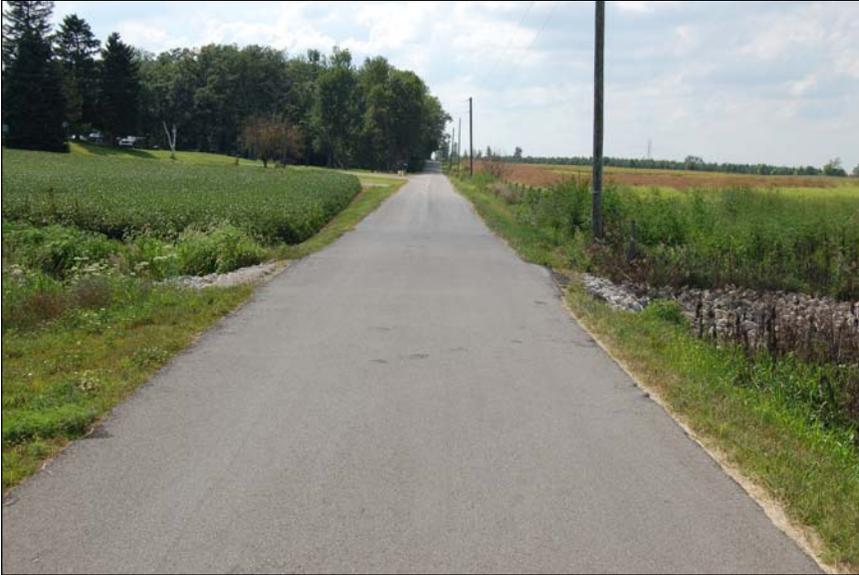
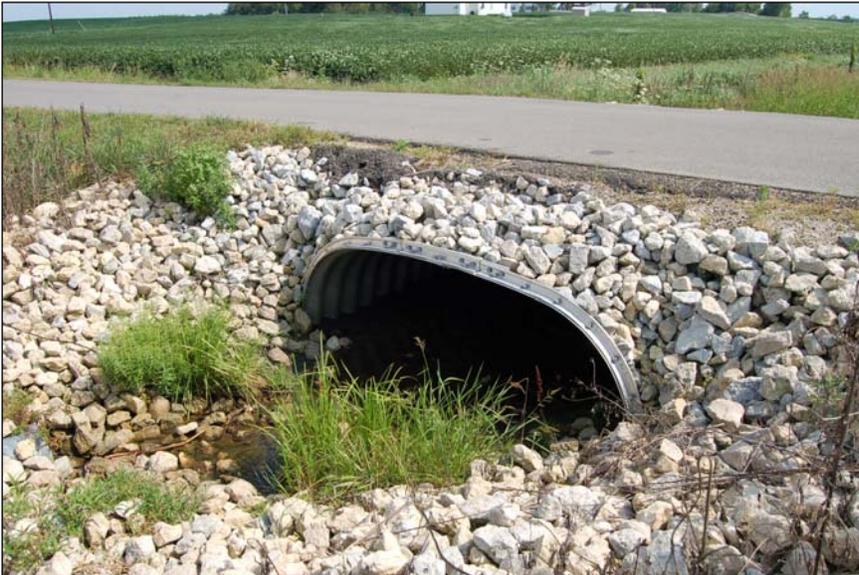
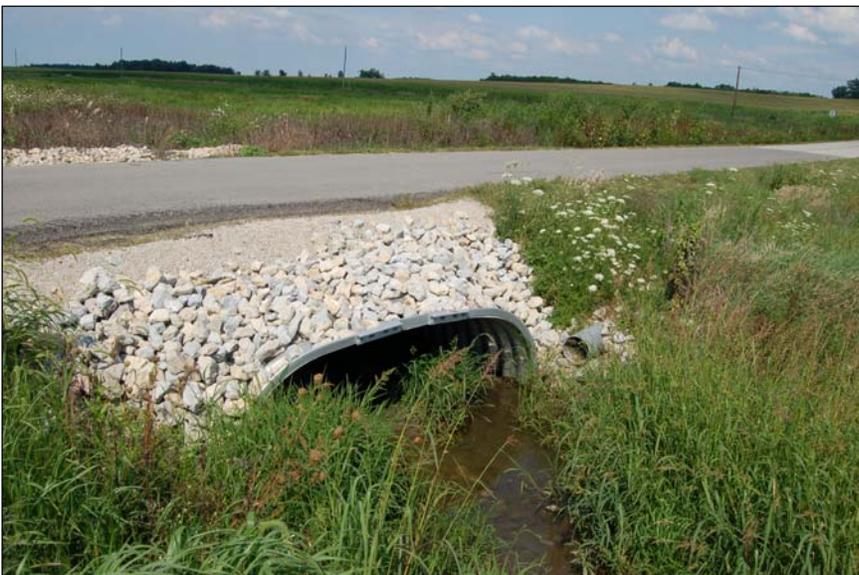
Small Bridge No. 1377

Waterway Open (sqft): 31 **Drain Area (acres):** 367
Structure Type: Aluminum Box Culvert **Span / Height (ft):** 10.5 / 3.5
Skew (deg): 05 **Approx Cover (ft):** 1.5
Culvert Length (ft): 31 **Roadway Width (ft):** 15.5
No of Spans/Barrels: 1 **Wearing Surface:** Bituminous

<u>Description</u>	<u>Priority</u>	<u>Cost</u>
Bank/Stream:		
Safety-Signs: Place OM2s	3.3	\$38
Safety-GR:		
Replace:		
Road/Shld:		
Other:

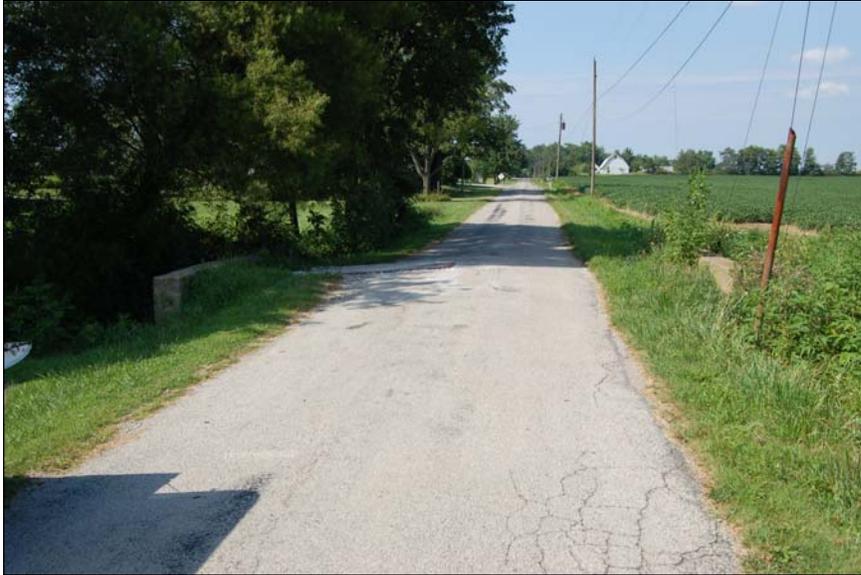
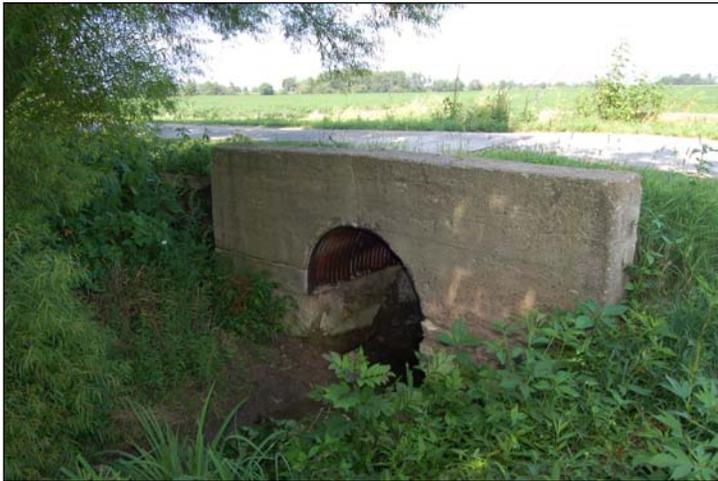
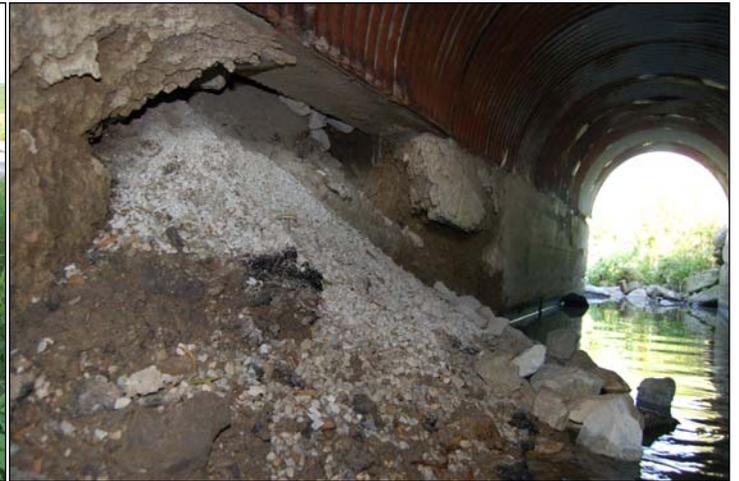
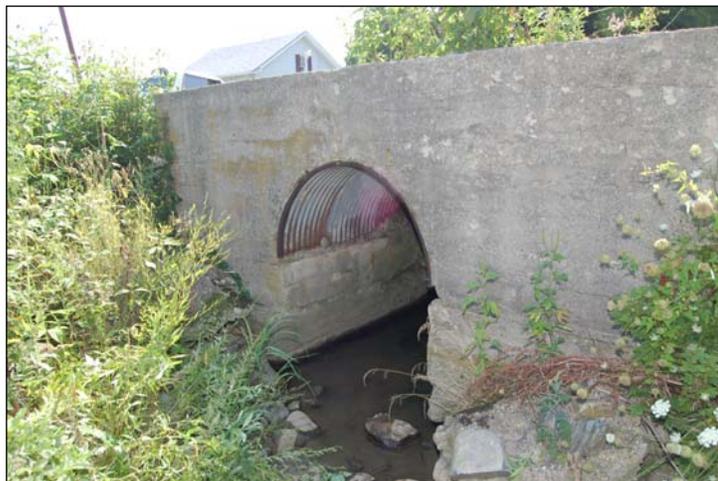
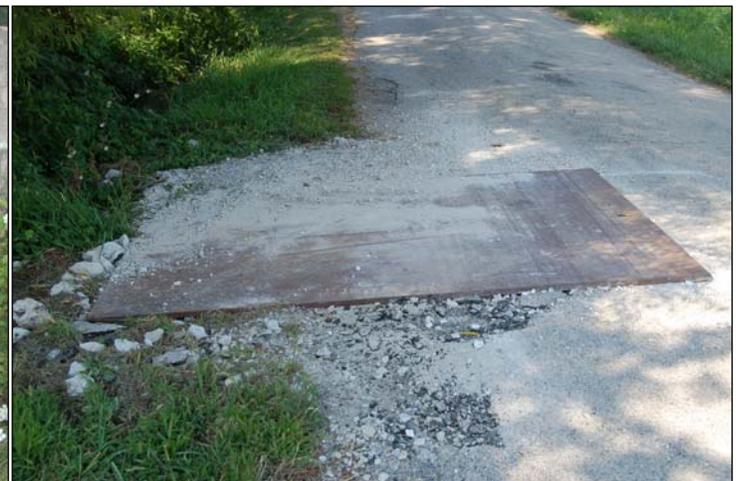
Small Bridge No. 1412

Poor, failed at north-mid point

Good, cracked

Fair, heavy rust in spots

Remarks: Existing repairs will extend life.

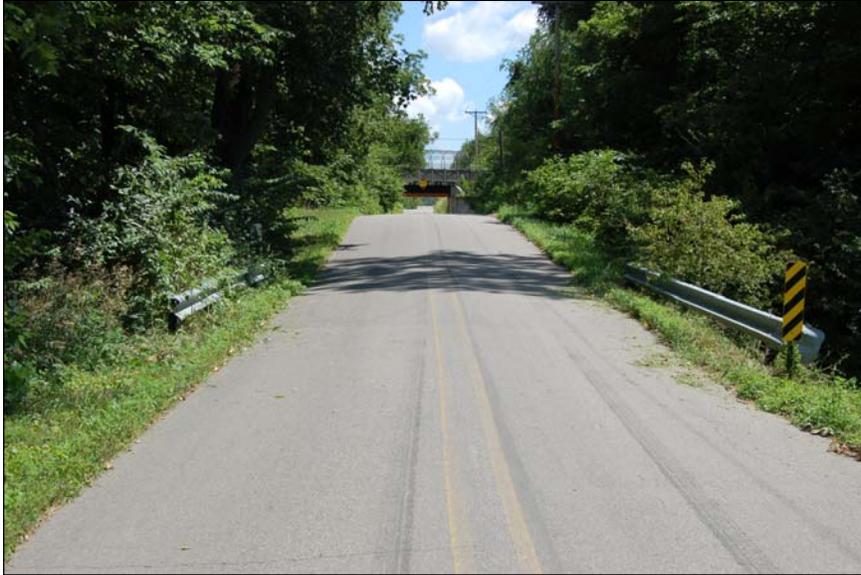
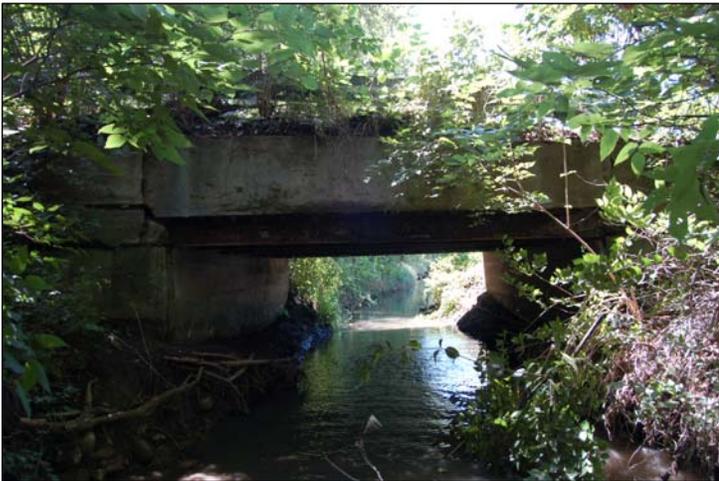
Looking East

Deck: Concrete Moderate to heavy spalling
Superstructure: Steel Beam Encased Poor, heavy corrosion, holes in 5 beams
Substructure: Concrete Good
Channel: Natural Overgrown, straight
Headwall: Concrete Cracked & leaning
Culvert: n.a. n.a.
Road: Bituminous Good
Rail: Steel W-shaped Good
Load Rating: H11

<u>Description</u>	<u>Priority</u>	<u>Cost</u>
Bank/Stream:		
Safety-Signs: Post "11 Ton Weight Limit".	1	\$60
Safety-GR:		
Replace: Replace structure	2	\$59,300
Road/Shld:		
Other:

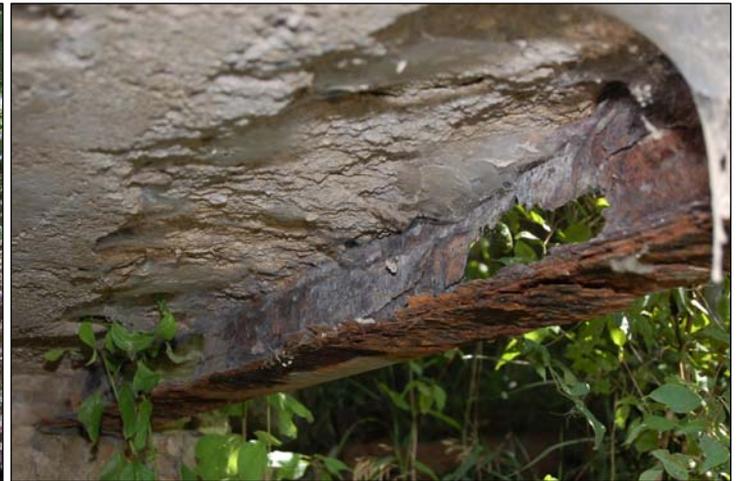
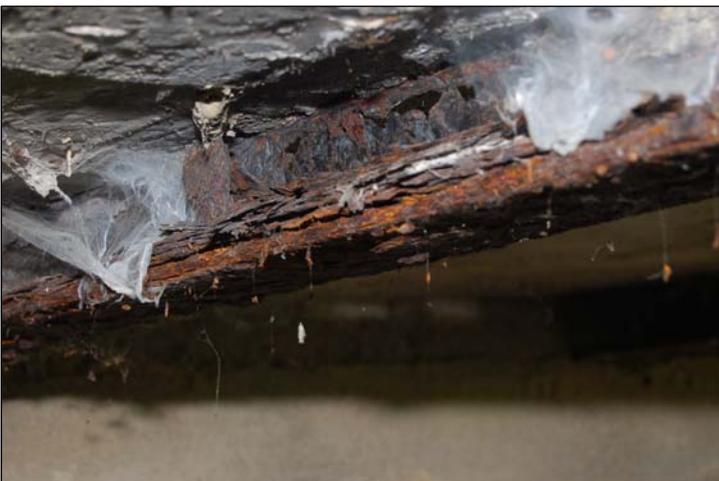
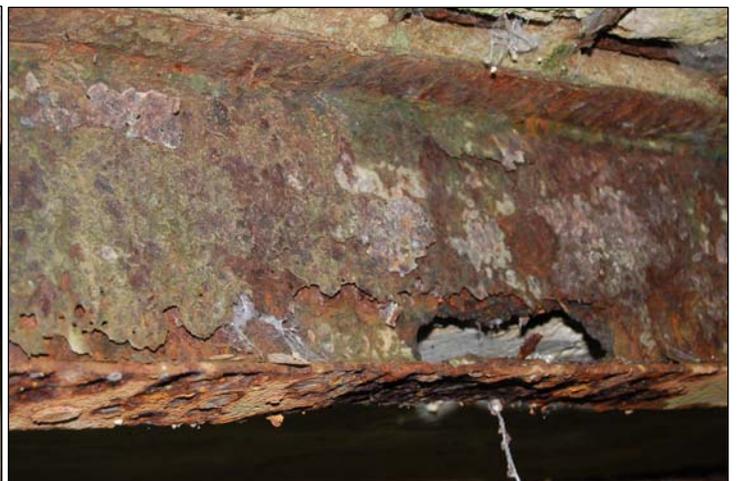
Beam # 1 (from south)

Inspected by: LJR **Inspection Date:** 8/7/2008
Est Remain Life (yr): 3
Remarks: Recommend 12-month reinspection. Corrosion is progressing.

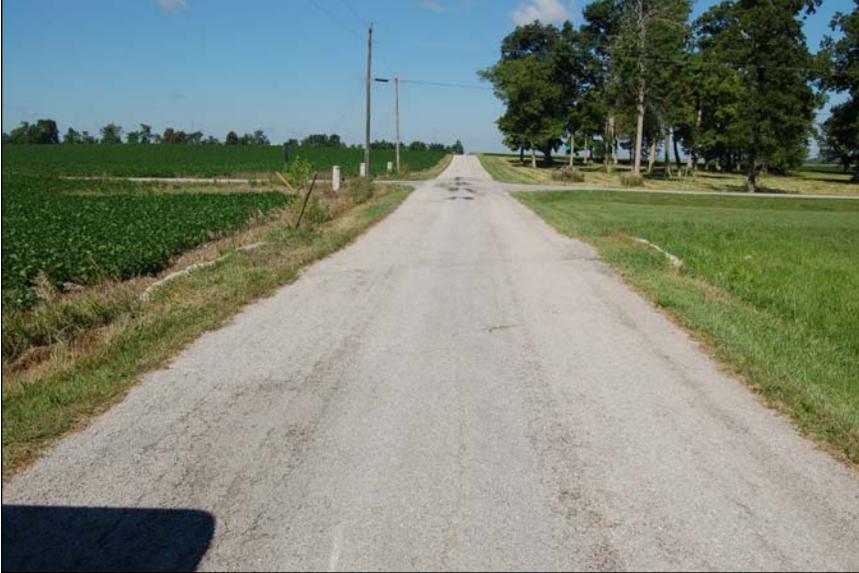
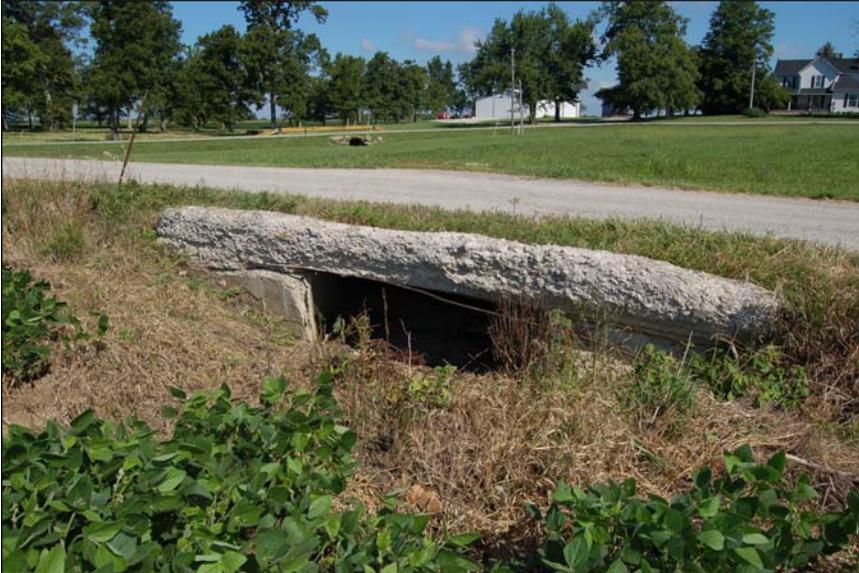
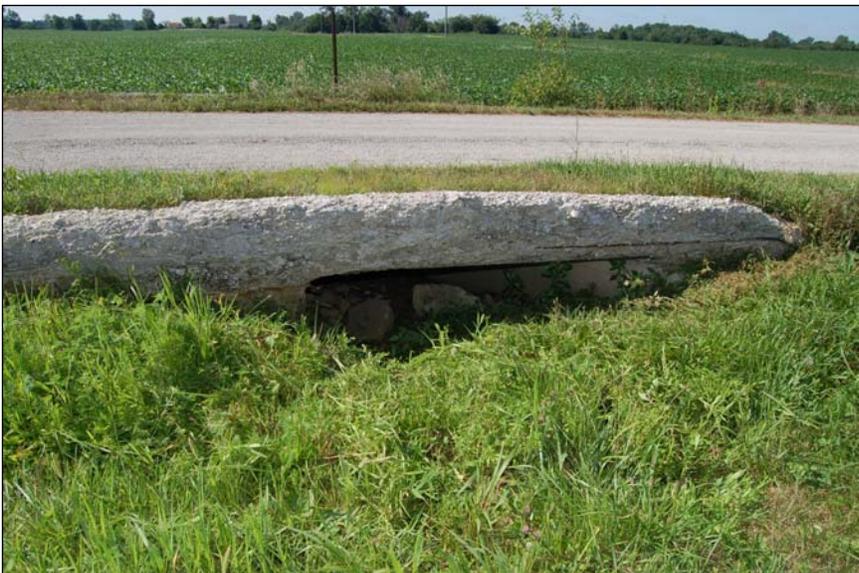
Looking West

Poor, heavily spalled

Poor, heavy spalling, moderate rust

Poor, heavy spalling

Poor, spalled

<u>Description</u>	<u>Priority</u>	<u>Cost</u>
Bank/Stream:		
Safety-Signs: Place OM2s	3.4	\$38
Safety-GR:		
Replace: Replace structure	4	\$23,600
Road/Shld:		
Other:

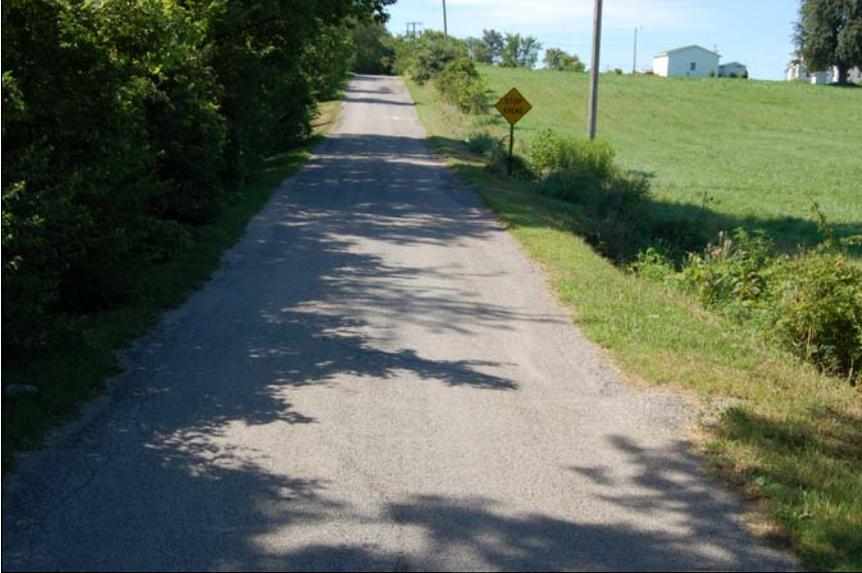
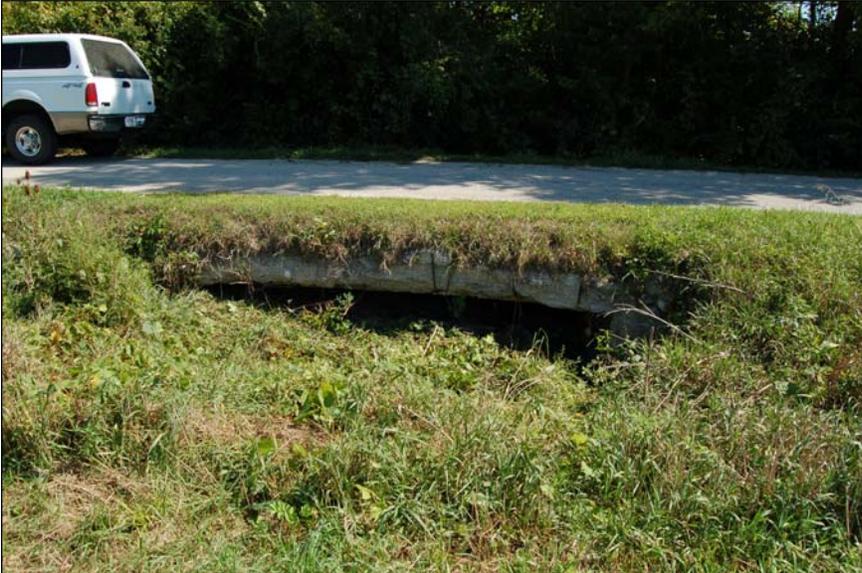
Looking South

Deck: Concrete	Fair, spalled at edges
Superstructure: Reinforced Concrete Slab	Fair, heavy spalling at edges
Substructure: Concrete	Fair, moderate cracks
Channel: None	n.a.
Headwall: None	n.a.
Culvert: -	-
Road: Chip & Seal	Good
Rail: None	Failed, missing
Load Rating: H20

<u>Description</u>	<u>Priority</u>	<u>Cost</u>
Bank/Stream:		
Safety-Signs: Place OM3s	3.2	\$56
Safety-GR:		
Replace:		
Road/Shld:		
Other:

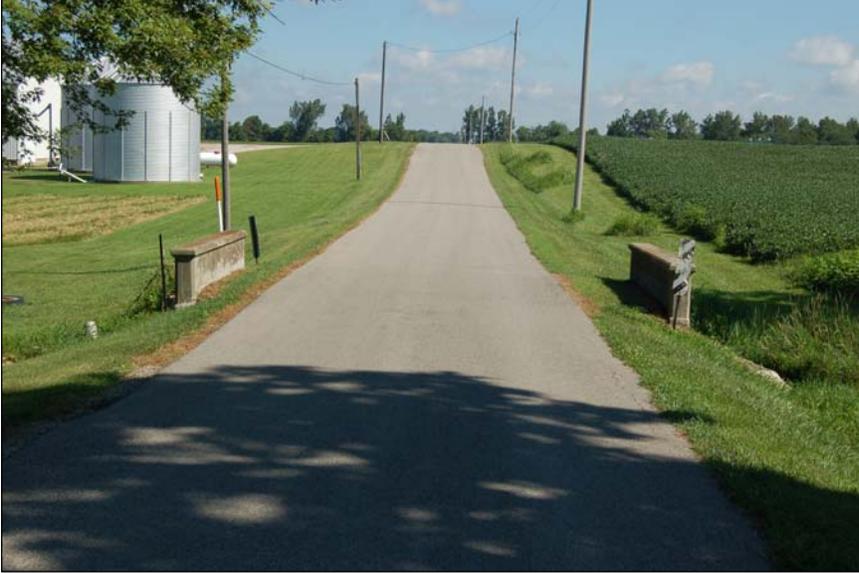
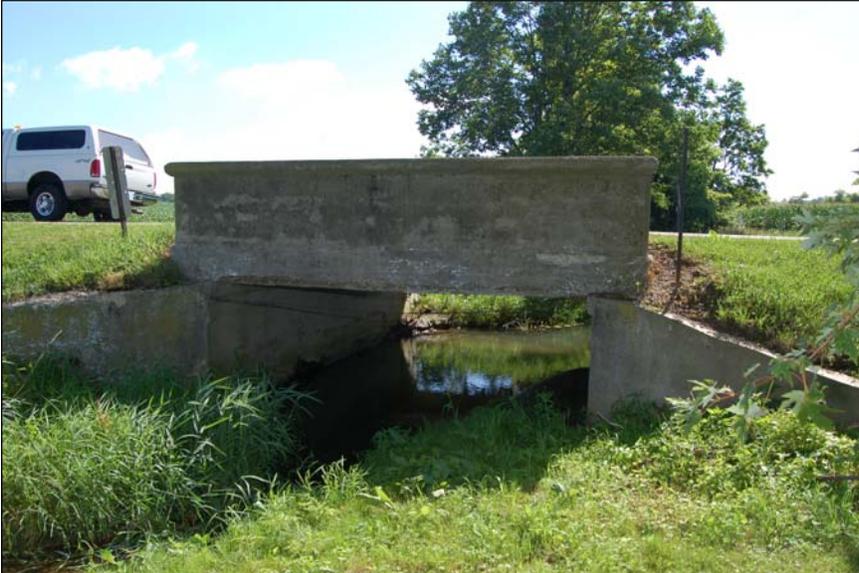
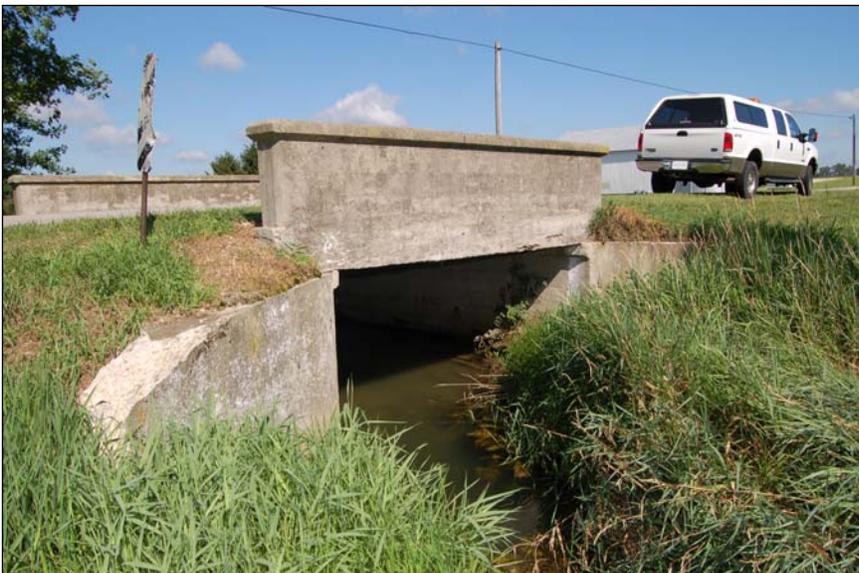
Looking North

Deck: Concrete Good, light to moderate spalling in spots
Superstructure: Reinforced Concrete Slab Good, moderate efflorescence
Substructure: Concrete Good, minor cracks
Channel: Grass Good
Headwall: Concrete Light spalling
Culvert: n.a. n.a.
Road: Bituminous Good
Rail: Concrete Not standard
Load Rating: H20

<u>Description</u>	<u>Priority</u>	<u>Cost</u>
Bank/Stream:		
Safety-Signs: Replace OM2s	3.5	\$38
Safety-GR:		
Replace:		
Road/Shld:		
Other:
