DELAWARE COUNTY, INDIANA
CULVERT INSPECTION & REPORT

DECEMBER 31, 2008

SMALL BRIDGE INSPECTION REPORT

DELAWARE COUNTY, INDIANA
December 31, 2008

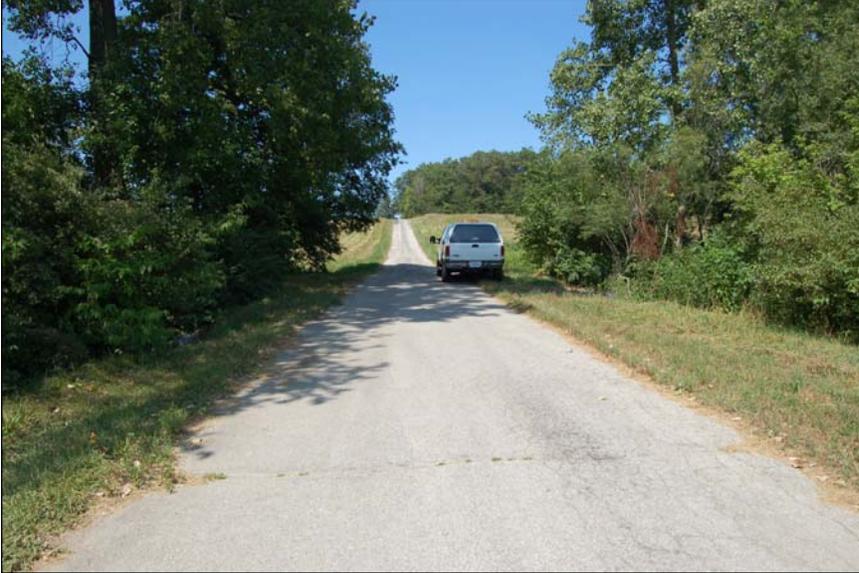
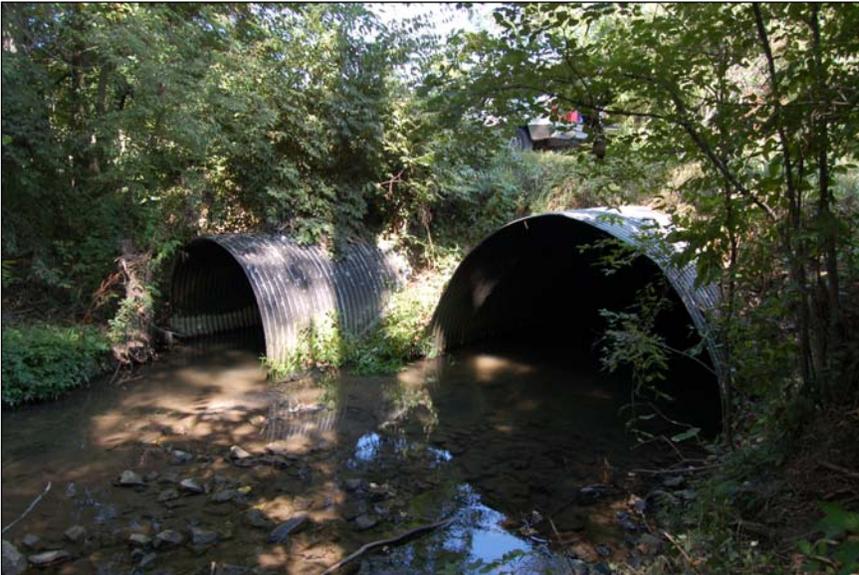
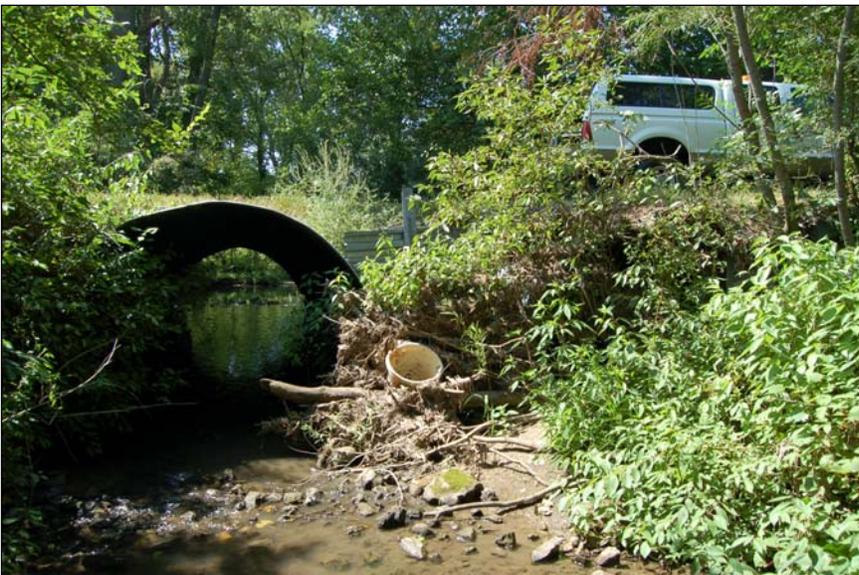
Looking North

Culvert: Corrugated Metal Pipe Arch Good, inadequate cover

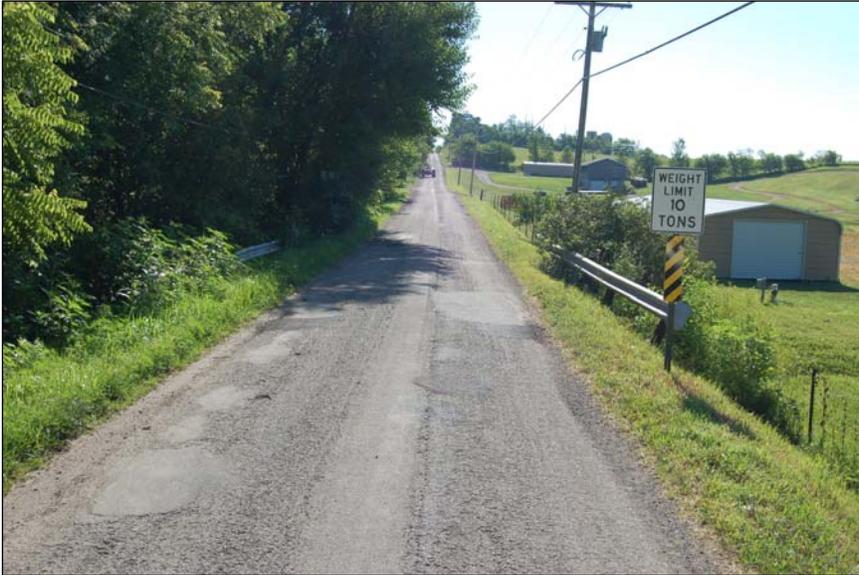
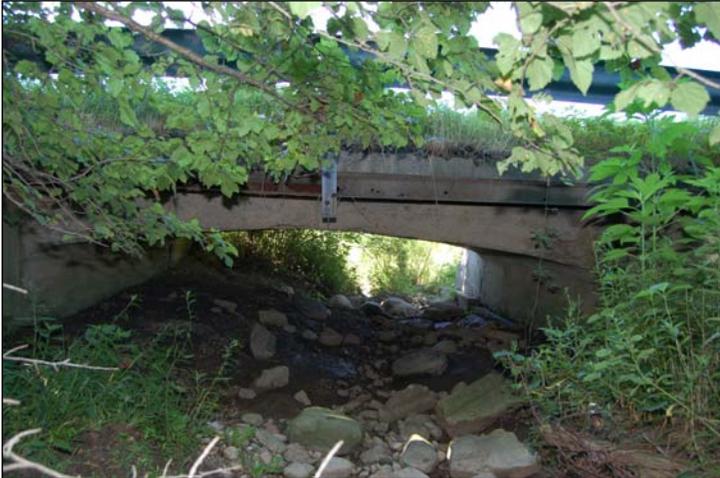
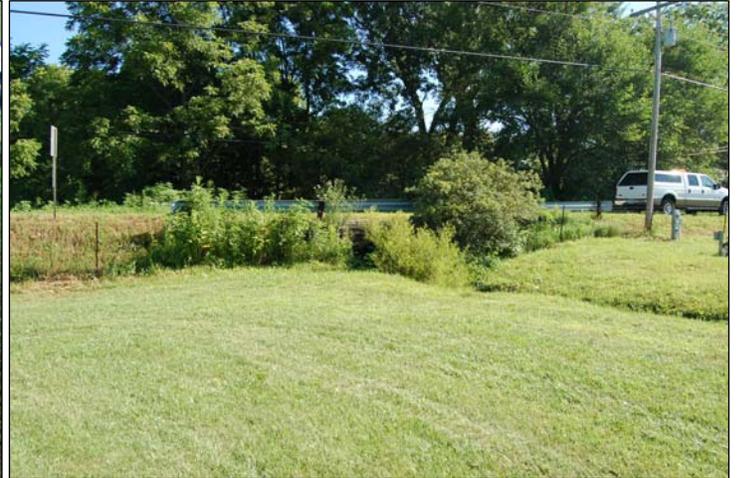
Looking East

Good, light to moderate spalling

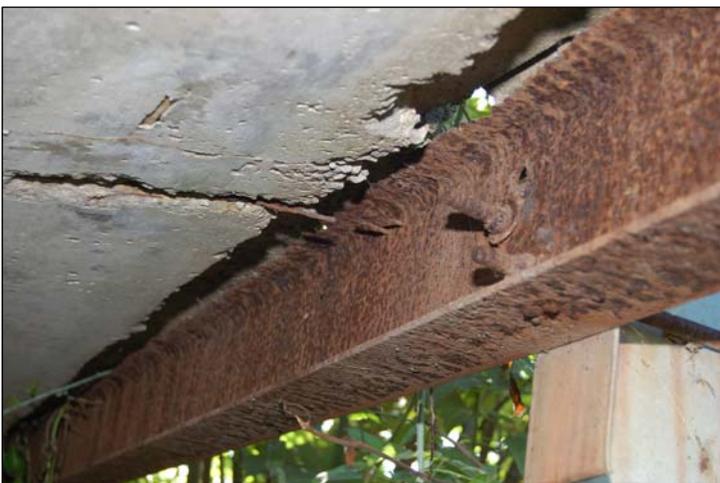
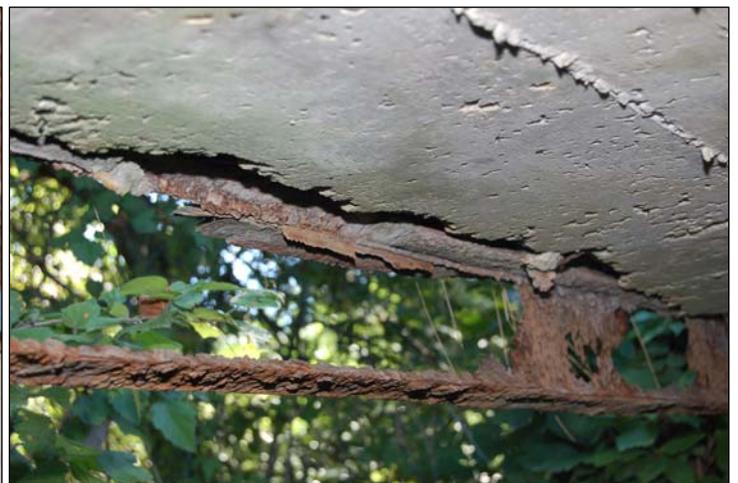
South Beam

Failed

Remarks: Steel beams support bridge shoulders. Outside steel beams have failed.
Posted 10 Ton. Two OM2s in place.

<u>Description</u>	<u>Priority</u>	<u>Cost</u>
Bank/Stream:		
Safety-Signs: Place barricades, close shoulders	1	\$100
Safety-GR:		
Replace: Replace shoulder beams	3	\$24,000
Road/Shld:		
Other: Clear vegetation	1	\$0

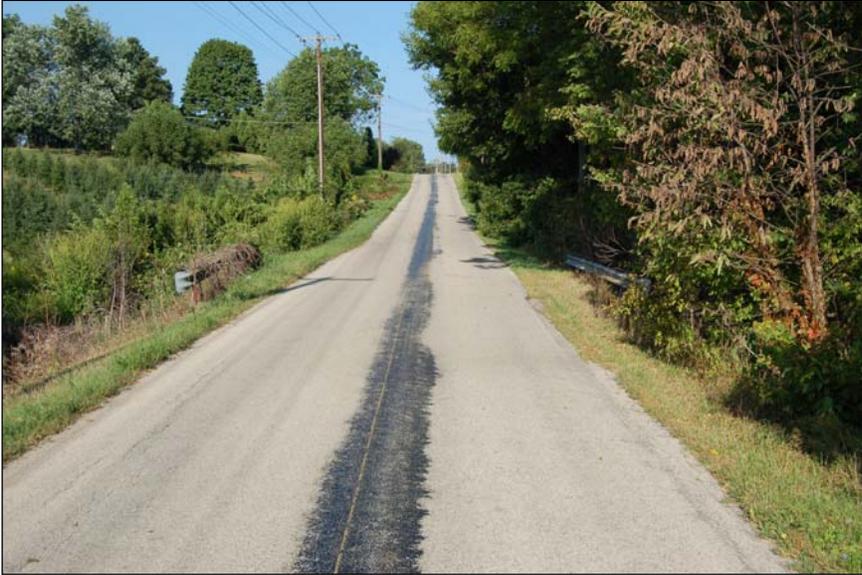
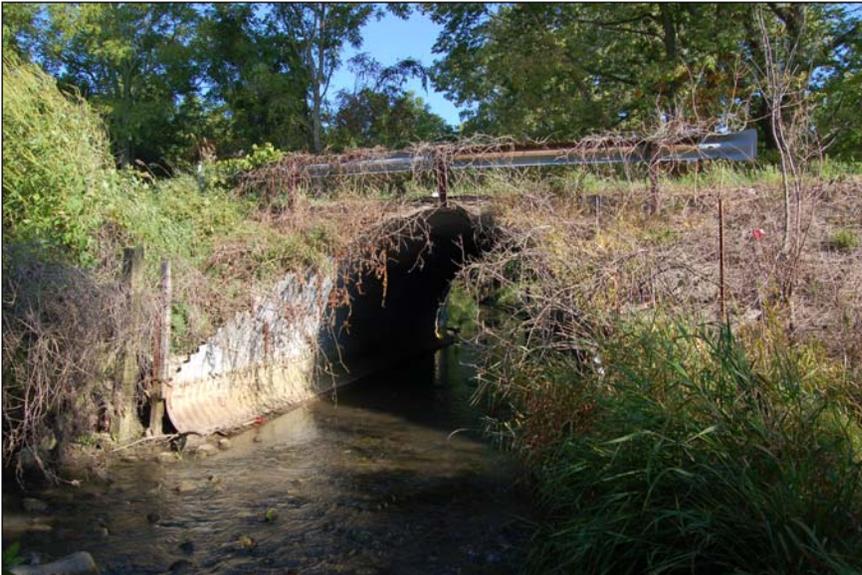
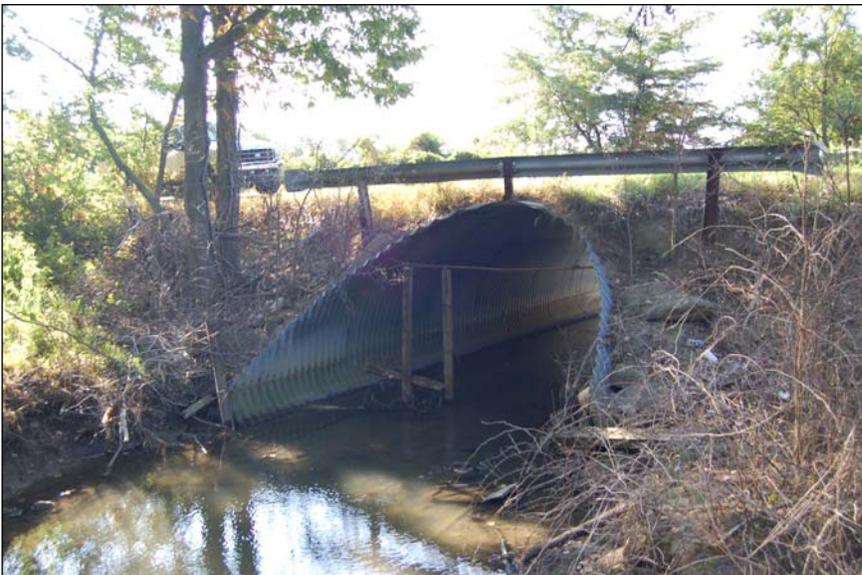
Looking West

Good, inadequate cover

<u>Description</u>	<u>Priority</u>	<u>Cost</u>
Bank/Stream:		
Safety-Signs: Place OM2s. Post "15 Ton".	1	\$98
Safety-GR:		
Replace:		
Road/Shld:		
Other: Post 15 Ton or increase cover to 2.0 feet.	1	\$12,900

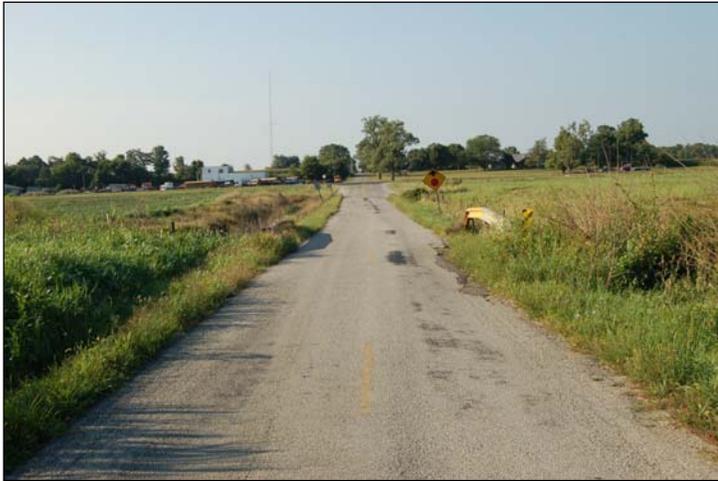
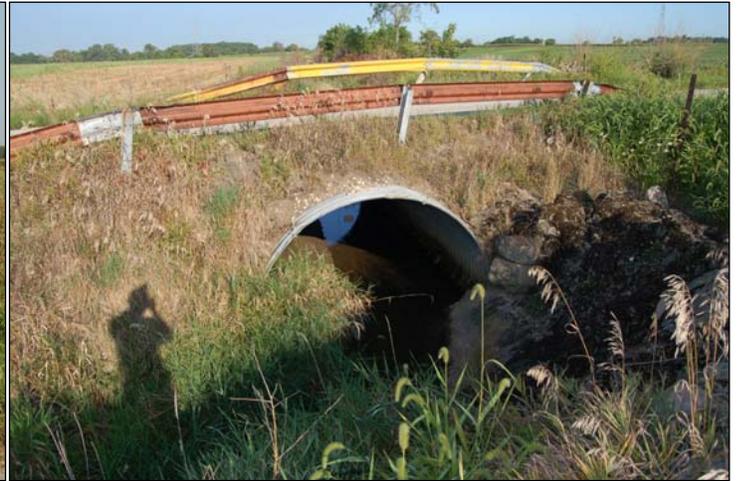
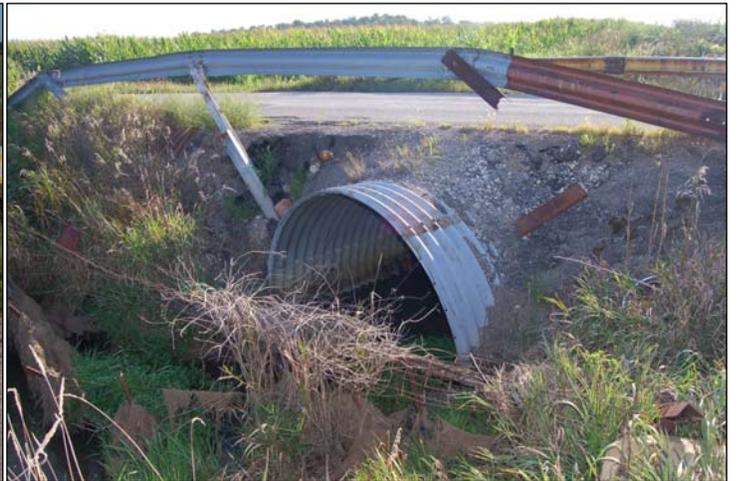
Looking South

Poor, partially failed, large rust hole

Poor, damaged west, pulled out of ground

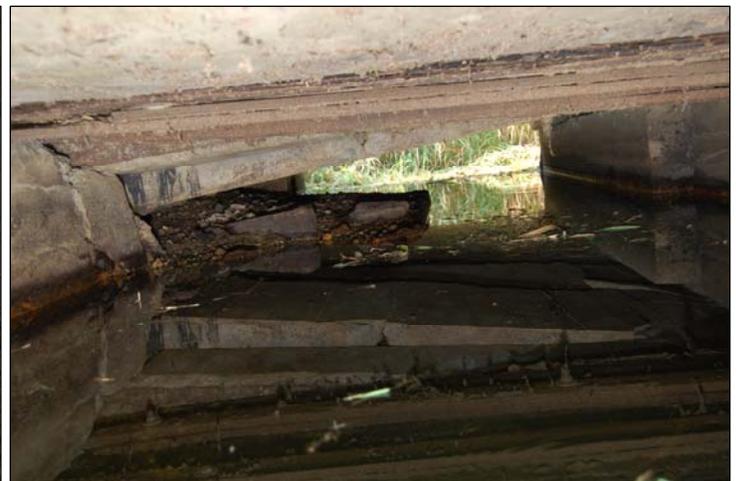
Collapsed at Mid Point

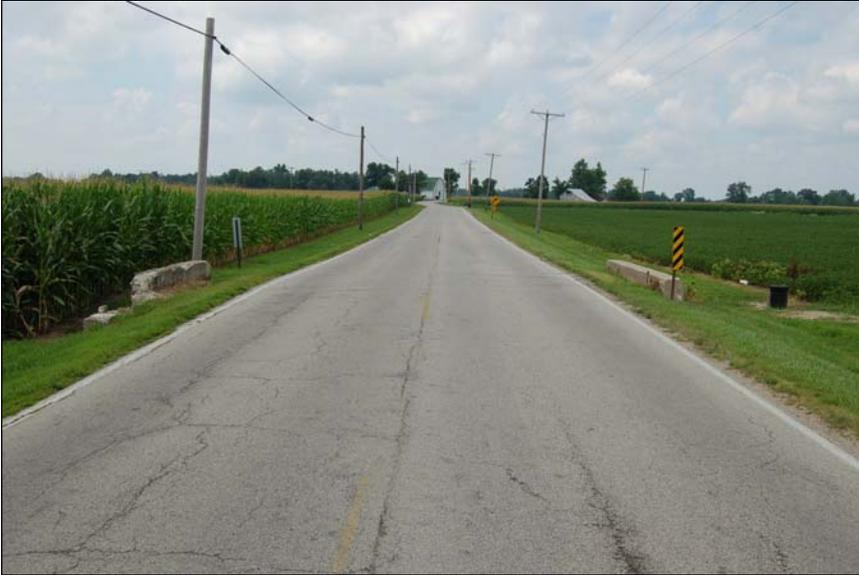
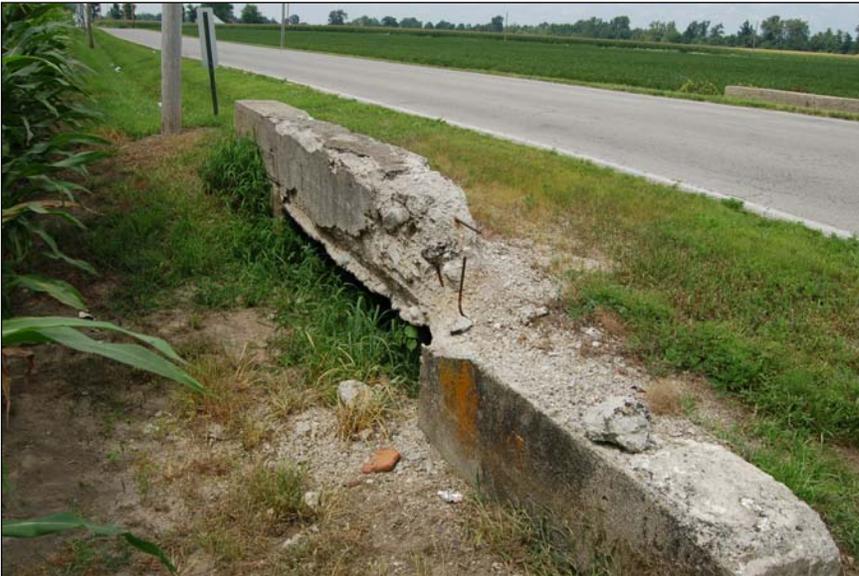
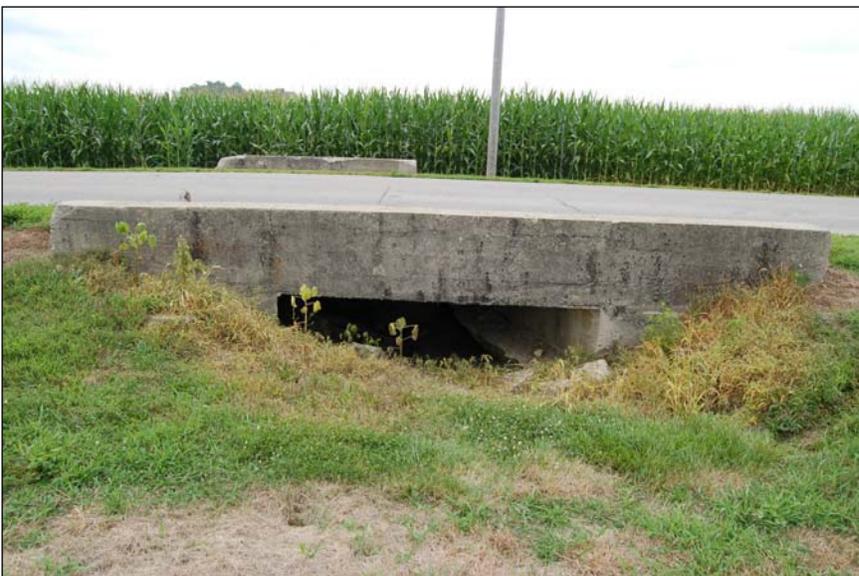
Small Bridge No. 1752

Deck: Concrete	Good
Superstructure: Reinforced Concrete Slab	Good
Substructure: Concrete	Good
Channel: None	n.a.
Headwall: Concrete	Heavily spalled west
Culvert: n.a.	n.a.
Road: Chip & Seal	Good
Rail: None	n.a.
Load Rating: H20

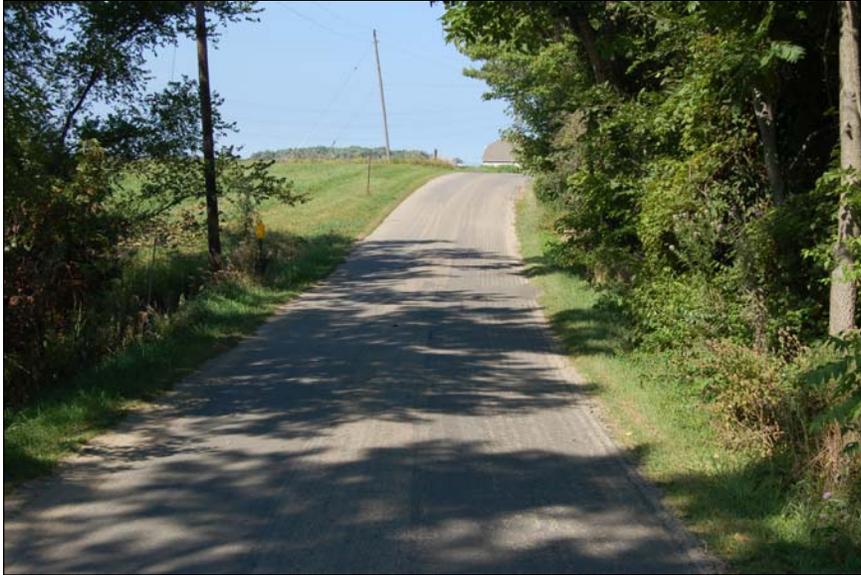
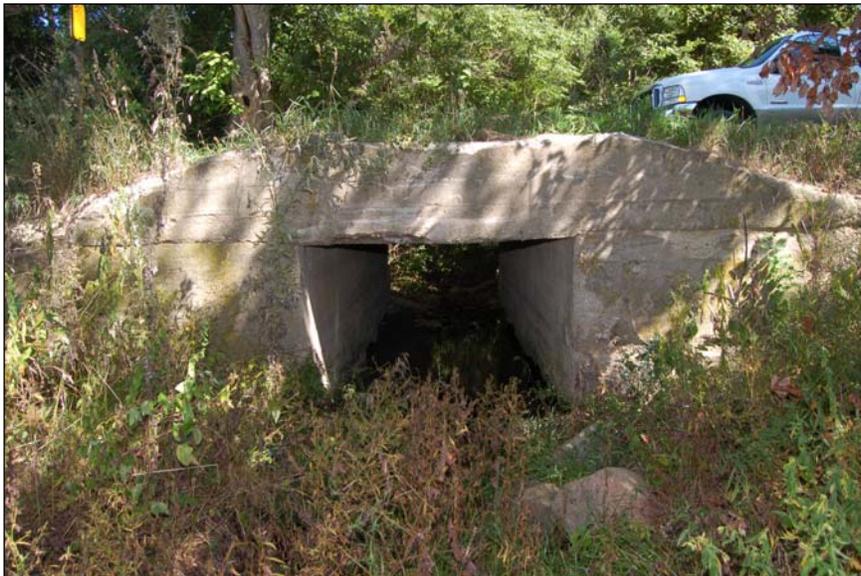
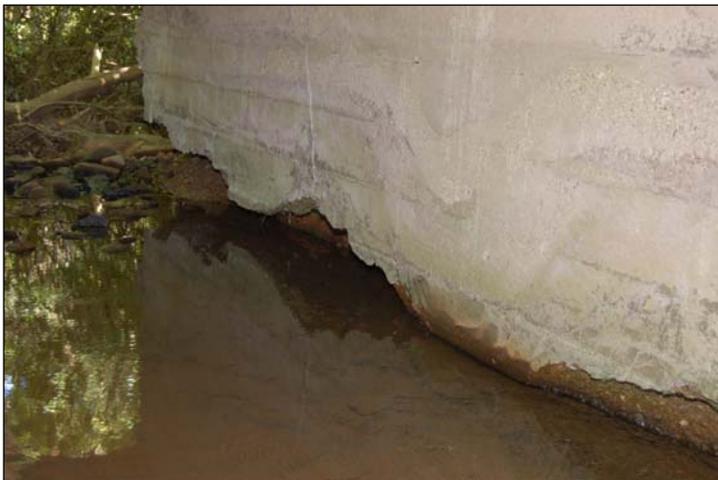
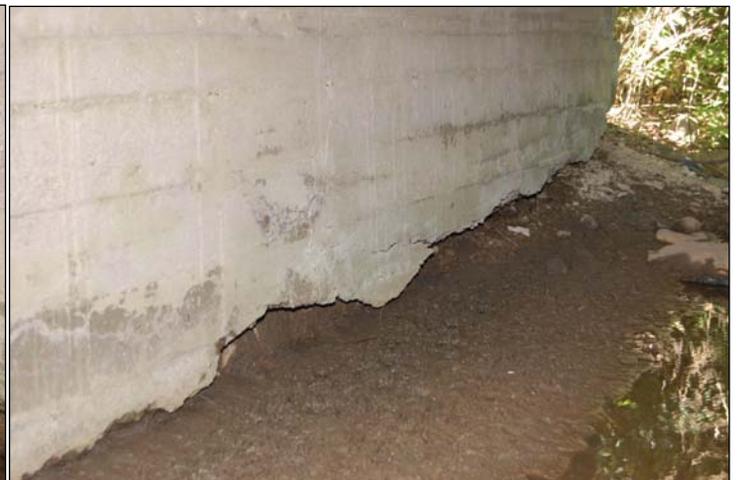
Small Bridge No. 2653

Fair, heavy spalling in spots

Poor, heavy spalling, some undermining

Poor, heavily spalled

<u>Description</u>	<u>Priority</u>	<u>Cost</u>
Bank/Stream:		
Safety-Signs: Place OM2s	3.5	\$38
Safety-GR:		
Replace:		
Road/Shld:		
Other: Underpin abutments	2	\$6,000

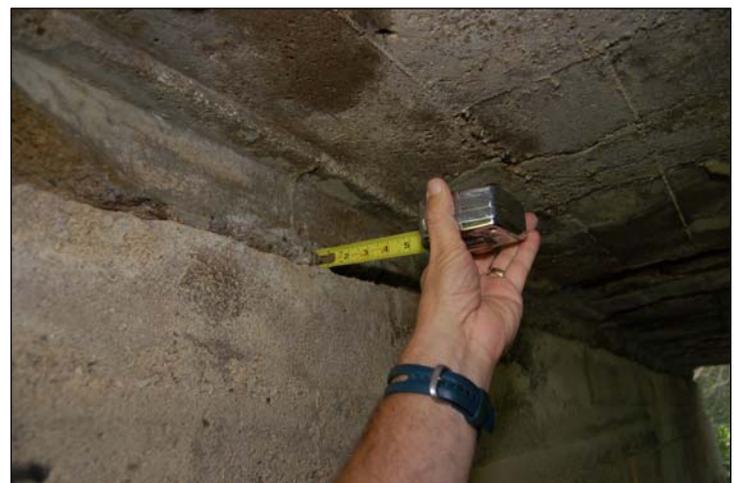
Top of East Wall, 1" leaning

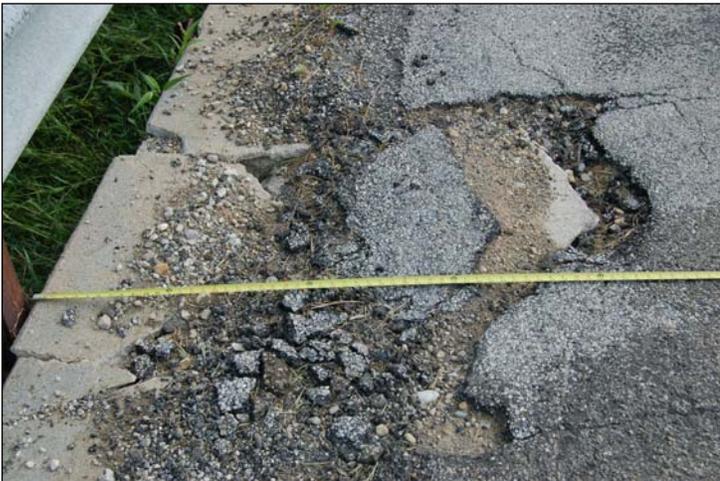
NE Corner Top View

Poor, failed NE, spalled throughout

<u>Description</u>	<u>Priority</u>	<u>Cost</u>
Bank/Stream:		
Safety-Signs: Place OM3s. Post 15 Ton	1	\$56
Safety-GR:		
Replace: Replace structure	3	\$24,000
Road/Shld:		
Other:

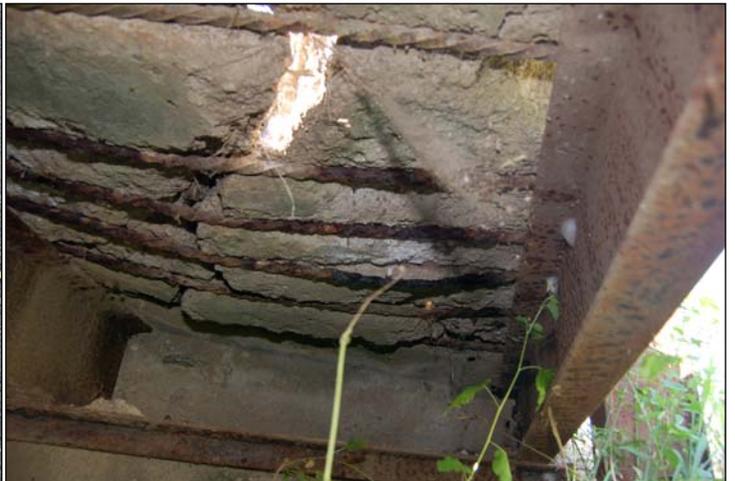
NE Corner Bottom View

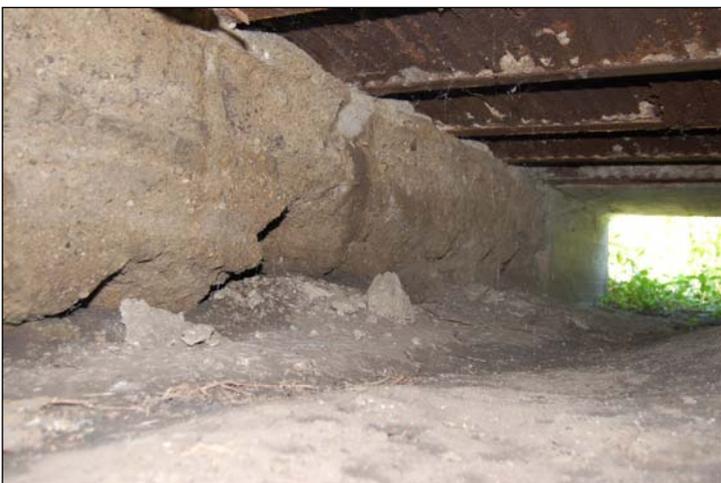
West Abutment

Poor, heavily spalled west

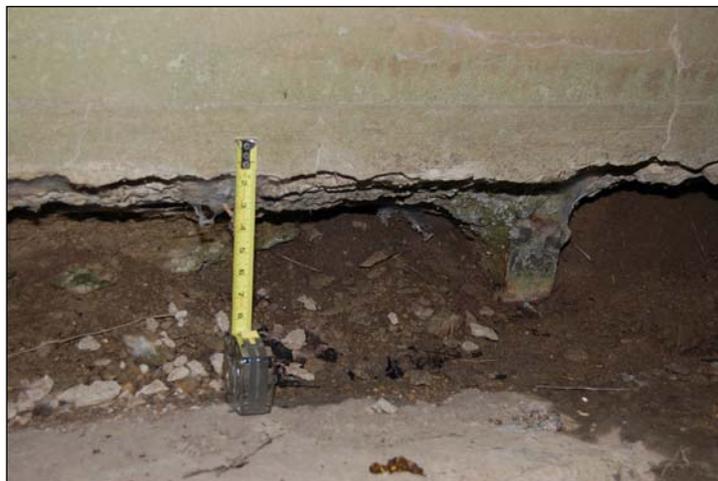
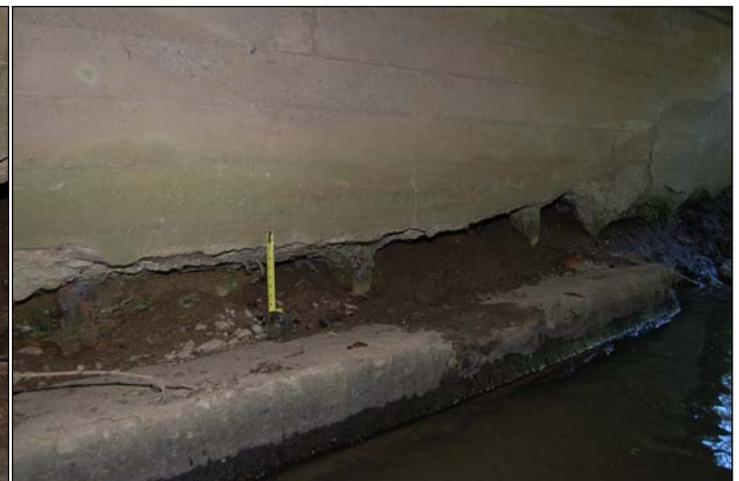
South Abutment

<u>MATERIAL</u>	<u>CONDITION</u>
Deck: Concrete	Good
Superstructure: Steel Beam Encased	Good
Substructure: Concrete	Poor, heavily spalled south
Channel: Natural	Good, fence blocks flow
Headwall: Concrete	Good
Culvert: n.a.	n.a.
Road: Chip & Seal	Rough, sinkhole at south end of culvert
Rail: Steel Tube	Inadequate
Load Rating: H20

<u>Description</u>	<u>Priority</u>	<u>Cost</u>
Bank/Stream:		
Safety-Signs: Place OM2s	3.4	\$38
Safety-GR:		
Replace:		
Road/Shld:		
Other: Repair south abutment	2	\$3,000
