CITY OF MUNCIE, INDIANA  
**American with Disabilities Act  
Transition and Implementation Plan**

December 2, 2011

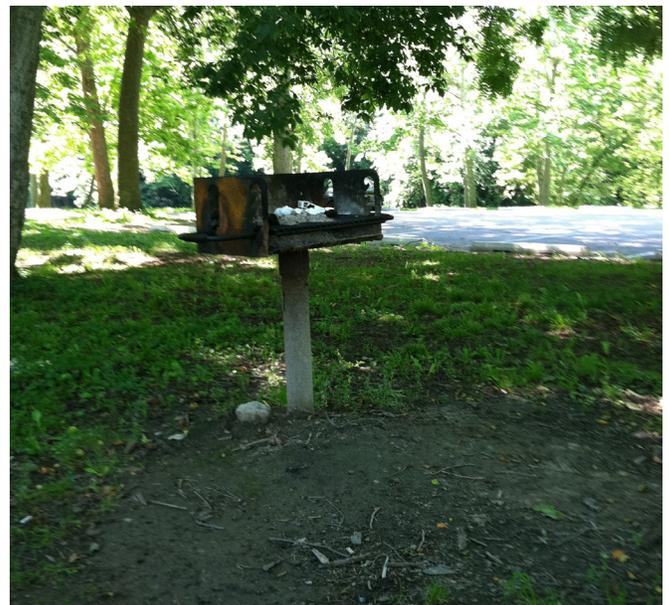
Typical park grill

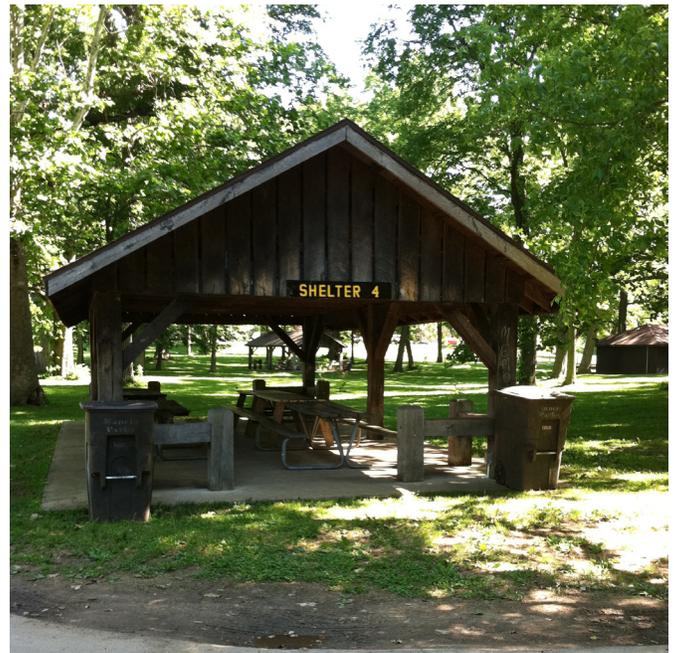
Shelter 4 with Shelter 3 and restrooms in background

Modify an existing picnic table, or purchase a new picnic table that provides accessible seating	Low	\$750.00 - \$1500.00 (new, varies by type)
<b>Shelter #4</b>		
Add accessible route to Shelter 4 from ADA parking stall	High	\$5.00 LF (5' wide, asphalt)
Move grill to level area. Add accessible route to and concrete pad around grill, with minimum clear space of 48" on all usable sides.	High	\$5.00 LF (5' wide, asphalt), \$4.00/SF concrete
Modify an existing picnic table, or purchase a new picnic table that provides accessible seating	High	\$750.00 - \$1500.00 (new, varies by type)

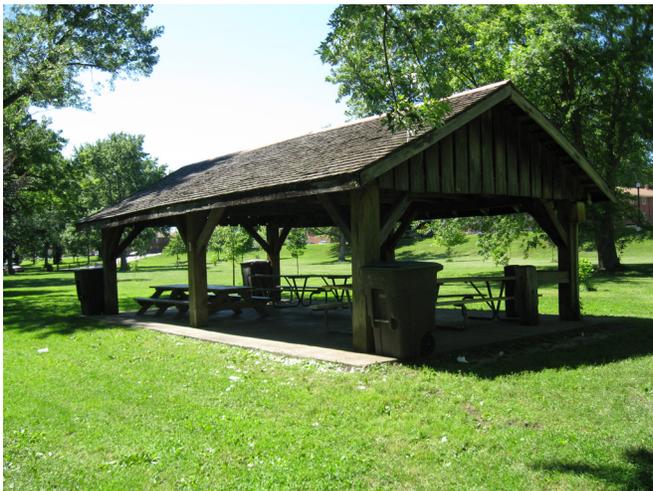
Shelter One

COMPLIANCE ITEM AND CORRECTIVE ACTION	PRIORITY	ESTIMATED COST
<b>Shelter #1</b>		
Add accessible route to Shelter 1	Low	\$5.00 LF (5' wide, asphalt)
Add accessible route to and concrete pad around grill, with minimum clear space of 48" on all usable sides	Low	\$5.00 LF (5' wide, asphalt), \$4.00/SF concrete
Modify an existing picnic table, or purchase a new picnic table that provides accessible seating	Low	\$750.00 - \$1500.00 (new, varies by type)
<b>Shelter #2</b>		
Accessible Route – see playground recommendations	High	See playground recommendations
Add accessible route to and concrete pad around grill, with minimum clear space of 48" on all usable sides	High	\$5.00 LF (5' wide, asphalt), \$4.00/SF concrete
Modify an existing picnic table, or purchase a new picnic table that provides accessible seating	High	\$750.00 - \$1500.00 (new, varies by type)
<b>Shelter #3</b>		
Add accessible route to Shelter 3	Low	\$5.00 LF (5' wide, asphalt)

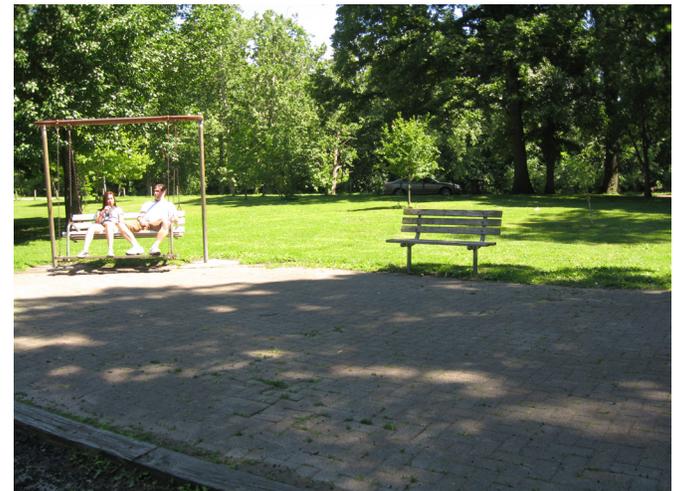
Seating and swing at playground

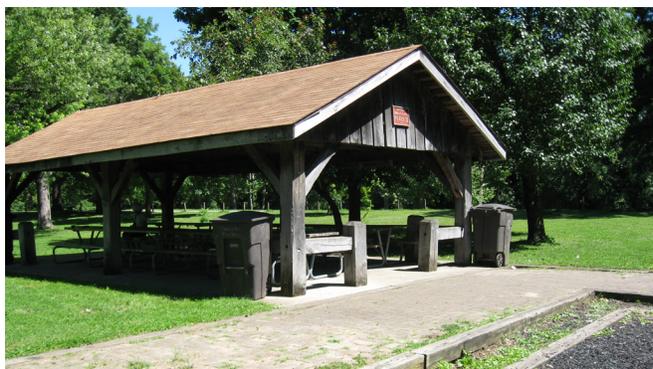
Shelter Two

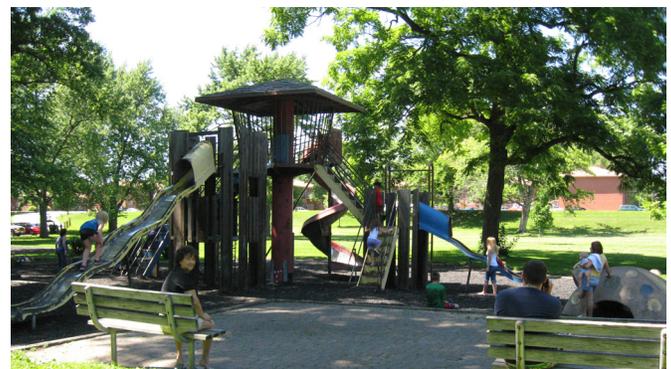
Playground structure

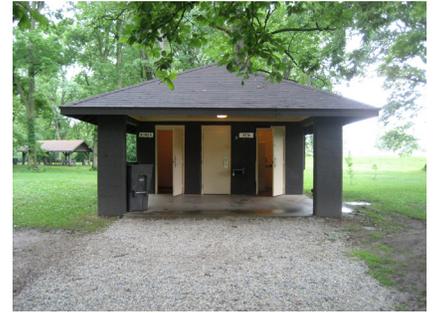
The public restroom building was the only enclosed building surveyed at Westside Park. It requires minor modification to be brought into compliance with the Standards.

Please note that door closers are not required at public bathrooms, but are sometimes desirable. If they were to be added, the door to the men's toilet would need to be rehung with the hinge on the left (as viewed from the outside) to maintain accessible maneuvering space.

<b>TOTAL CORRECTIVE ACTIONS: ENCLOSED BUILDING</b>		
	<b>QUANTITY</b>	<b>ESTIMATED COST</b>
<b>HIGH PRIORITY</b>	5	\$380.00
<b>MEDIUM PRIORITY</b>	2	\$5,000.00
<b>LOW PRIORITY</b>	1	\$2,000.00

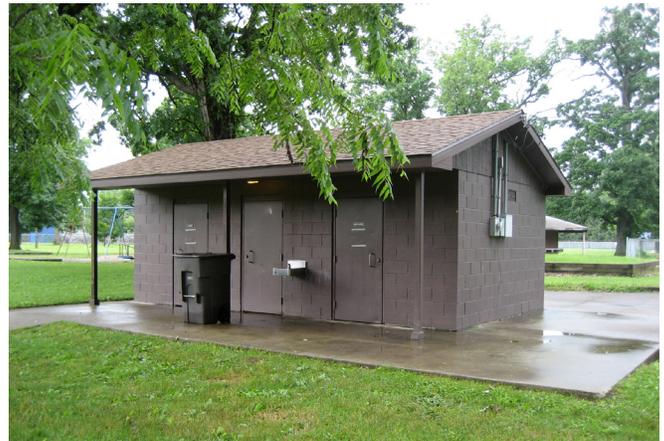
**PUBLIC RESTROOMS  
GENERAL COMPLIANCE ITEMS**

- drinking fountain- noncompliant and inoperative, is not cane-detectable
- signage- noncompliant

RESTROOMS GENERAL CORRECTIVE ACTIONS	ESTIMATED COST	PRIORITY
Install ADA compliant signage on both restrooms	\$60.00	High
Remove existing, non-working drinking fountain	\$300.00	High
Replace drinking fountain with two-height ADA compliant	\$2,000.00	Low

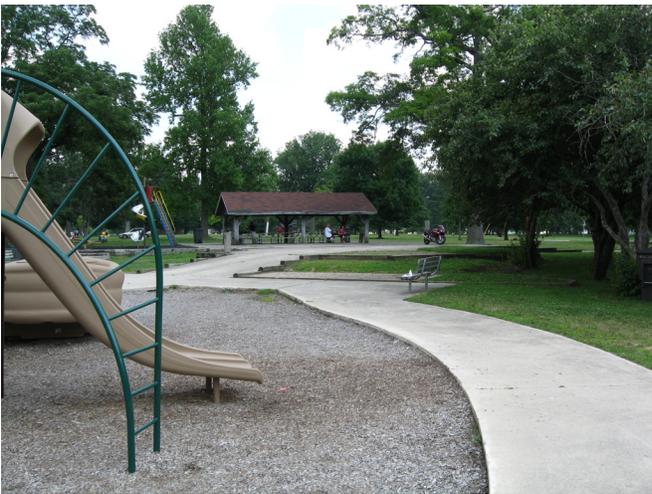
- Parking is provided at an adjacent parking lot serving the playground and picnic shelter.
- A concrete path leads from the parking lot to the playground. On the route to the playground, the walk elevates to a plateau condition, and then descends to a connecting walk located along the edge of the playground. Slopes of the walk at the elevation exceed 7% on the parking lot side, and approach almost 9% on the playground side, exceeding ADA standards for an accessible route.

Walk at playground, the picnic shelter and approach from parking lot can be seen in the background.

COMPLIANCE ITEM AND CORRECTIVE ACTION	PRIORITY	ESTIMATED COST
<ul style="list-style-type: none"> <li>▪ Provide accessible route from the parking lot, connecting the two playgrounds and picnic shelter. A spur that bypasses the elevated plateau and connects to the existing walk is the recommended alternative.</li> </ul>	High	\$5.00 LF (5’ wide, asphalt)
<ul style="list-style-type: none"> <li>▪ Replace wood mulch play surfacing with accessible playground surfacing.</li> </ul>	Medium	Varies with type/depth
<ul style="list-style-type: none"> <li>▪ Replace rubber mulch surfacing with accessible playground surface.</li> </ul>	Low	Varies with type/depth

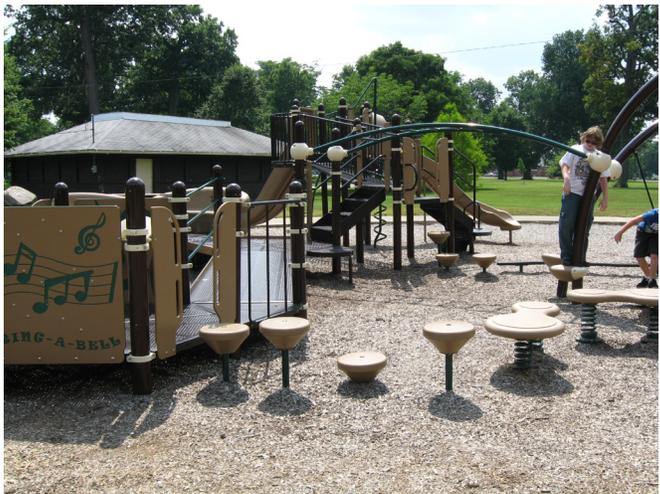
- Additional stand-alone ground level play components include a three-bay swing set, a teeter-totter and a rotating seat on a wood mulch surface. Also a spring-rider and a spiral slide are located nearby, on a rubber mulch play surface.

Ramped and ground level play components on composite play structure. Transfer steps to additional elevated play components can be seen on the far unit.

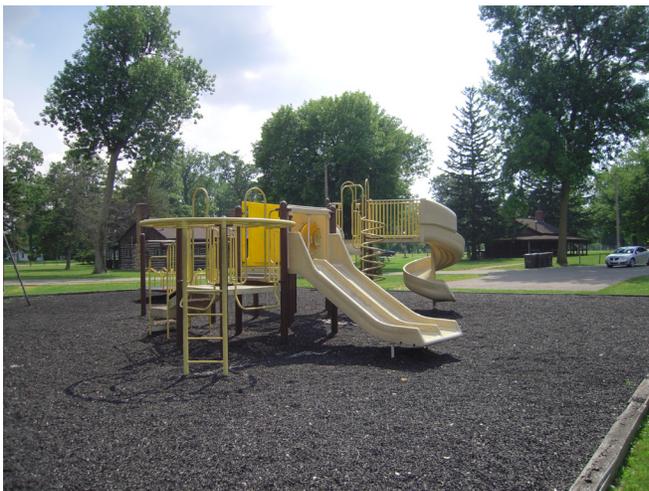
- The playground includes a composite play structure with seven elevated play components on a rubber mulch surface and three stand-alone play components, including a concrete climbing 'turtle' located in a lawn area. The transfer steps on the composite play structure do not meet ADA standards for dimensions. While it may be possible to modify the steps to provide greater accessibility, typically modifications of play equipment void manufacturer warranties and are not recommended without manufacturer approval.

Playground at Cabins, with parking area in background.

COMPLIANCE ITEM AND CORRECTIVE ACTION	PRIORITY	ESTIMATED COST
Replace composite play structure with accessible play structure (minimum of 50% of play components to be accessible, see 240.2.2)	Low	Varies with equipment selected.
Add accessible route from parking to playground, with accessible entrance to playground.	Low	\$5.00 LF (5' wide, asphalt)
Replace playground surface with accessible playground surface.	Low	Varies w/ type/depth

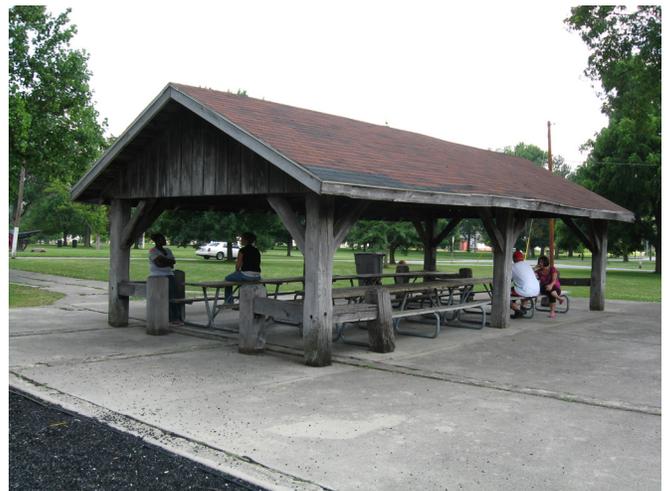
- The shelter contains four 12' x 28' picnic benches that do not provide accessible seating opportunities. A concrete path leads from the parking lot to the playground.
- The route from the parking lot to the main playground also provides access to the picnic shelter. See main playground discussion for description of accessible route and recommendations for improvements.

Heekin Park picnic shelter.

COMPLIANCE ITEM AND CORRECTIVE ACTION	PRIORITY	ESTIMATED COST
▪ Replace at least one picnic table with a picnic table that is shorter in length (to provide required maneuvering room) and has accessible seating options.	High	\$750.00 - \$1500.00 (new, varies by type)

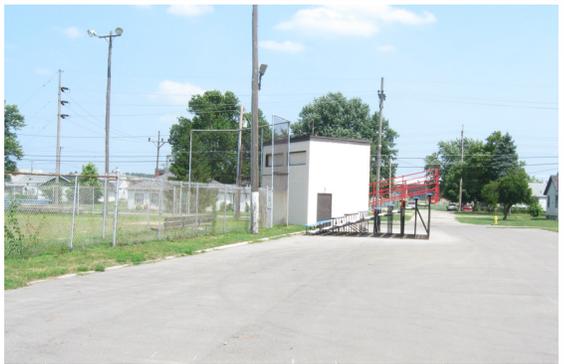
**BASEBALL DIAMOND**

- The baseball diamond is not currently used for scheduled play, but may be used for informal pick-up games or practice. Because the field sees little play, improvements for this amenity are a low priority.
- Parking is provided adjacent to the ball diamond, in the unmarked parking lot that serves the park office.
- Bleachers for the ball diamond sit on the asphalt parking lot pavement. A person using a wheelchair could sit alongside the bleachers to watch a game.
- The diamond itself does not include an accessible route to the bench/field.

COMPLIANCE ITEM AND CORRECTIVE ACTION	PRIORITY	ESTIMATED COST
Add marked/signed ADA parking stall and access aisle adjacent to the ball diamond.	Low	\$2.50 SF (asphalt) \$200.00 signage and striping
Add accessible route from the parking lot to the team benches.	Low	\$5.00 LF (5' wide, asphalt)

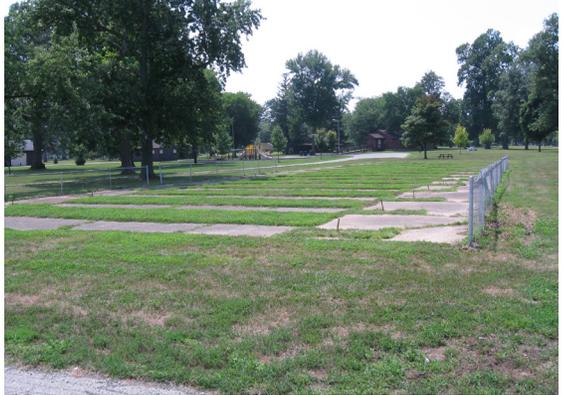
**HORSESHOE PITS**

- The eight horseshoe pits are in poor condition and see little play. Consequently, the ADA improvements to this amenity are medium to low priority.
- While ADA standards/guidelines specifically for Horseshoe pits have not been developed, improvements based upon current standards and practices can provide greater accessibility to this amenity. These improvements include
  - accessible parking
  - an access route to the amenity
  - clear turning spaces and an access route to allow travel from one end of the pit to the other
  - Given the limited amount of use of this amenity, it is recommended that initial improvements are made to provide access to a minimum of one horseshoe pit.

COMPLIANCE ITEM AND CORRECTIVE ACTION	PRIORITY	ESTIMATED COST
Mark and sign an accessible parking stall	Low	\$200.00
Provide accessible route from the parking stall to the nearest horseshoe pit, connecting both ends of the play area and providing turning space at either end meeting 304 Turning Space	Medium	\$5.00 LF (5' wide, asphalt)

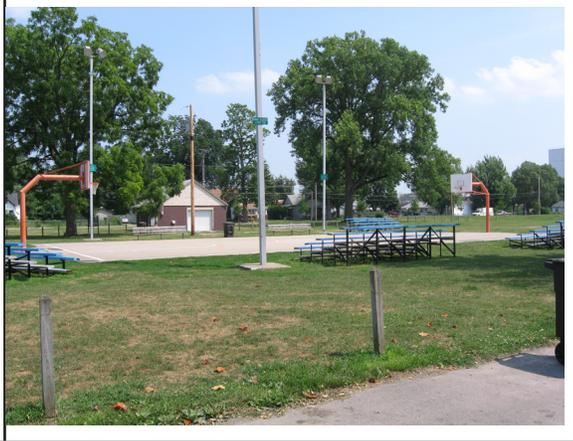
- Parking is provided at an adjacent parking lot.
- An access route from the parking lot to the court and the bleachers is needed.
- A paved pad adjacent to the bleachers would provide opportunities for a person using a wheelchair to watch a game and interact with others on the bleachers.

COMPLIANCE ITEM AND CORRECTIVE ACTION	PRIORITY	ESTIMATED COST
Add access route from parking lot to bleachers and basket ball court.	High	\$5.00 LF (5' wide, asphalt)
Add paved surface of sufficient size to accommodate wheelchair access adjacent to the bleachers.	Medium	\$4.00 SF (concrete)

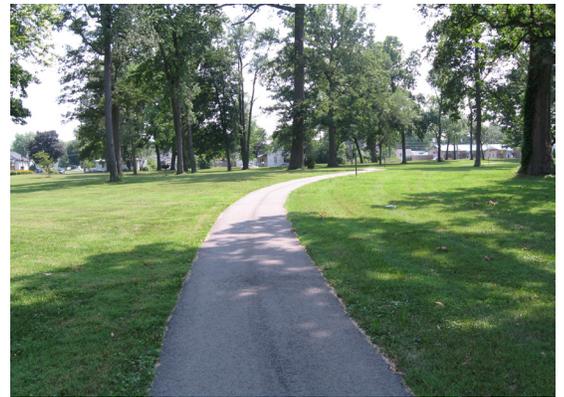
- Unmarked parking is available along the road or marked parking at the playground parking lot.
- The majority of the trail is within ADA standards for slope, with the exception of the approach immediately adjacent to the road. The approach could be modified to accommodate the existing grade change with a longer, more moderately sloped connection to the road.

COMPLIANCE ITEM AND CORRECTIVE ACTION	PRIORITY	ESTIMATED COST
Add accessible parking adjacent to trail access.	Low	\$2.50 SF (asphalt) \$200.00 signage and striping
Modify trail approach to meet ADA standards for slope	Medium	\$450.00

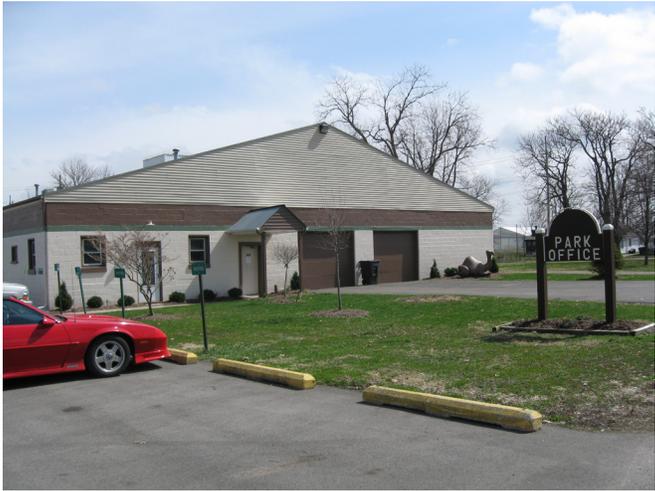
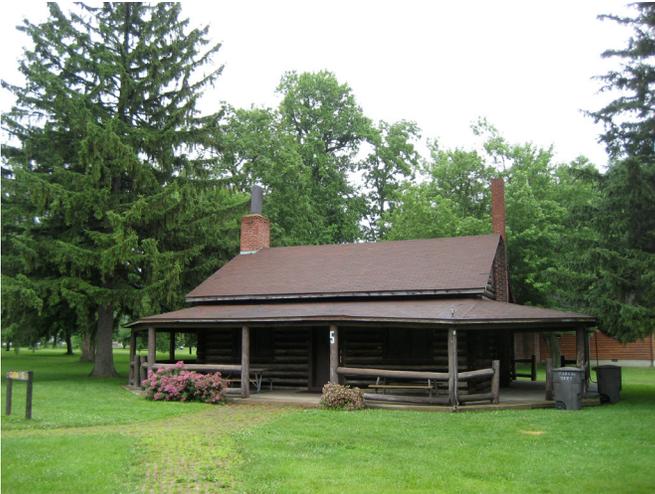
- Low-hanging fruit: Cabins 1, 4, and 5 can be brought into compliance with little effort.
- Costly but critical: Cabin 3 requires a fair amount of remodeling. The toilet room is an extra amenity not provided in the other cabins, and will require moving walls to bring into compliance. The existing ramp is “close to compliant” and should be replaced, but is a much lower priority than the toilet room.
- Not recommended: Cabin 2 can't be brought into complete compliance without serious structural implications to the historic nature of the building. In these cases, some modifications can be made to make the building easier to access. They are given a lower priority, as available funds should first be spent on other recommendations.
